BUGATTI COOLING SYSTEM PIPE – AL ALLOY – FRANCE

Artefact name	Bugatti cooling system pipe
Authors	Granget. Elodie (, None) & . (MNAM (Musée National de l'Automobile de Mulhouse), Mulhouse, Alsace, France)
Url	/artefacts/670/

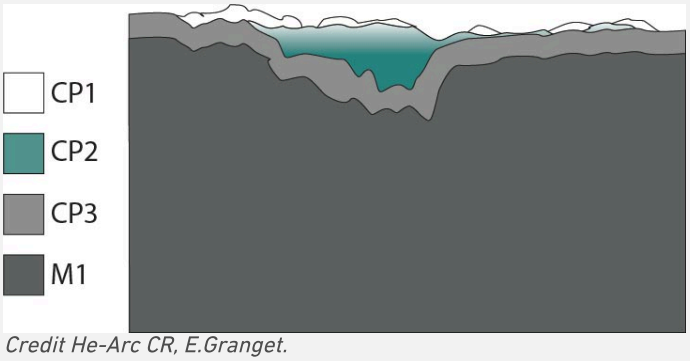
Fig. 4: Stratigraphic representation of the corrosion structure of the external surface of the water pipe in cross section,

The stratum M is an aluminium alloy. Three CP strata have been identified. CP3 has a greyish mate color and is covering all of the corroded side of the pipe. Scattered over this uniform layer, blue-green (CP2) and white (CP1) spots of corrosion products can be found.

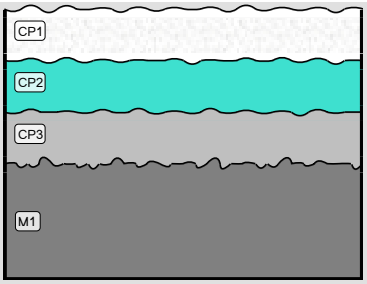
Fig. 5: Stratigraphic representation of the Bugatti water pipe under binocular using the MiCorr application. The characteristics of the strata are only accessible by clicking on the drawing that redirects you to the search tool by stratigraphy representation. This representation can be compared to Fig. 4, Credit HE-Arc CR, E.Granget.

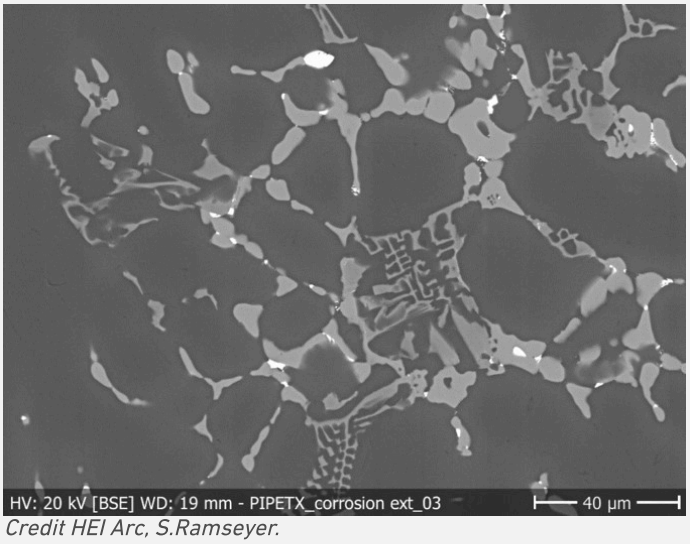
Fig. 10: SEM image (BSE mode) of the metal sample from Fig. 9 showing the microstructure of the pipe. Dark grey = main phase (Al), medium grey = interdendritic phase 1 (eutectic Fe, Cu), light grey = interdendritic phase 2 (Cu) and white = precipitates (Si, Sn),

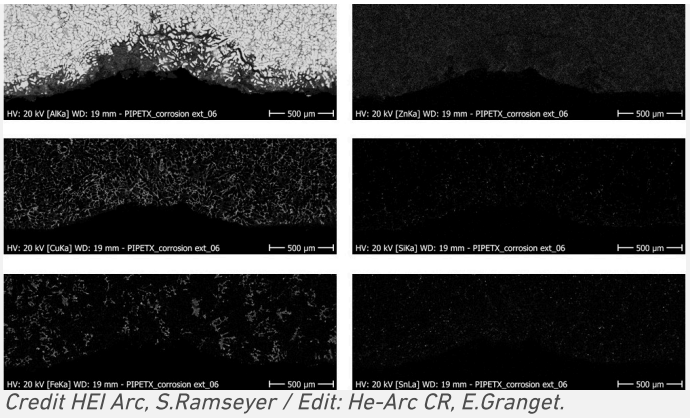
Fig. 11: Close-up image of Fig. 10,

Fig. 12: SEM image and EDS elemental chemical distribution of main and interdendritic phases of the pipe. 20kV,

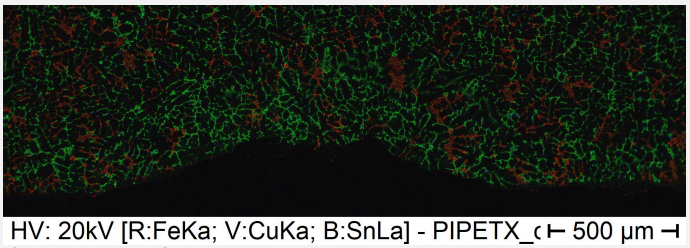
Point analyses of the main dendritic phase showed that it is made of Al, Cu and Zn (Table 1 and Fig. 11). Elemental chemical distribution with EDS allowed to identified the following repartition (Fig. 12): Zn is uniformely present in the alloy. There are two interdendritic phases (Fig. 13): a eutectic phase containing Fe and Cu, and a second phase containing mostly Cu. Additionally Sn and Si precipitates could be identified.

Fig. 13: Fe (red), Cu (green) and Sn (blue) chemical distribution of the area of Fig. 9. Method of analysis: SEM-EDS. Lab. of Electronic Microscopy and Microanalysis, Néode, HEI Arc,

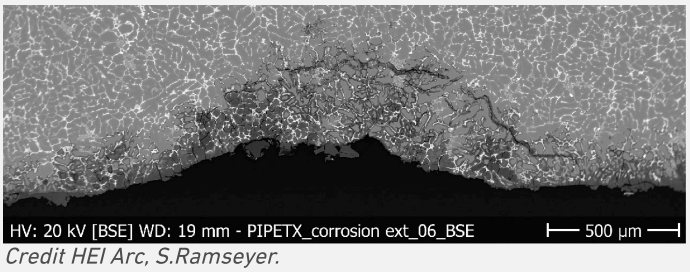
The BF and DF images (Figs. 8 and 9) show a few big cracks at the interface between CM1 and M1. The SEM image shows that they expand in a network of additional microcracks (Fig. 14). The pipe suffers from a uniform interdendritic corrosion. The Al, Cu and Zn phase is oxidising preferentially, developing then aluminium oxides, versus the interdendritic phases. In some places, pits of corrosion formed. SEM cartography showed a concentration of Cl at the base of the pit (Fig. 14: Green).

Fig. 14: SEM image of the pitting corrosion of the pipe. BSE, 20kV. Black = Cracks, Dark grey = oxydation, Medium grey = main phase, Light grey = interdendritic phase,

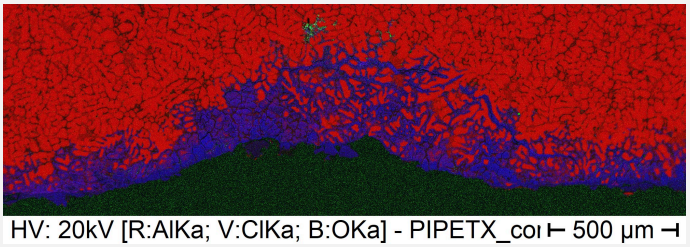
Fig. 15: SEM cartography of a pit of corrosion developing on the pipe. 20kV. Red = Al, Green = Cl, Blue = O,

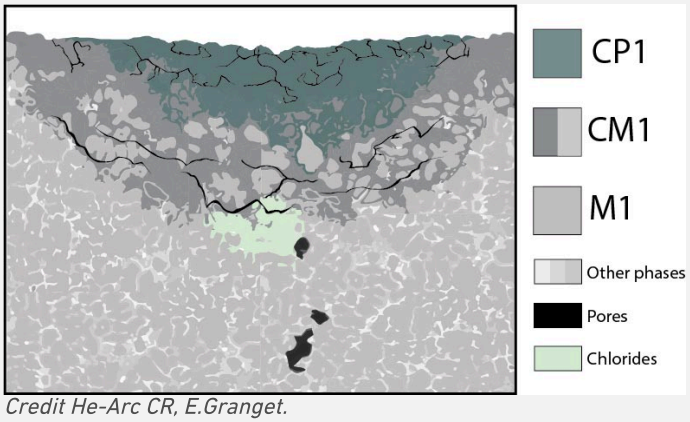
Fig. 16: Improved stratigraphic representation of the exit pipe,

The external surface shows a uniform interdendritic corrosion preferentially consuming the dentritic phase (Al, Cu, Zn). Pitting corrosion has been identified, with Cl pockets at the base of the pit.
