BUGATTI 37 CYLINDER HEAD GASKET 0416 - AL ALLOY - MODERN TIMES - FRANCE

Artefact name	Bugatti 37 cylinder head gasket 0416
Authors	Granget. Elodie (, None) & . (MNAM (Musée National de l'Automobile de Mulhouse), Mulhouse, Alsace, France)
Url	/artefacts/671/

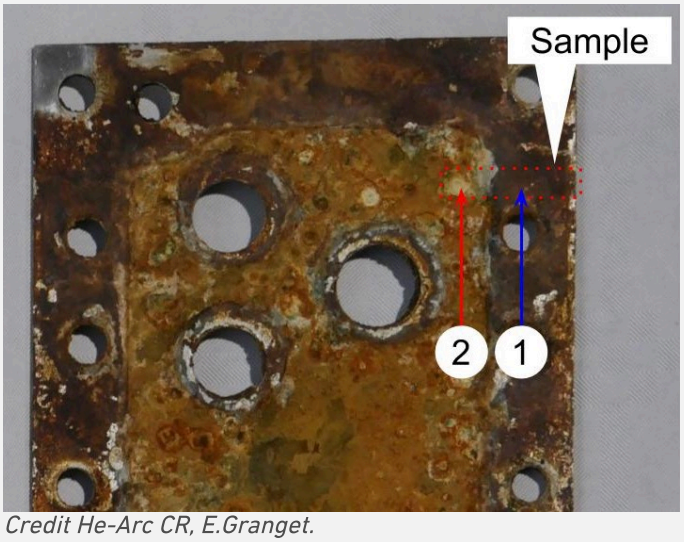
Fig. 3: Bugatti Type 37 cylinder head gasket. Location of the sampling area (red rectangle). Stratigraphic observation sites, in contact with the block [1] and in contact with the coolant [2],

Fig.3 clearly shows the limit where the gasket is in contact with the cylinder block ([1] edges and circular openings in the center) and where it is in contact with the coolant ([2] center).

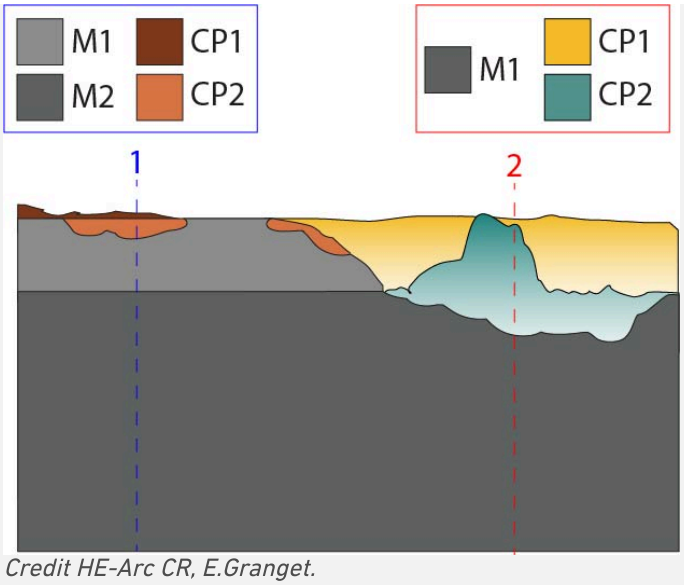
The schematic representation below gives an overview of the corrosion layers encountered on these areas (Fig. 4). The metal core (M1) is colaminated on both sides with metal M2.

Stratigraphy [1]	Stratigraphy [2]
The metal contains the strata M1 and M2.	The first metal stratum is missing and only the core metal (M2 in strat.[1], now M1) remains.
The CP1 is a thin brown layer loosely attached to the surface of M1. It can be removed with a firm brush.	The CP1 is a thick bright orange layer, really powdery and easily detached. It can be partly removed with a firm brush. The coloration is less important closer to the metal interface, where the products are white. This layer is also really fragile and friable.
In some places, CP2 develops within M1. It is colored in bright orange and can be broken in pieces with a toothpick.	The CP2 is peaking through CP1 in some places, colored in green.

Fig. 4: stratigrphic representation of corrosion zones in contact with the block [1] and in contact with the coolant [2],

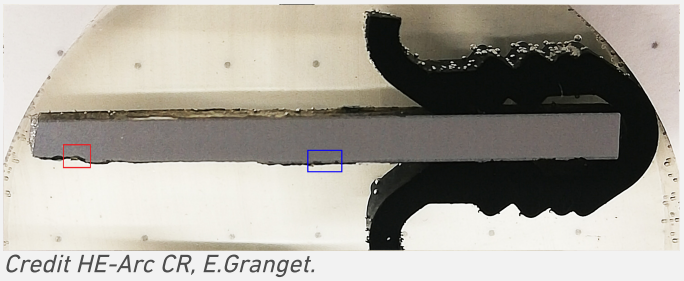
Fig. 5: Micrograph of the cross-section sampled from the Bugatti T37 gasket showing the location of zone 1 in blue (Fig. 8) and zone 2 in red (Fig. 10),

Description of sample	The sample shown on Fig.5 is a transversal cut of the gasket presenting 3 different corrosion sites. Bottom side: Contact with coolant [1] Fig. 7. Contact with block [2] Fig. 6. Top side: Contact with oil (not presented in this artefact sheet).
Alloy	Al Alloy
Technology	Rolled (probably hot rolling) and annealed
Lab number of sample	
Sample location	HE-Arc CR, Neuchâtel, Neuchâtel
Responsible institution	MNAM (Musée National de l'Automobile de Mulhouse), Mulhouse, Alsace
Date and aim of sampling	31.12.2019 - Sampled for Metallography

During sampling, a large part of the top corrosion layer (CP1) was lost for both zones 1 and 2.

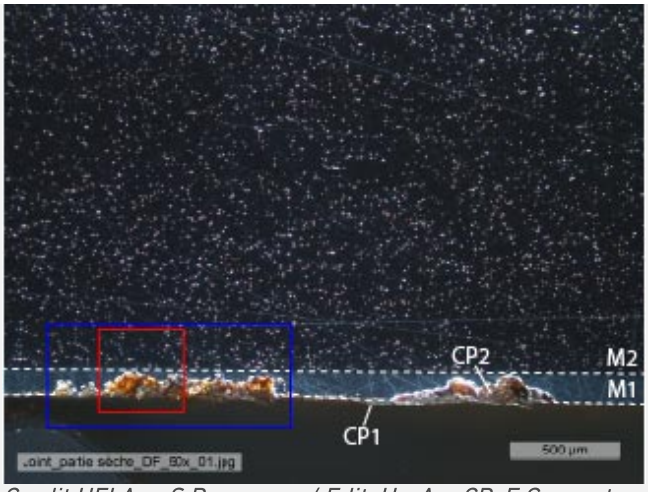
Fig. 8: Micrograph of the cross-section of the gasket, zone 1, shown on Fig. 5 unetched, dark field, showing the location of the EDS elemental chemical distribution of Fig. 12 to 15 (in blue) and of the SEM image of Fig. 9 (in red),

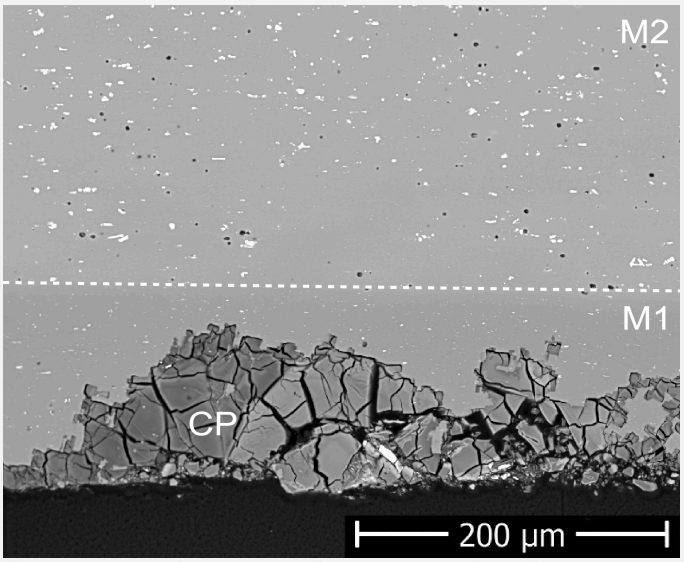
Fig. 9 shows oriented inclusions on both M1 and M2, as well as a lot of small pores in M2.

Ponctual analyses on each phase appearing on Fig. 9 showed that the roll-bounded metal M1 is a compact (non-porous) sheet of pure Al (Table 1) with oriented inclusions of Fe and Si. The core M2 is a very porous alloy composed of Al with bigger oriented inclusions of Si, Mn, Fe, Mg.

Fig 9: SEM detail (BSE mode) of zone 1 of the colaminated sheet in cross-section. The core metal (M2) is porous (in black) and shows oriented inclusions (in white) and the colaminated metal (M1) is compact and has smaller oriented inclusions (in white). Corrosion products (in dark grey) are limited to M1,

Fig. 9 shows that the corrosion products progress through M1 and develop a network of cracks. Fig. 10 shows that the corrosion can expand even further through M2, the corrosion products being more stratified (Fig. 11).

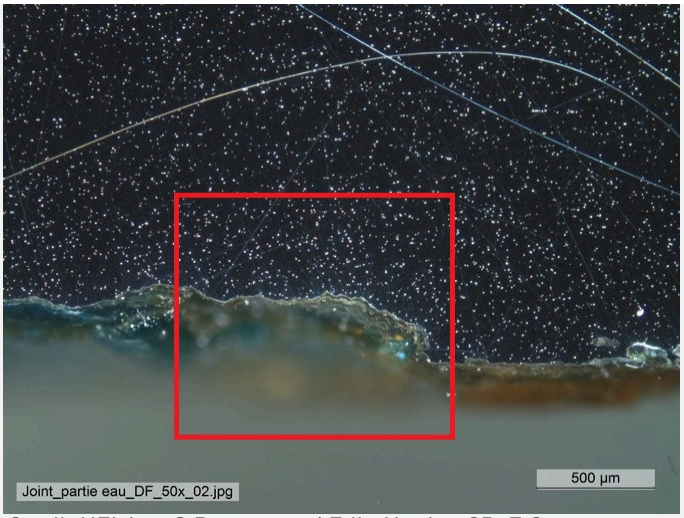
Fig. 10: Micrograph of the cross-section of the gasket, zone 2, shown on Fig. 5 unetched, dark field, showing the location of the SEM image of Fig. 11 (in red),

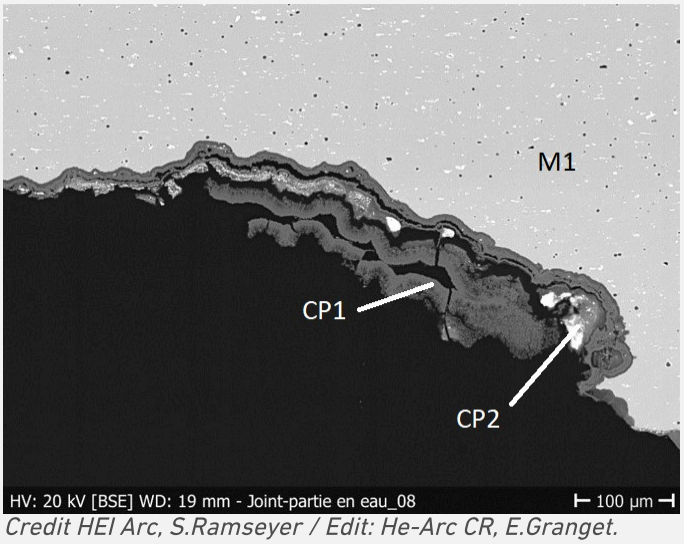
Fig 11: SEM detail (BSE mode) of zone 1 of the gasket in cross-section. The colaminated Al is missing. The core metal (now M1) is porous (black spots) and shows oriented inclusions (in white). The corrosion products (CP1) are very friable and retain clusters of inclusions that are also corroded (CP2),

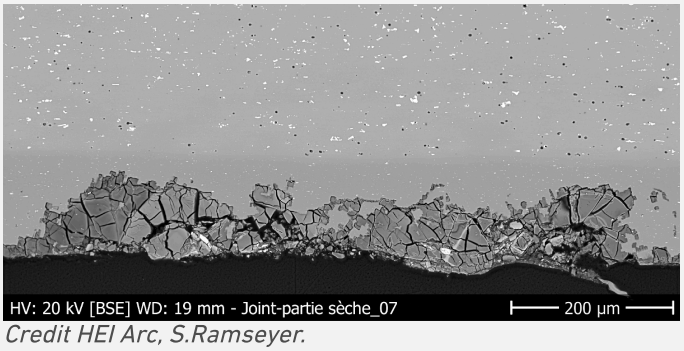
Fig. 12: SEM image (BSE mode) of the cross-section of zone 2 of the gasket (detail of Fig. 8) showing the core metal on top (M2) and the heavily corroded colaminated metal (M1),

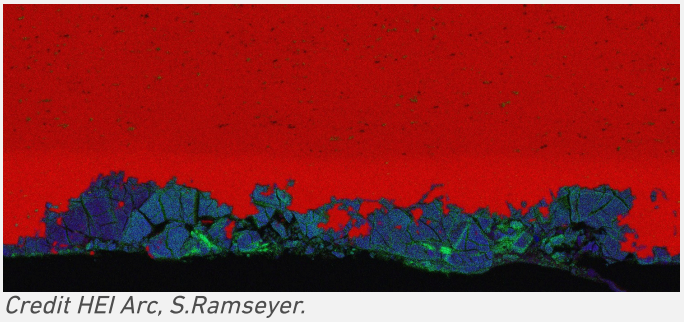
The EDS elemental chemical distribution of zone 1 is given in Fig. 13 to 15. The corrosion layers contain S (probably aluminium sulfate (Fig. 14), polluted with Fe (Fig. 13)). The presence of sulfur can be explained by the proximity of the gasket to the combustion chamber. As for the iron, it is probably coming from the steel block.

Fig. 13: Al (red), O (blue) and Fe (green) chemical distribution of the area of Fig. 12. Method of analysis: SEM-EDS. Lab. of Electronic Microscopy and Microanalysis, Néode, HEI Arc.

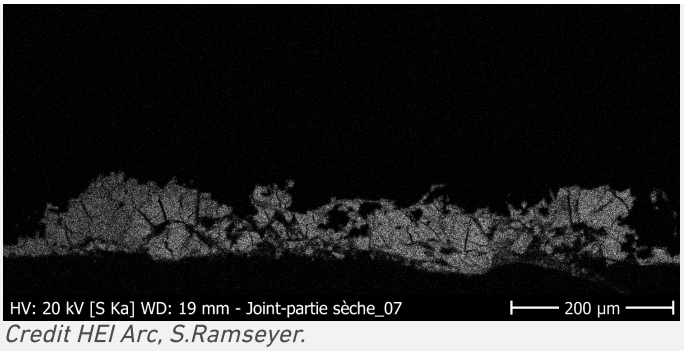
Fig. 14: S chemical distribution of the area of Fig. 12. Method of analysis: SEM-EDS. Lab. of Electronic Microscopy and Microanalysis, Néode, HEI Arc.

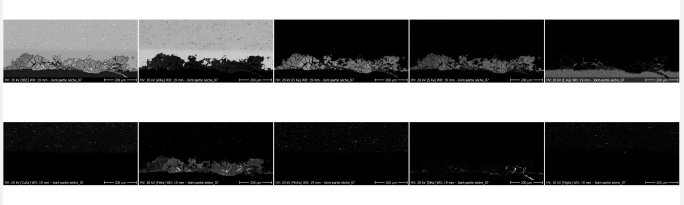
Fig. 15: SEM image and elemental chemical distribution of the area of Fig. 12. Method of analysis: SEM-EDS. Lab. of Electronic Microscopy and Microanalysis, Néode, HEI Arc.

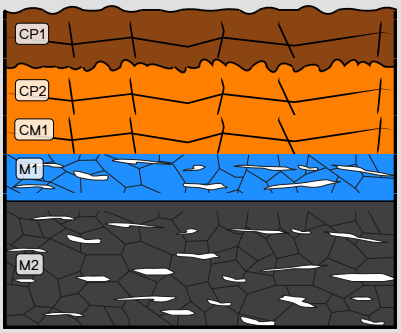
Fig. 6: Stratigraphic representation of the gasket (zone 1) in cross-section (dark field), using the MiCorr application. The characteristics of the strata are only accessible by clicking on the drawing that redirects you to the search tool by stratigraphy representation. This representation can be compared to Fig. 9, Credit HE-Arc CR, E.Granget.

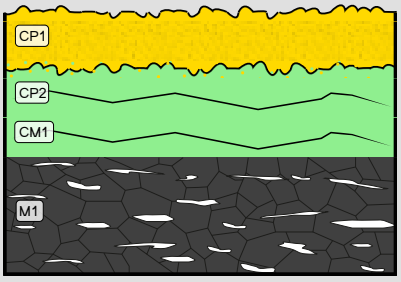
Fig. 7: Stratigraphic representation of the gasket (zone 2) in cross-section (dark field), using the MiCorr application. The characteristics of the strata are only accessible by clicking on the drawing that redirects you to the search tool by stratigraphy representation. This representation can be compared to Fig. 11, Credit HE-Arc CR, E.Granget.

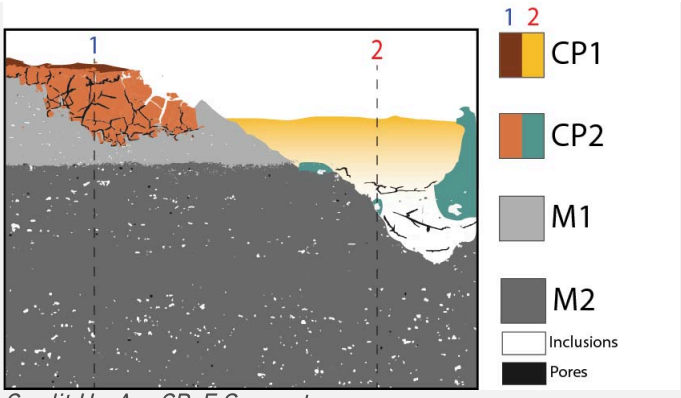
The schematic representations of corrosion layers of Figs. 6 and 7 integrating additional information based on the analyses carried out is given in Fig. 16.

No analyses could be carried out on the top thicker part of CP1.

Fig. 16: Improved stratigraphic representation of the 2 corrosion structures of the Bugatti cylinder head gasket. CP1 could not be analysed,
