BUGATTI 37 CYLINDER HEAD GASKET 0416 – AL ALLOY – MODERN TIMES – FRANCE

Artefact name Bugatti 37 cylinder head gasket 0416

Authors Granget. Elodie (, None) & . (MNAM (Musée National de l'Automobile de Mulhouse), Mulhouse, Alsace, France)

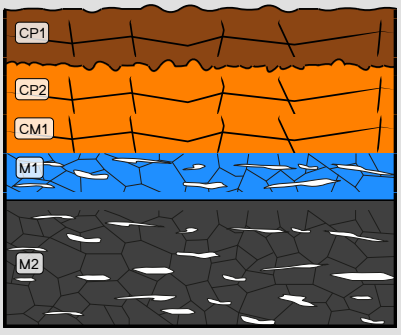
Fig. 6: Stratigraphic representation of the gasket (zone 1) in cross-section (dark field), using the MiCorr application. The characteristics of the strata are only accessible by clicking on the drawing that redirects you to the search tool by stratigraphy representation. This representation can be compared to Fig. 9, Credit HE-Arc CR, E.Granget.

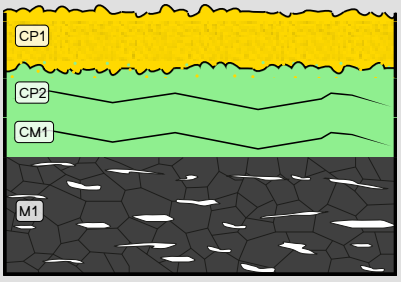
Fig. 7: Stratigraphic representation of the gasket (zone 2) in cross-section (dark field), using the MiCorr application. The characteristics of the strata are only accessible by clicking on the drawing that redirects you to the search tool by stratigraphy representation. This representation can be compared to Fig. 11, Credit HE-Arc CR, E.Granget.

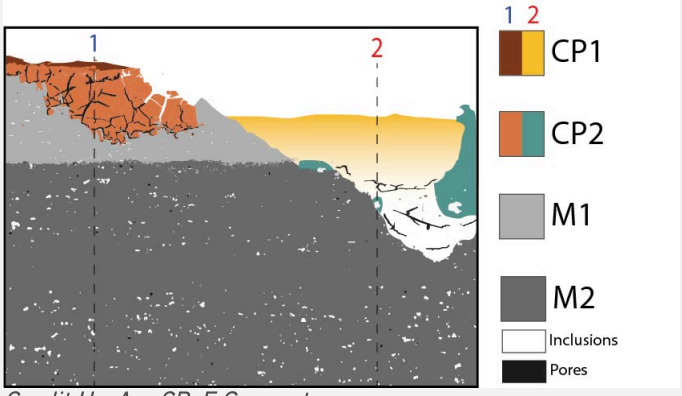
Fig. 16: Improved stratigraphic representation of the 2 corrosion structures of the Bugatti cylinder head gasket. CP1 could not be analysed,

The side of the gasket facing the cylinder block has a different corrosion pattern depending on whether the area is immersed or not. The surface in contact with the cylinder block shows a priori corrosion consisting of highly cracked aluminium sulphate (network). The surface immersed in the coolant is heavily corroded. The colaminated Al sheet has been completely consumed, and the corrosion progresses through the support metal, retaining inclusions of the alloy in its products. This layer is very brittle and tends to delaminate.

All the corrosion products are contaminated with iron oxides, probably from the block. The immersed part is covered with a thick crust of what is believed to be a mixture of ferrous and aluminium-based products.
