FRAGMENT OF AN AEGIS OF NEÏTH 1886.305.0096 - LEADED BRONZE

Artefact name Fragment of an Aegis of Neïth 1886.305.0096

Authors Line. Pedersen (HE-Arc, Neuchâtel, Neuchâtel, Switzerland) & Christian. Degrigny (HE-Arc CR, Neuchâtel, Neuchâtel, Switzerland) & Valentin. Boissonnas (HE-Arc CR, Neuchâtel, Neuchâtel, Switzerland)

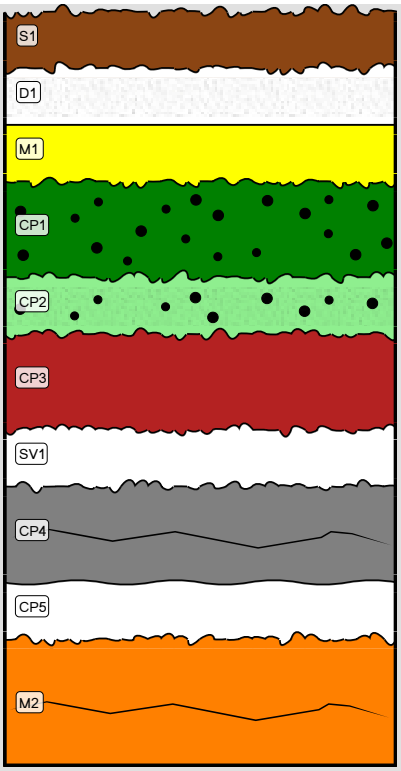
Fig.9: Schematic representation combining stratigraphies 1 and 2 under binocular and using the MiCorr application. The characteristics of the strata are only accessible by clicking on the drawing that redirects you to the search tool by stratigraphy representation, Credit He-Arc CR, L.Pedersen.

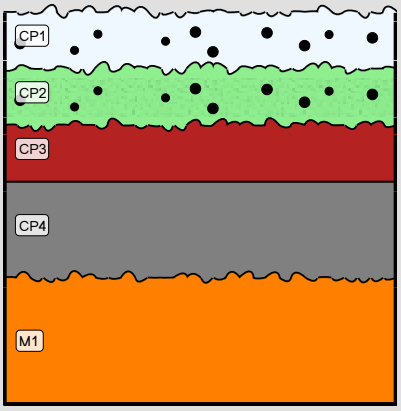
Fig.10: Schematic representation of stratigraphy 3 under binocular and using the MiCorr application. CP1 is CP6 in Fig. 8. The characteristics of the strata are only accessible by clicking on the drawing that redirects you to the search tool by stratigraphy representation, Credit He-Arc CR, L. Pedersen.
