COOKING POT HANDLE FRAGMENT V.008.2/2948.1. - LEADED BRONZE - ROMAN TIMES - SWITZERLAND

Artefact name Cooking pot handle fragment V.008.2/2948.1.

Authors Christian. Degrigny (HE-Arc CR, Neuchâtel, Neuchâtel, Switzerland) & Lucile. Ruynat (HE-Arc CR, None) & Valentin. Boissonnas (HE-Arc CR, Neuchâtel, Neuchâtel, Switzerland)

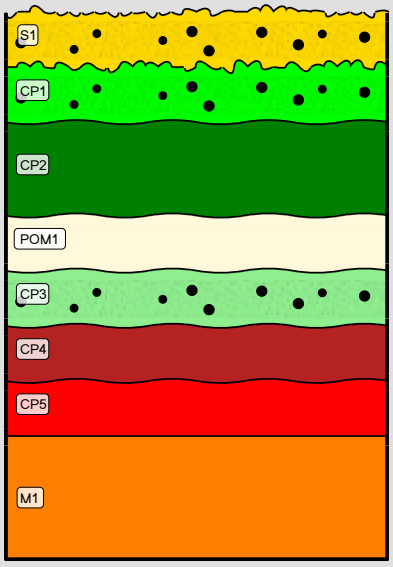
Fig. 4: Stratigraphic representation of the cooking pot handle fragment under binocular using the MiCorr application (to be compared to Fig. 3). The stratum SV1 is missing because it is integrated in CP2 and it was not possible to represent it in MiCorr while POM1 and POM2 are merged as POM1. The characteristics of the strata are only accessible by clicking on the drawing that redirects you to the search tool by stratigraphy representation, Credit HE-Arc CR, L.Ruynat.

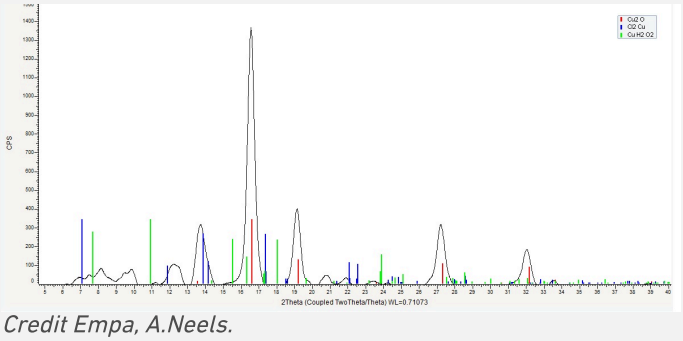
Above the well-preserved metal core, CP4 is discontinuously interlocked in CP5. The XRD analysis done on a sample (Fig. 2, red square 2) of both corrosion products, shows that they are mainly constituted of cuprite (Cu2O), (Fig. 5). The colour difference can be explained by a tin enrichment in the darker CP4, as measured by XRF. XRF analyses of CP4 (Fig. 2, blue dot 5) and CP5 (Fig. 2, blue dot 4) are given in Table 2. The EDS analysis of the light green CP3 (red square 1 Fig. 2) layer did not reveal the presence of chlorides (Fig. 6). Complementary XRD analysis validated the absence of nantokite. Indeed the XRD and Raman indexing was not successful probably because the compound has a large amorphous part. The other layers were not analysed, we expect CP1 and CP2 to be malachite (copper carbonate hydroxyde) because of the green colour and absence of chlorides. Organic remains were mineralised and preserved by the corrosion process.

Elements mass %	Cu	Sn	Pb	Sb	As	Ag	Fe	P	Cl	S	BAL
Dark-red layer (CP4)	24.9	18.2	11.2	0.7	0.1	0.09	0.1	0.3	0.4	7.2	36.1
Red area layer (CP5)	33.5	14.5	16	0.5	0.8	0.1	0.05	1.3	0.6	1.5	30.5

Table 2: Chemical compositions of the dark-red and the red layers. Method of analysis: XRF, mode mining Cu/Zn, 180s (filters M30/Lo30/H60/Li60). BAL corresponds to the elements not analysed: O and C, credit MiCorr_HE-Arc CR, C.Degrigny.
