BLADE FRAGMENT OF A WINGED AXE FK43 – TIN BRONZE – MIDDLE BRONZE AGE – SWITZERLAND

Artefact name	Blade fragment of a winged axe FK43
Authors	Marianne. Senn (EMPA, Dübendorf, Zurich, Switzerland) & Christian. Degrigny (HE-Arc CR, Neuchâtel, Neuchâtel, Switzerland)
Url	/artefacts/679/

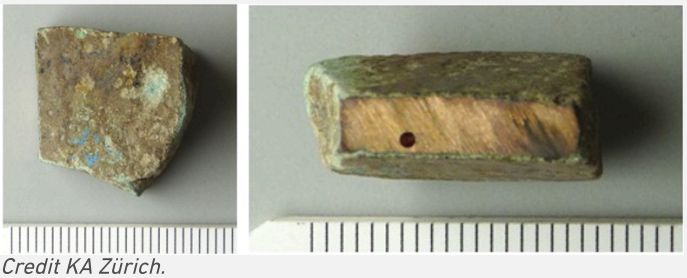
Fig. 1: Blade fragment of winged axe. The drilling on the right picture was carried out at a later stage and does not form part of the original object,

Description of the artefact	Blade fragment of a semi-finished median-winged axe. Its surface is covered with a thick dark green corrosion crust (Fig. 1). Dimensions: L = 20mm; Tmax. = 8.5mm; WT = 15g.
Type of artefact	Tool
Origin	Obstgartenstrasse, Erlenbach, Zurich, Switzerland
Recovering date	Excavation 1980.002
Chronology category	Middle Bronze Age
chronology tpq	1550 B.C.
chronology taq	1350 B.C.
Chronology comment	
Burial conditions / environment	Soil
Artefact location	Kantonsarchäologie, Dübendorf, Zurich
Owner	Kantonsarchäologie, Dübendorf, Zurich
Inv. number	FK43
Recorded conservation data	Not conserved

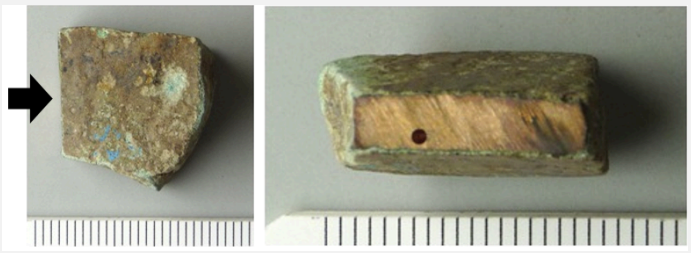
Fig. 2: Location of sampling area (arrow, left picture) and side view (right picture),

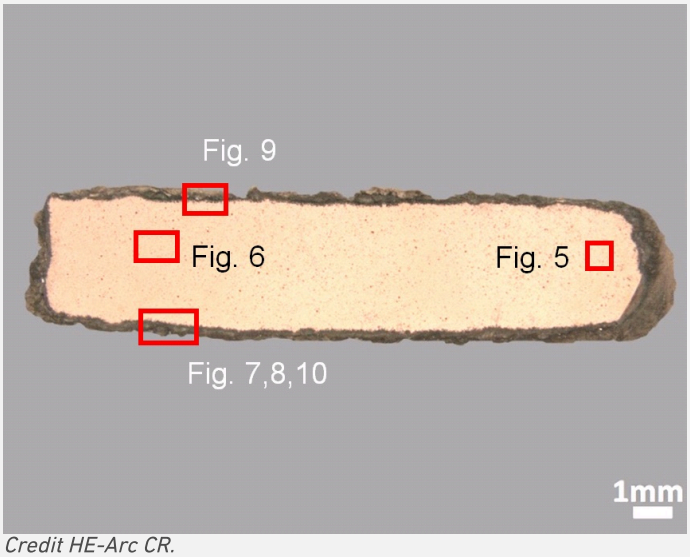
Fig. 3: Micrograph of the cross-section of the sample taken from the blade fragment of the winged axe showing the location of Figs. 5 to 10,

Description of sample	The sample was cut from the fragment shown in Fig. 2. The cross-section is rectangular in shape (L = 17mm, W= 4mm) and has a thick corrosion crust (Figs. 2 and 3).
Alloy	Tin Bronze
Technology	As-cast

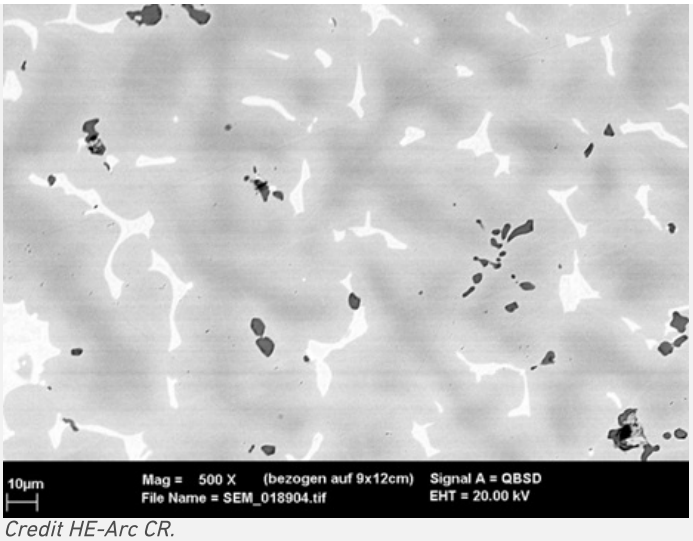
The remaining metal is a tin bronze (Table 1) with high porosity and grey copper sulphide inclusions (Figs. 5 and 6, Table 2). The etched metal has the typical dendritic structure of a cast tin bronze with an average hardness of HV1 135 (Fig. 6). The cored dendritic structure is surrounded by an alpha-delta eutectoid. The core of the dendrites is rich in Cu whereas the outer layers are rich in Sn.

Fig. 5: SEM image of the metal sample from Fig. 3 (detail), BSE-mode. The cored alpha phase of the dendrites appears in grey, becoming lighter towards the periphery (more Sn). The alpha-delta eutectoid appears in white and the copper sulphide inclusions in dark-grey,

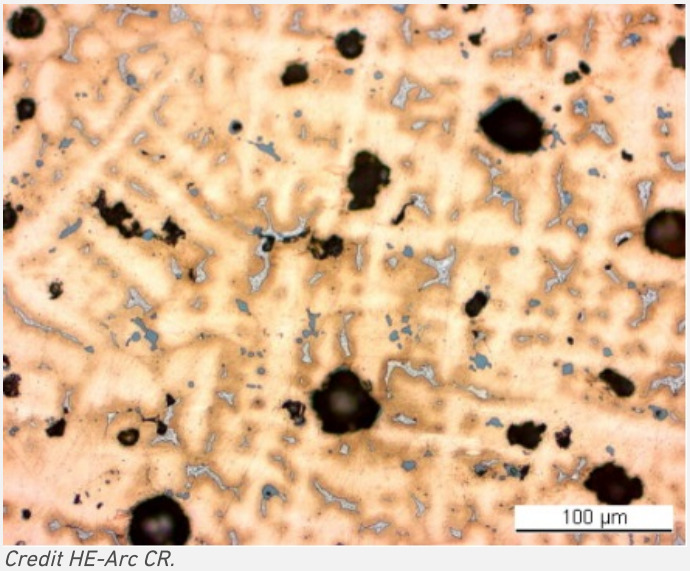
Fig. 6: Micrograph of the metal sample from Fig. 3, etched, bright field. We observe the eutectoid phase in light grey and copper sulphide inclusions in dark-grey,

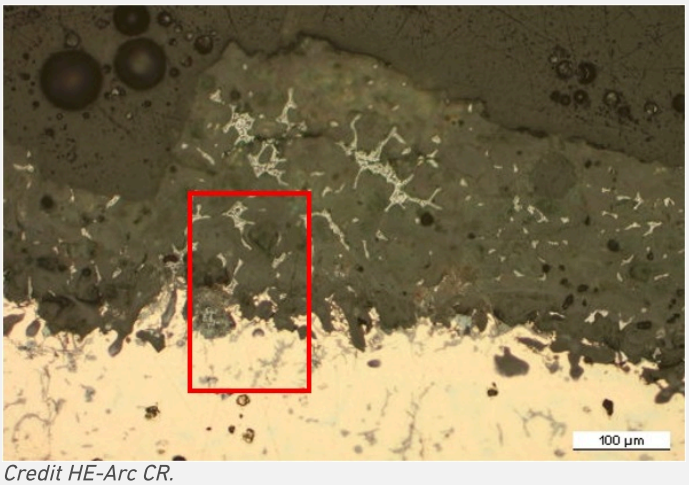
A dark green corrosion crust with a thickness between 100 and 320µm covers the entire surface of the blade fragment (Fig. 7). It retains a metallic ghost structure (Sn-rich eutectoid alpha + delta phase). Under polarized light localized orange and red corrosion products can be seen at the metal - corrosion crust interface (Fig. 8). Interdendritic corrosion and corroded slip lines can be seen in the metal structure and near fissures (Fig. 9). Elemental mapping (Fig. 10) shows that the green layer is Sn-rich (CP1, probably cassiterite, SnO_2) and depleted of Cu, whereas the orange and red corrosion particles are depleted of Sn and rich in Cu (Fig. 10, Table 3). Their Raman spectra indicate that they are mainly composed of cuprite (Fig. 11). The overall corrosion crust contains O, Si, C and Fe from the environment, while S is concentrated around the cuprite particles (Fig. 10).

Fig. 7: Micrograph of the metal sample from Fig. 3 (rotated 180°), unetched, bright field. A metallic ghost structure is preserved in the corrosion crust. The area selected for elemental chemical distribution (Fig. 10) is marked by a red rectangle,

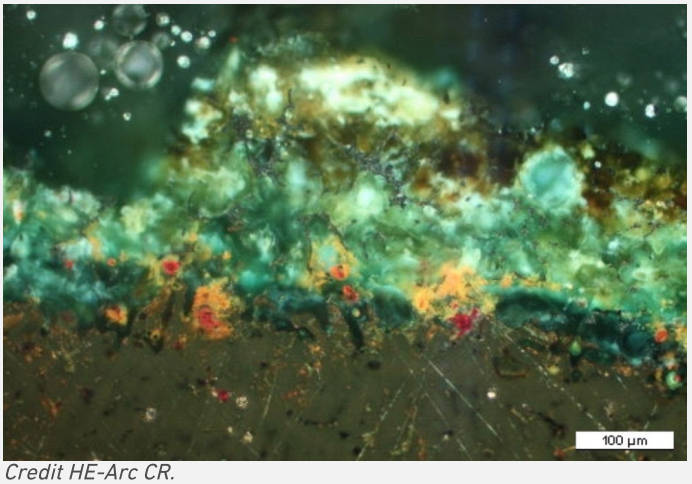
Fig. 8: Micrograph similar to Fig. 7 and corresponding to the stratigraphy of Fig. 4, polarised light. At the metal - green corrosion crust interface red and orange corrosion products can be seen,

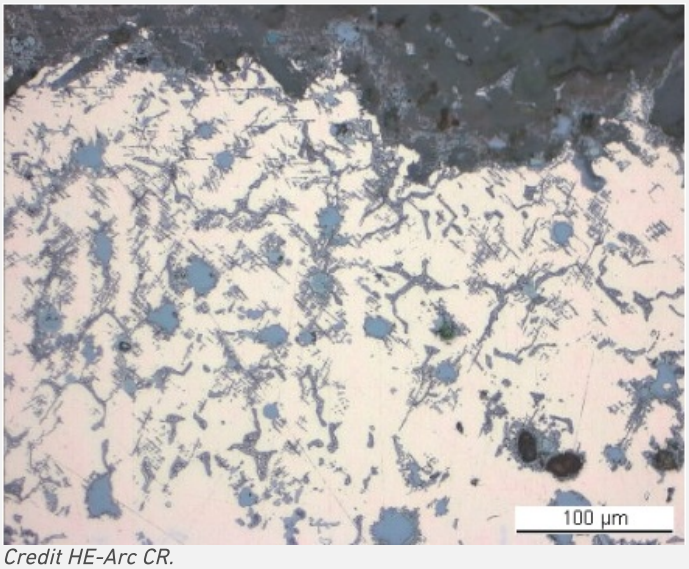
Fig. 9: Micrograph of the metal sample from Fig. 3 (detail), unetched, bright field. Metal with slip lines outlined by the corrosion,

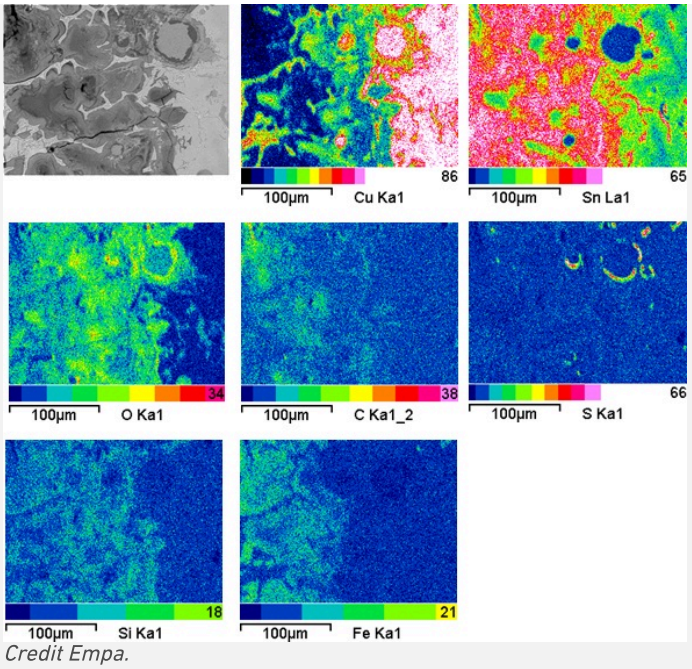
Fig. 10: SEM image, SE-mode, and elemental chemical distribution of the selected area of Fig. 7 (reversed picture rotated by 270°). Method of examination: SEM/EDS, Laboratory of Analytical Chemistry, Empa,

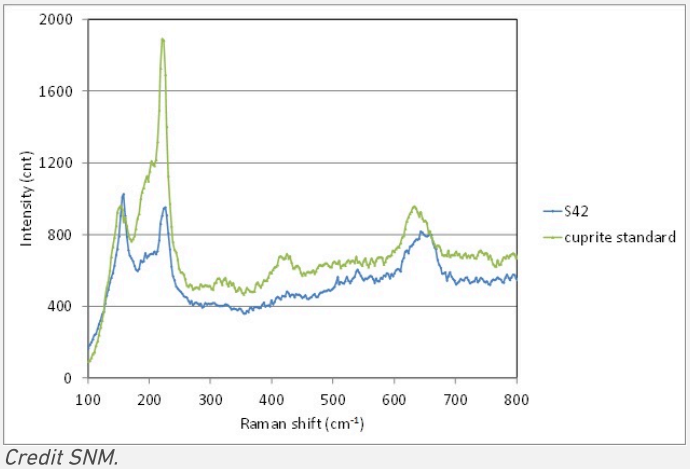
Fig. 11: Raman spectrum of a red-orange corrosion particle (S42) of Fig. 8 compared to the cuprite standard spectrum. Settings: laser wavelength 532nm, acquisition time 10s, one accumulation, filter D2 (0.75-0.8mW), hole 500, slit 80, grating 600. Method of analysis: Raman spectroscopy, Lab of Swiss National Museum, Affoltern a. Albis ZH,
