BLADE FRAGMENT OF A WINGED AXE FK43 – TIN BRONZE – MIDDLE BRONZE AGE – SWITZERLAND

Authors Marianne. Senn (EMPA, Dübendorf, Zurich, Switzerland) & Christian. Degrigny (HE-Arc CR, Neuchâtel, Neuchâtel, Switzerland)

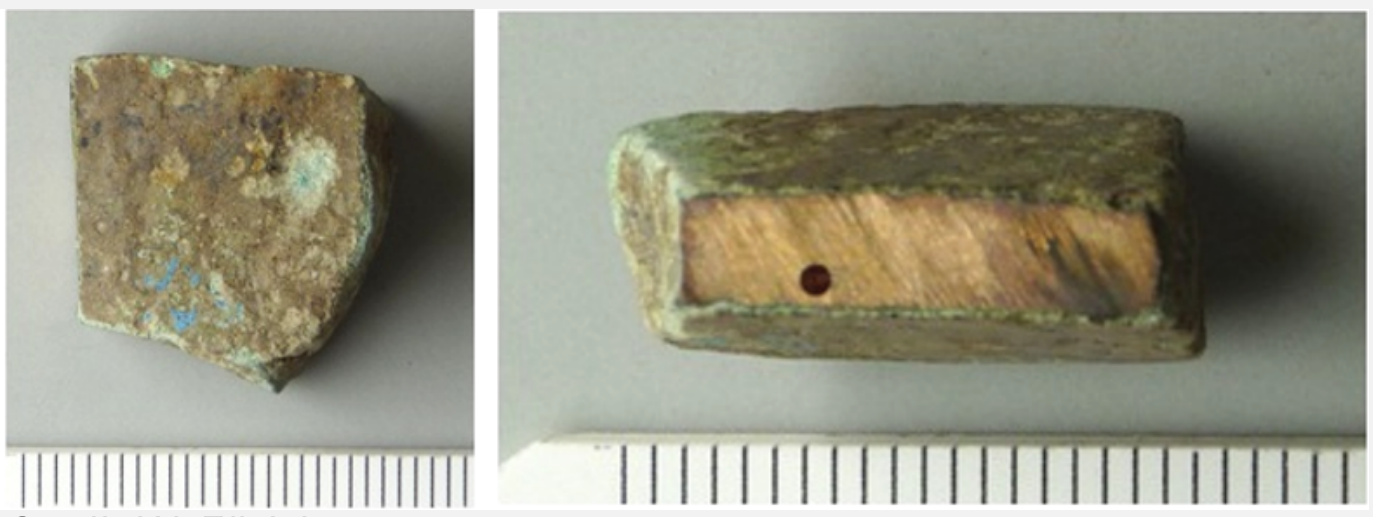
Fig. 1: Blade fragment of winged axe. The drilling on the right picture was carried out at a later stage and does not form part of the original object,

Description of the artefact	Blade fragment of a semi-finished median-winged axe. Its surface is covered with a thick dark green corrosion crust (Fig. 1). Dimensions: L = 20mm; Tmax. = 8.5mm; WT = 15g.
Type of artefact	Tool
Origin	Obstgartenstrasse, Erlenbach, Zurich, Switzerland
Recovering date	Excavation 1980.002
Chronology category	Middle Bronze Age
chronology tpq	1550 B.C.
chronology taq	1350 B.C.
Chronology comment	
Burial conditions / environment	Soil
Artefact location	Kantonsarchäologie, Dübendorf, Zurich
Owner	Kantonsarchäologie, Dübendorf, Zurich
Inv. number	FK43
Recorded conservation data	Not conserved

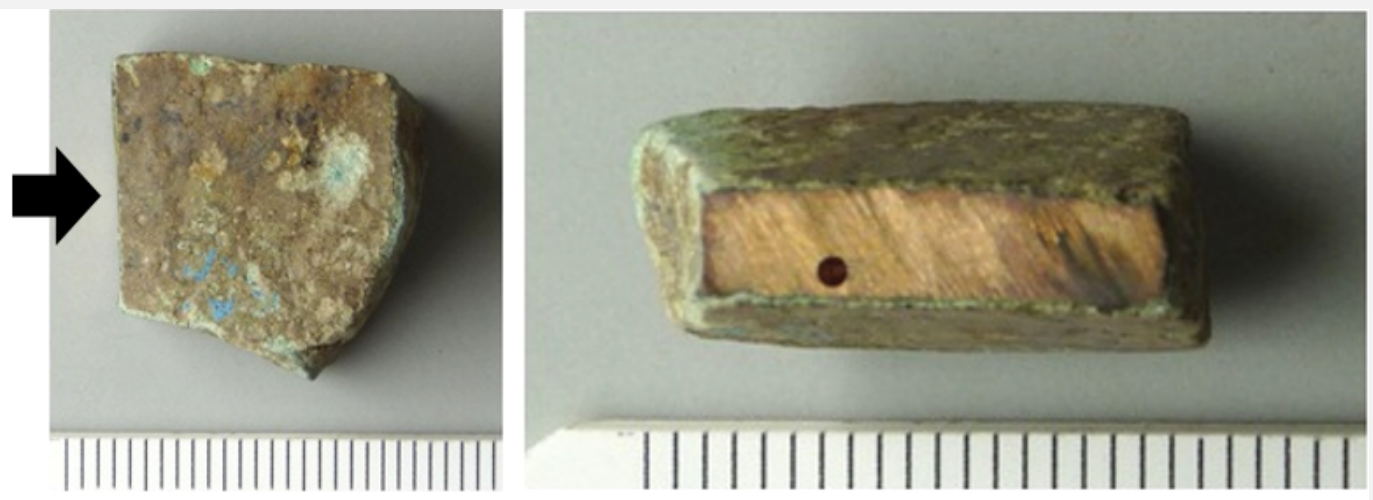
Fig. 2: Location of sampling area (arrow, left picture) and side view (right picture),

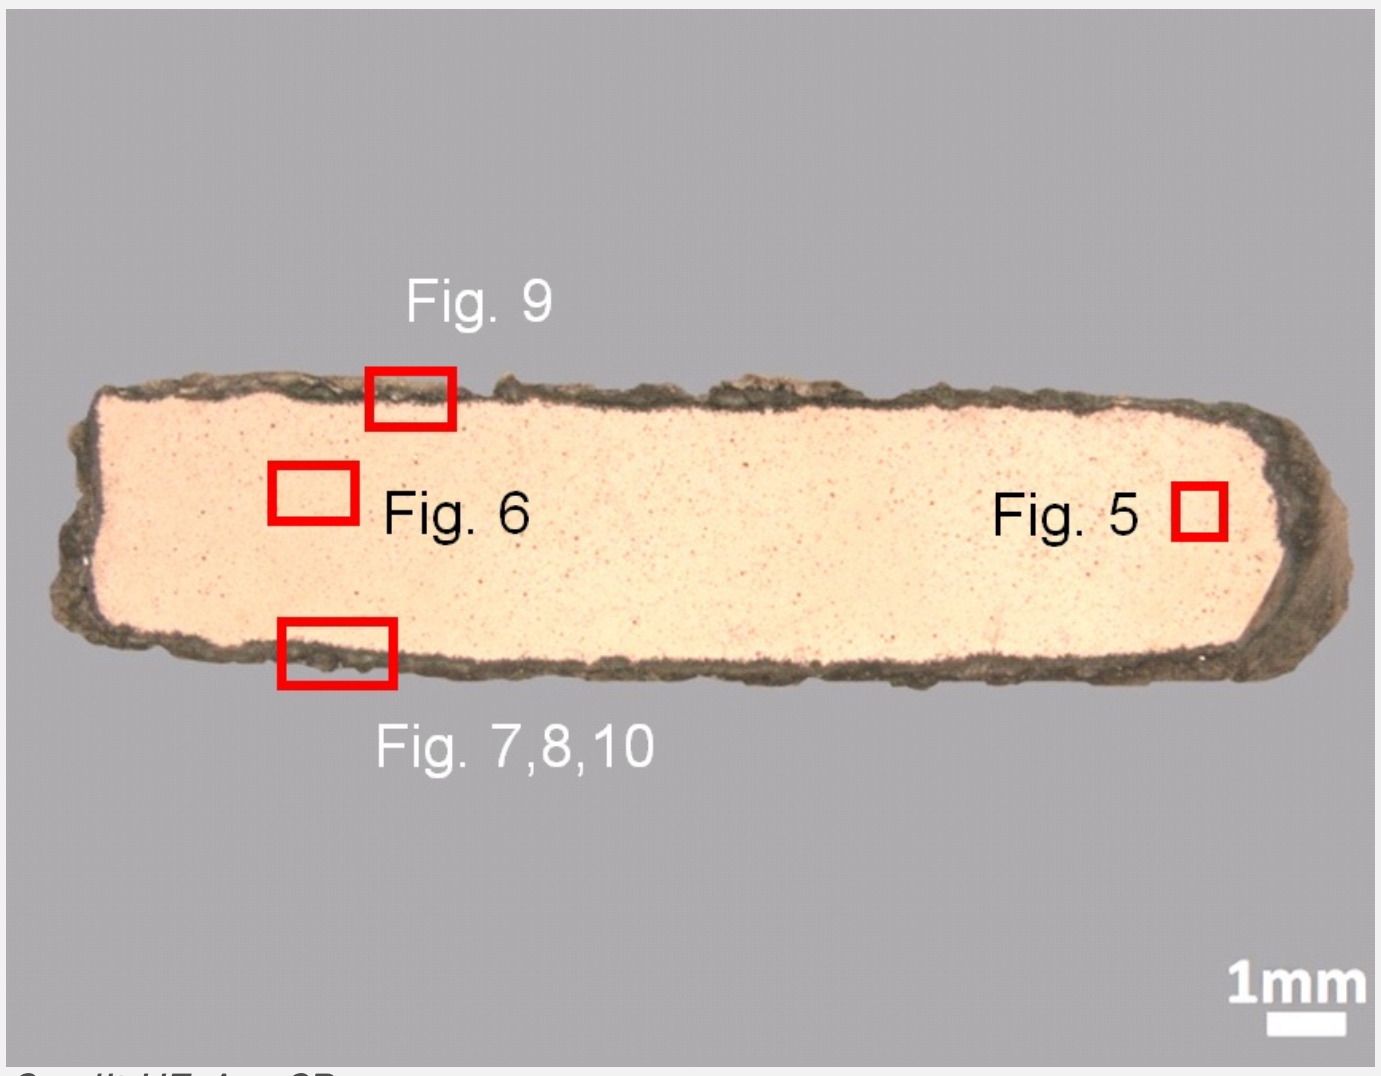
Fig. 3: Micrograph of the cross-section of the sample taken from the blade fragment of the winged axe showing the location of Figs. 5 to 10,

Description of sample	The sample was cut from the fragment shown in Fig. 2. The cross-section is rectangular in shape (L = 17mm, W= 4mm) and has a thick corrosion crust (Figs. 2 and 3).
Alloy	Tin Bronze
Technology	As-cast
Lab number of sample	ERL-43

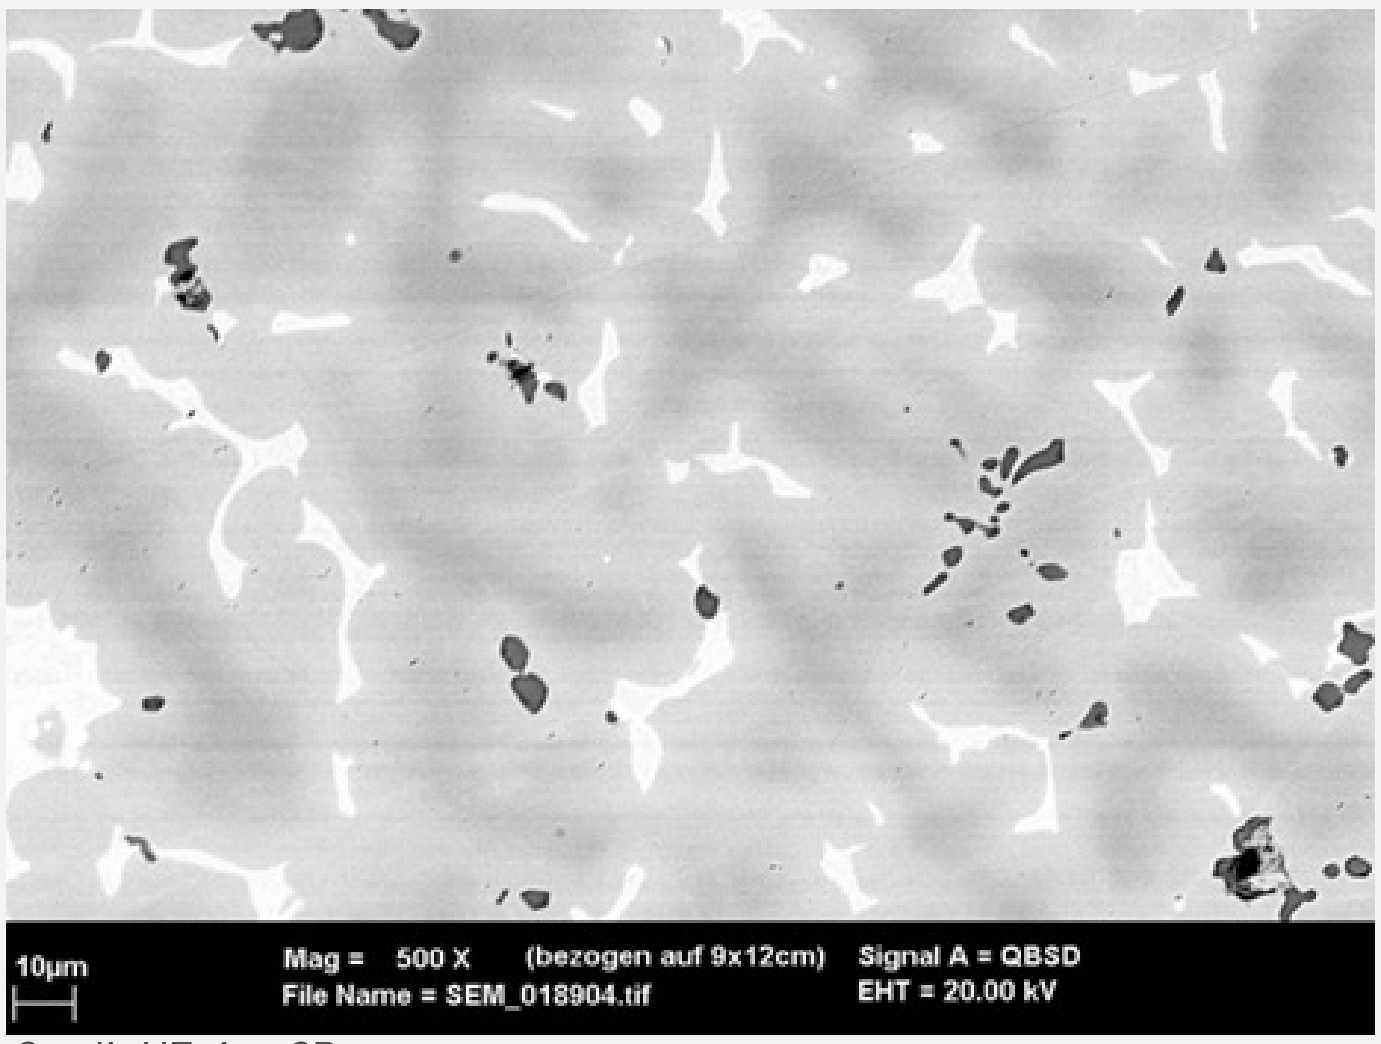
The remaining metal is a tin bronze (Table 1) with high porosity and grey copper sulphide inclusions (Figs. 5 and 6, Table 2). The etched metal has the typical dendritic structure of a cast tin bronze with an average hardness of HV1 135 (Fig. 6). The cored dendritic structure is surrounded by an alpha-delta eutectoid. The core of the dendrites is rich in Cu whereas the outer layers are rich in Sn.

Table 2: Chemical composition (mass %) of the dark-grey inclusions seen in Fig. 5. Method of analysis: SEM/EDS, Laboratory of Analytical Chemistry, Empa.

Fig. 5: SEM image of the metal sample from Fig. 3 (detail), BSE-mode. The cored alpha phase of the dendrites appears in grey, becoming lighter towards the periphery (more Sn). The alpha-delta eutectoid appears in white and the copper sulphide inclusions in dark-grey,

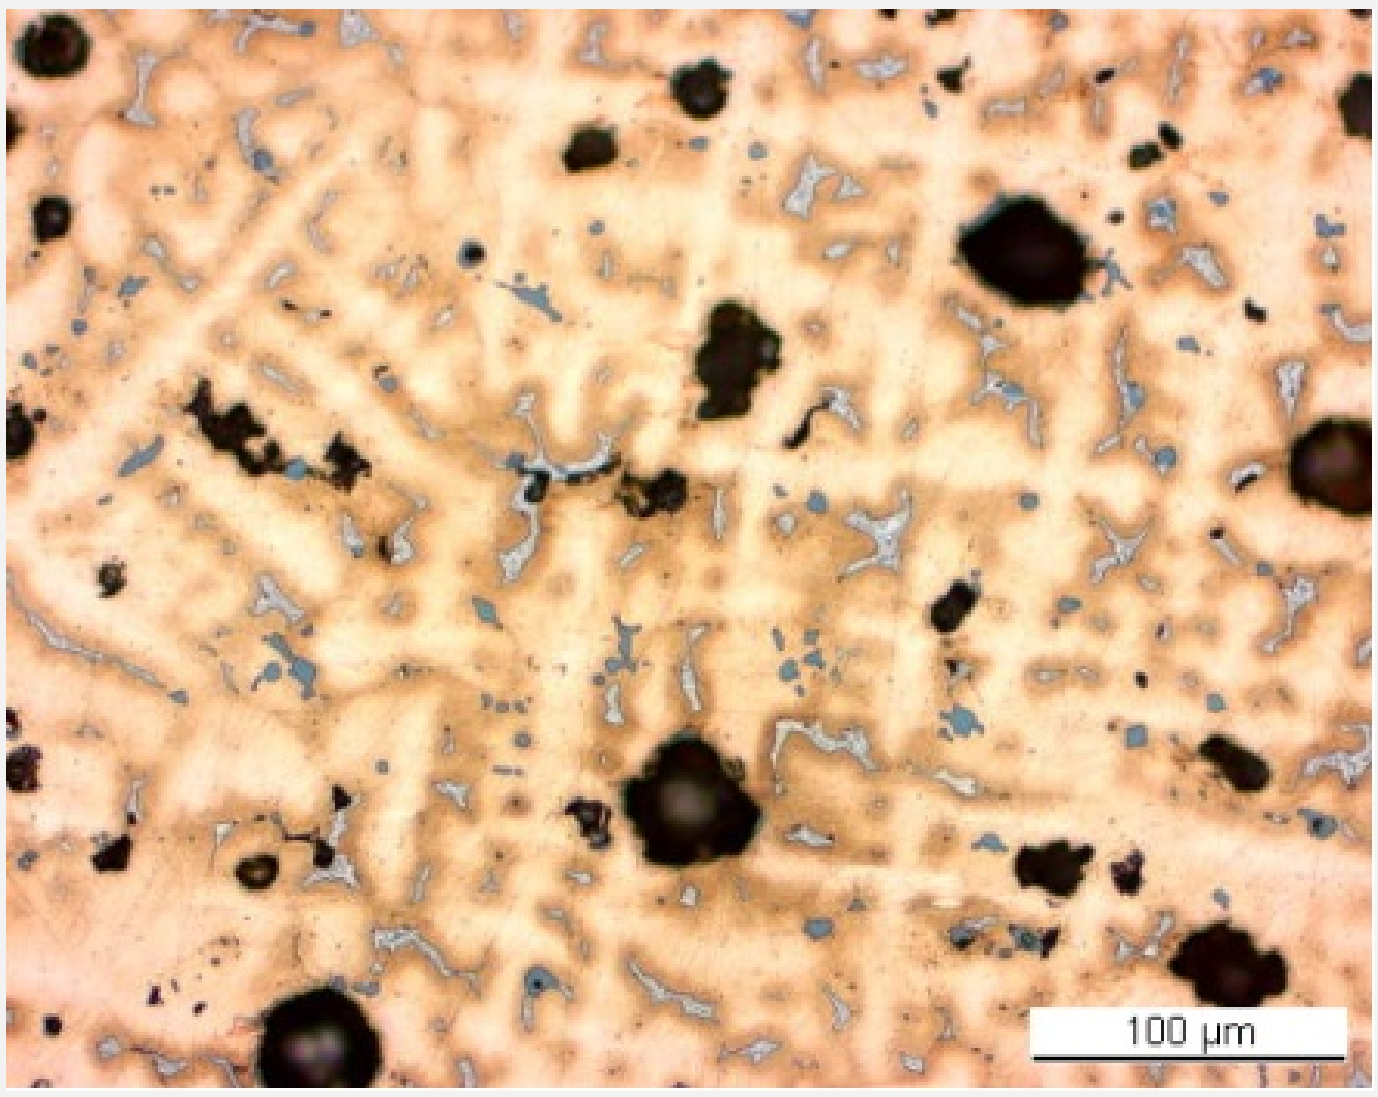
Fig. 6: Micrograph of the metal sample from Fig. 3, etched, bright field. We observe the eutectoid phase in light grey and copper sulphide inclusions in dark-grey,

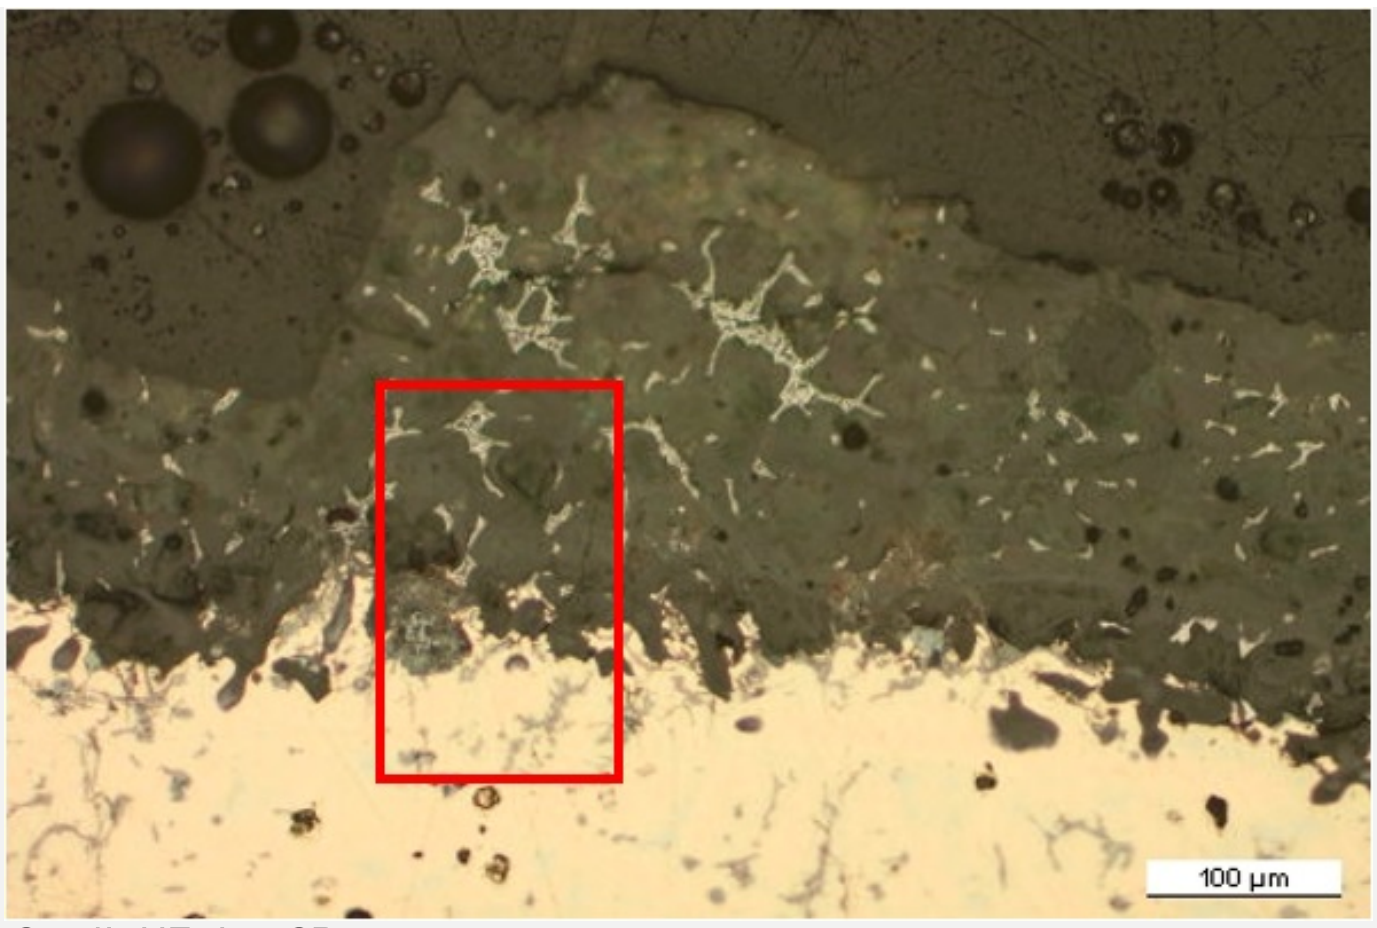
A dark green corrosion crust with a thickness between 100 and 320µm covers the entire surface of the blade fragment (Fig. 7). It retains a metallic ghost structure (Sn-rich eutectoid alpha + delta phase). Under polarized light localized orange and red corrosion products can be seen at the metal - corrosion crust interface (Fig. 8). Interdendritic corrosion and corroded slip lines can be seen in the metal structure and near fissures (Fig. 9). Elemental mapping (Fig. 10) shows that the green layer is Sn-rich (CP1, probably cassiterite, SnO_2) and depleted of Cu, whereas the orange and red corrosion particles are depleted of Sn and rich in Cu (Fig. 10, Table 3). Their Raman spectra indicate that they are mainly composed of cuprite (Fig. 11). The overall corrosion crust contains O, Si, C and Fe from the environment, while S is concentrated around the cuprite particles (Fig. 10).

Table 3: Chemical composition (mass %) of the corrosion crust from Fig. 7. Method of analysis: SEM/EDS, Laboratory of Analytical Chemistry, Empa.

Fig. 7: Micrograph of the metal sample from Fig. 3 (rotated 180°), unetched, bright field. A metallic ghost structure is preserved in the corrosion crust. The area selected for elemental chemical distribution (Fig. 10) is marked by a red rectangle,

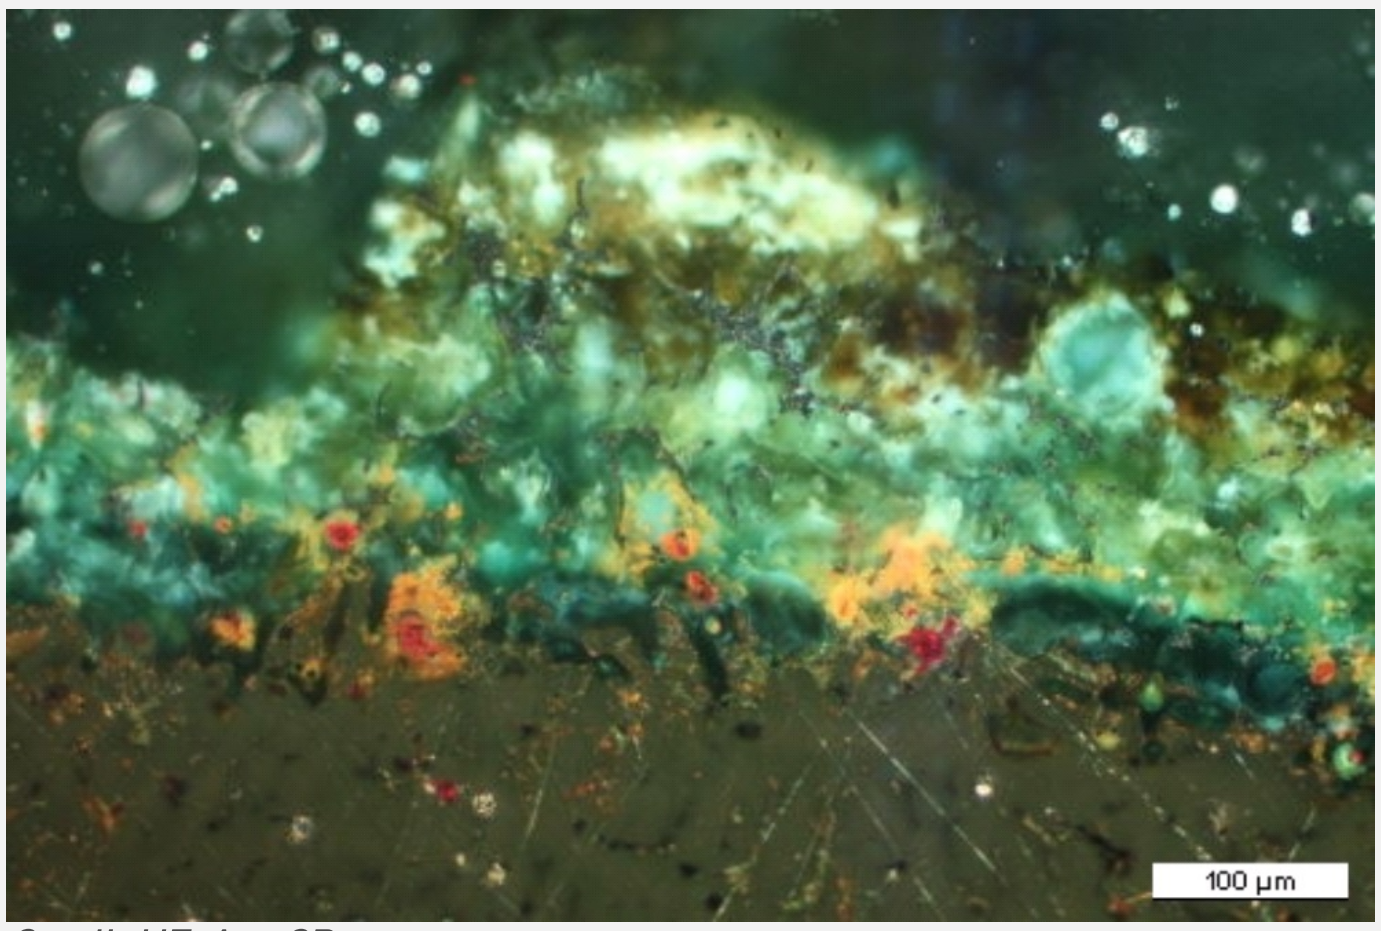
Fig. 8: Micrograph similar to Fig. 7 and corresponding to the stratigraphy of Fig. 4, polarised light. At the metal - green corrosion crust interface red and orange corrosion products can be seen,

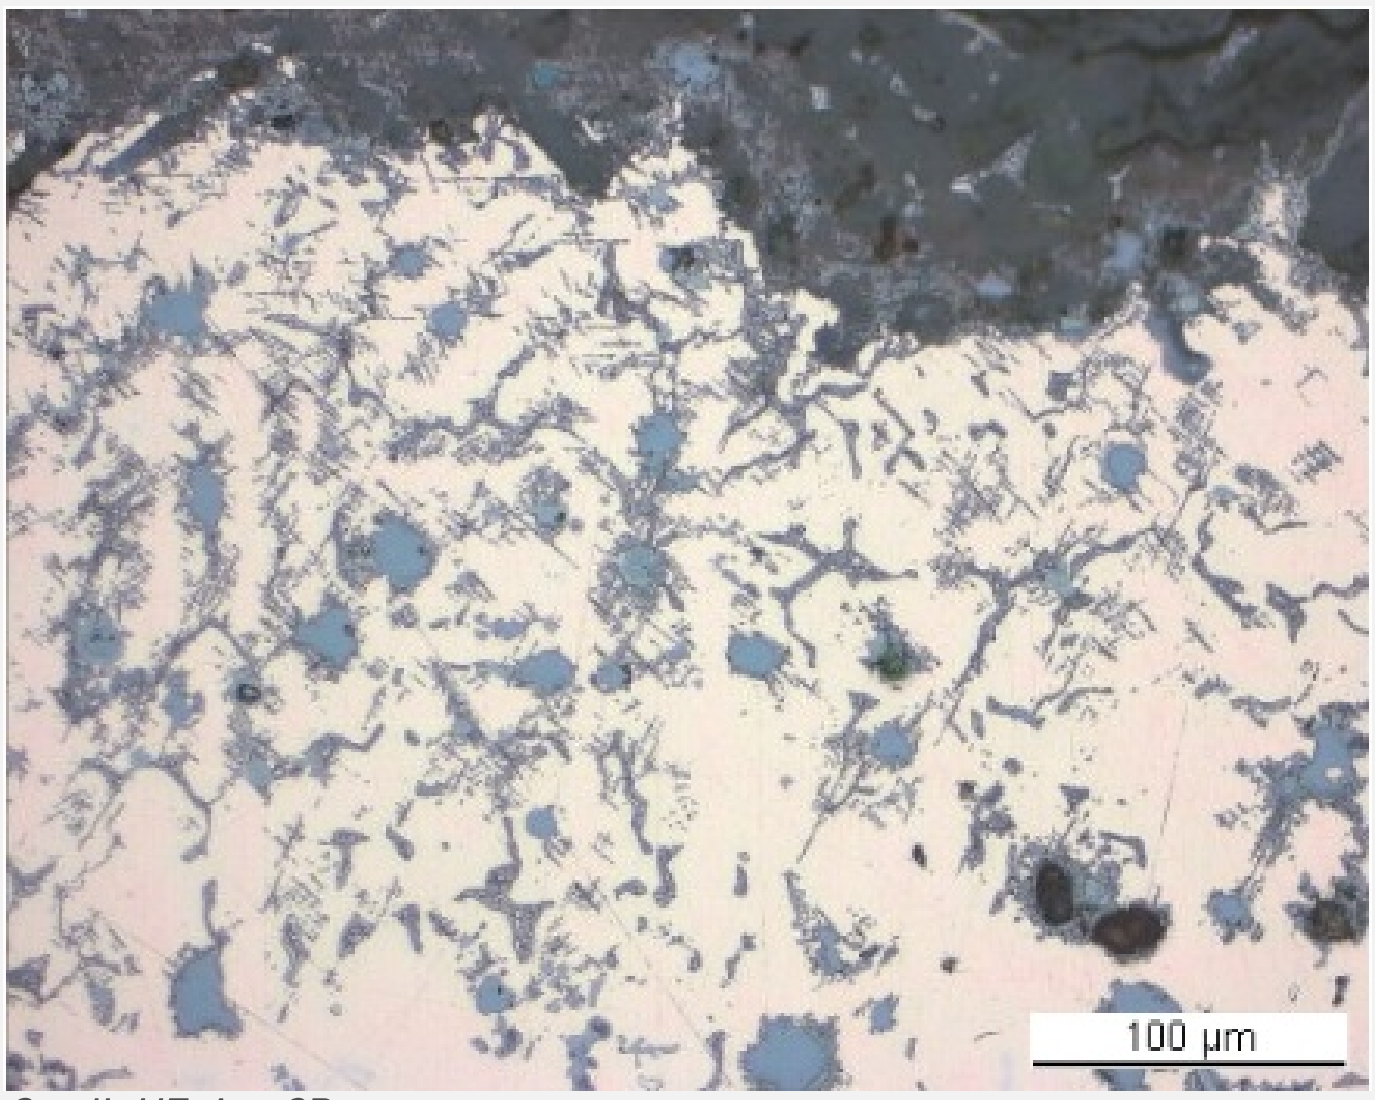
Fig. 9: Micrograph of the metal sample from Fig. 3 (detail), unetched, bright field. Metal with slip lines outlined by the corrosion,

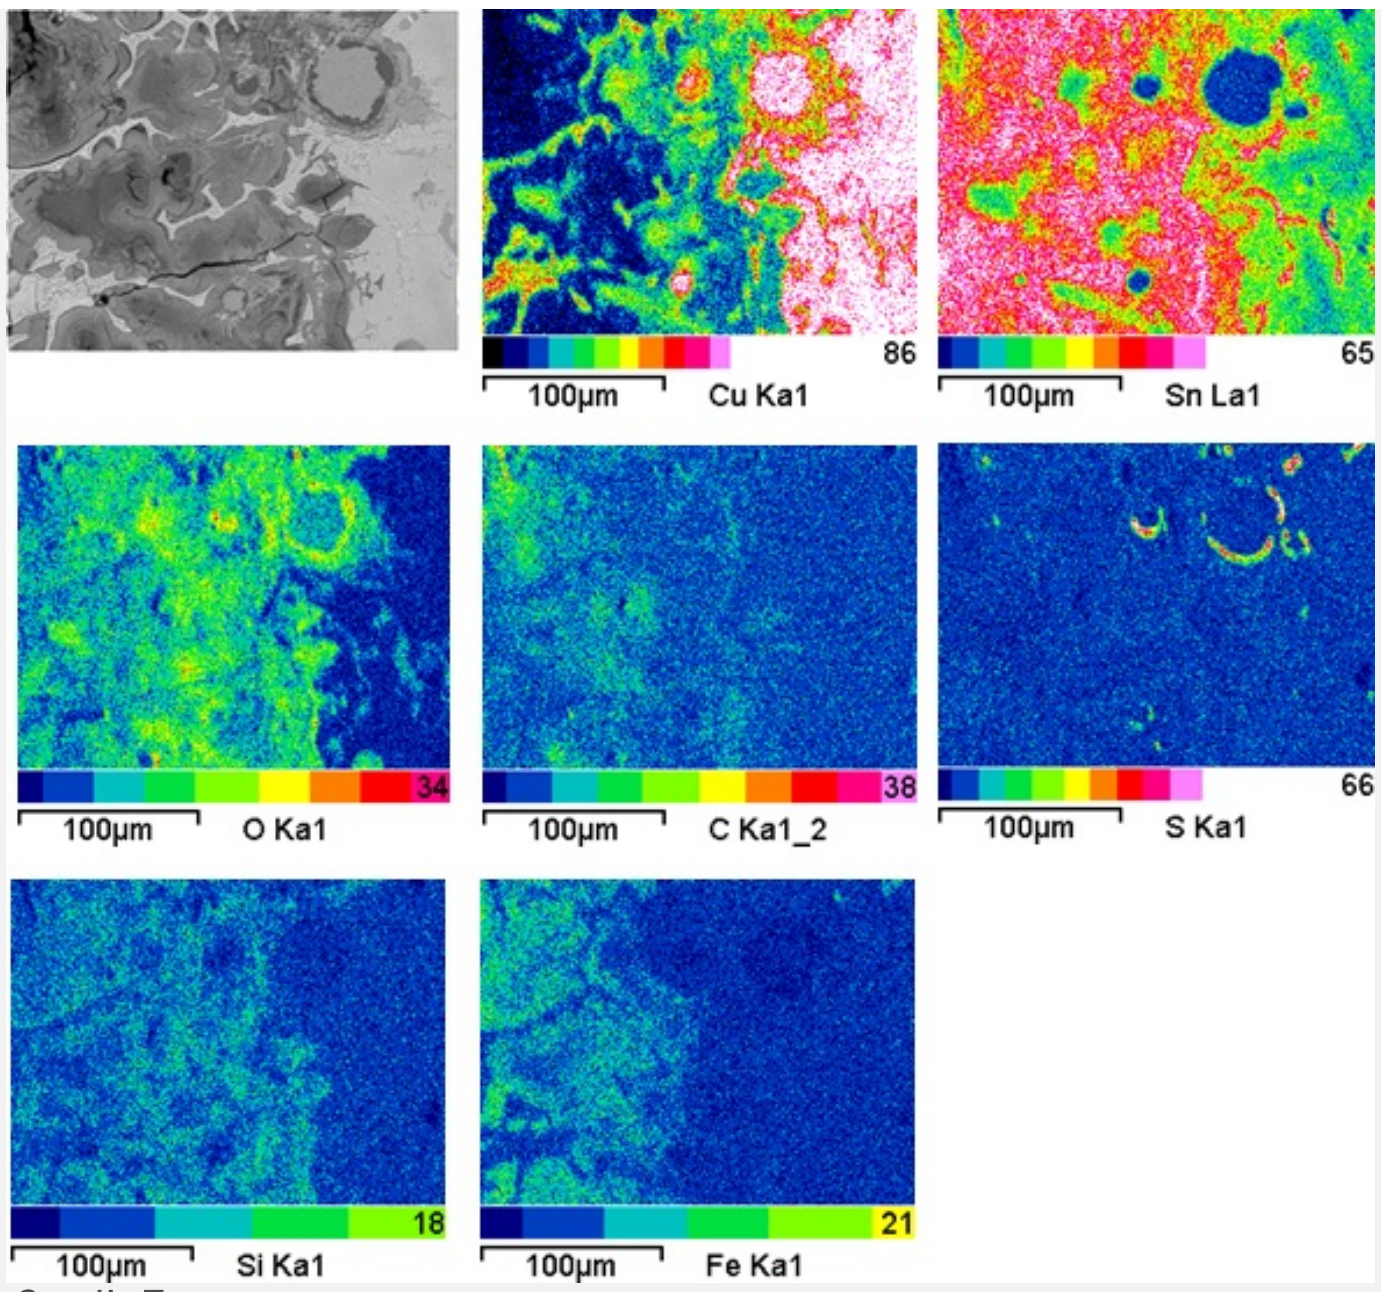
Fig. 10: SEM image, SE-mode, and elemental chemical distribution of the selected area of Fig. 7 (reversed picture rotated by 270°). Method of examination: SEM/EDS, Laboratory of Analytical Chemistry, Empa,

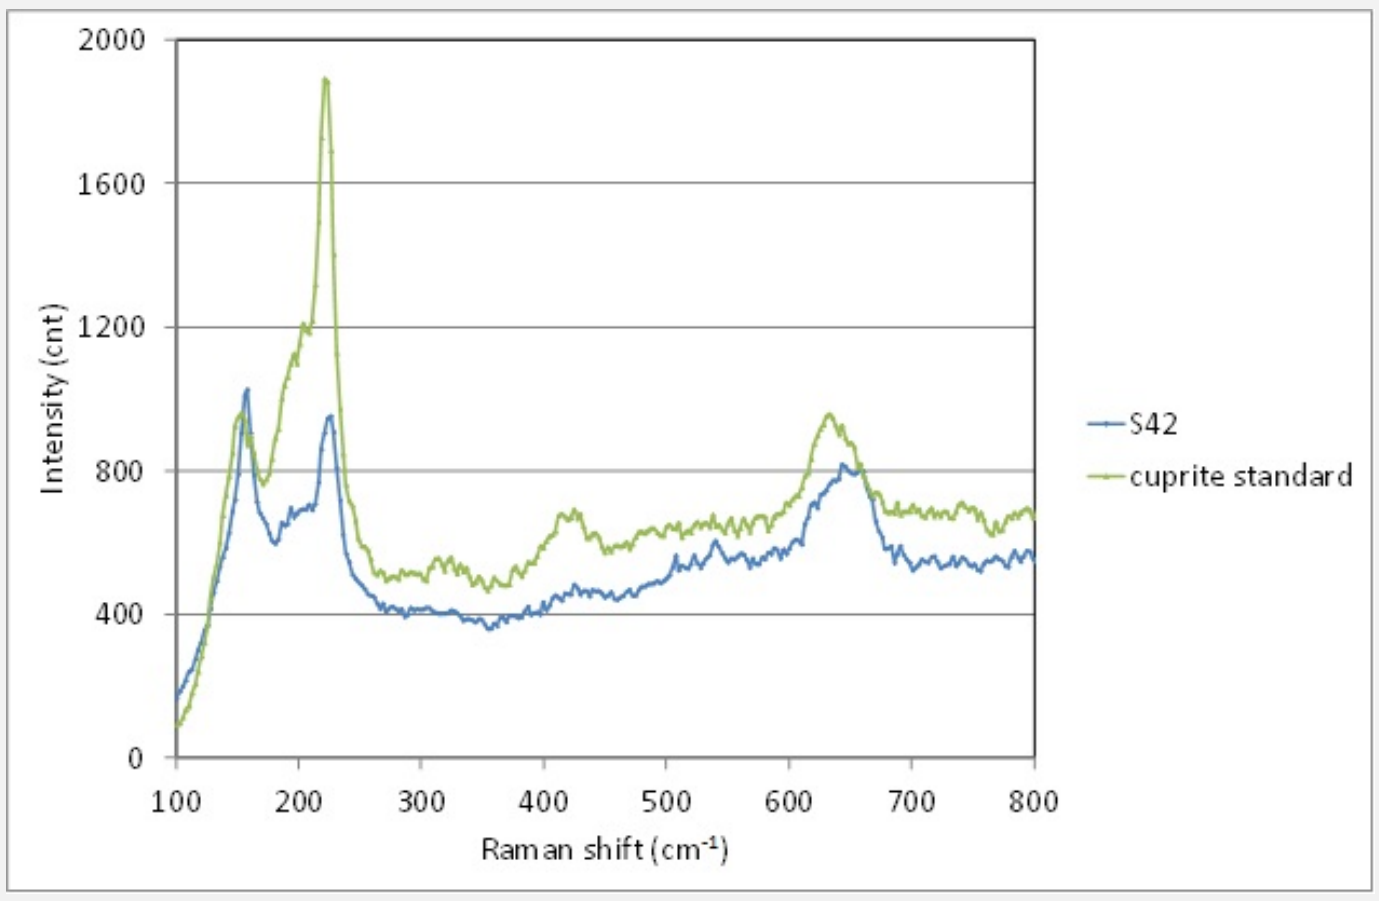
Fig. 11: Raman spectrum of a red-orange corrosion particle (S42) of Fig. 8 compared to the cuprite standard spectrum. Settings: laser wavelength 532nm, acquisition time 10s, one accumulation, filter D2 (0.75-0.8mW), hole 500, slit 80, grating 600. Method of analysis: Raman spectroscopy, Lab of Swiss National Museum, Affoltern a. Albis ZH,
