CIRCULAR DOOR KNOCKER STRIKING PLATE – CU ALLOY – MODERN TIMES – SWITZERLAND

Artefact name Circular door knocker striking plate

Authors Marianne. Senn (EMPA, Dübendorf, Zurich, Switzerland) & Christian. Degrigny (HE-Arc CR, Neuchâtel, Neuchâtel, Switzerland)

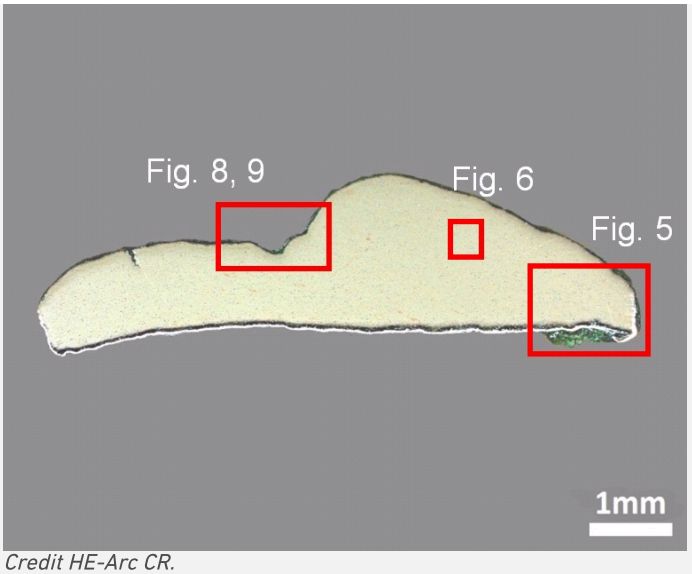
Fig. 3: Micrograph of the cross-section of the sample taken from the circular base showing the location of Figs. 5 to 6 and 8 to 9,

Description of sample	No information is given on where the sample has been taken. A supposed location is however illustrated in Fig. 2. The polished sample shows a well preserved metal surface with some cracks covered by a thin corrosion crust (Fig. 3).
Alloy	Cu Alloy
Technology	Rolled, annealed after cold working
Lab number of sample	MAH 94-156-001
Sample location	Musées d'art et d'histoire, Genève, Geneva
Responsible institution	Musées d'art et d'histoire, Genève, Geneva
Date and aim of sampling	1994, metallography and presence or not of a gilding treatment

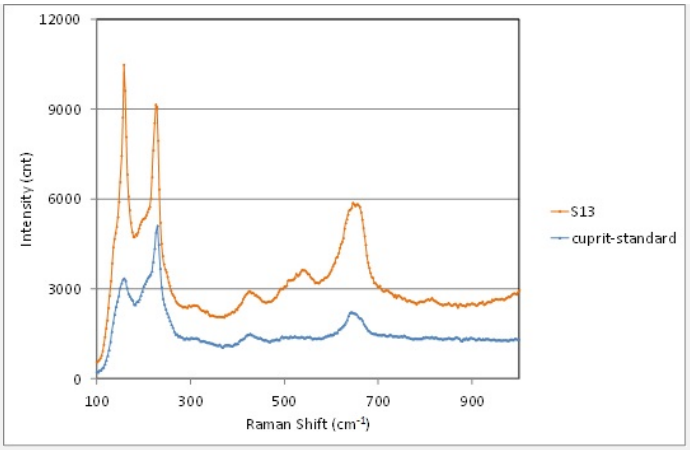
Fig. 7: Raman spectrum of a red inclusion (S13) of Fig. 5 compared to a cuprite standard spectrum. Settings: laser wavelength 532nm, acquisition time 100s, one accumulation, filter D2 (0.75-0.8mW), hole 500, slit 80, grating 600. Method of analysis: Raman spectroscopy. Lab of Swiss National Museum, Affoltern a. Albis ZH,

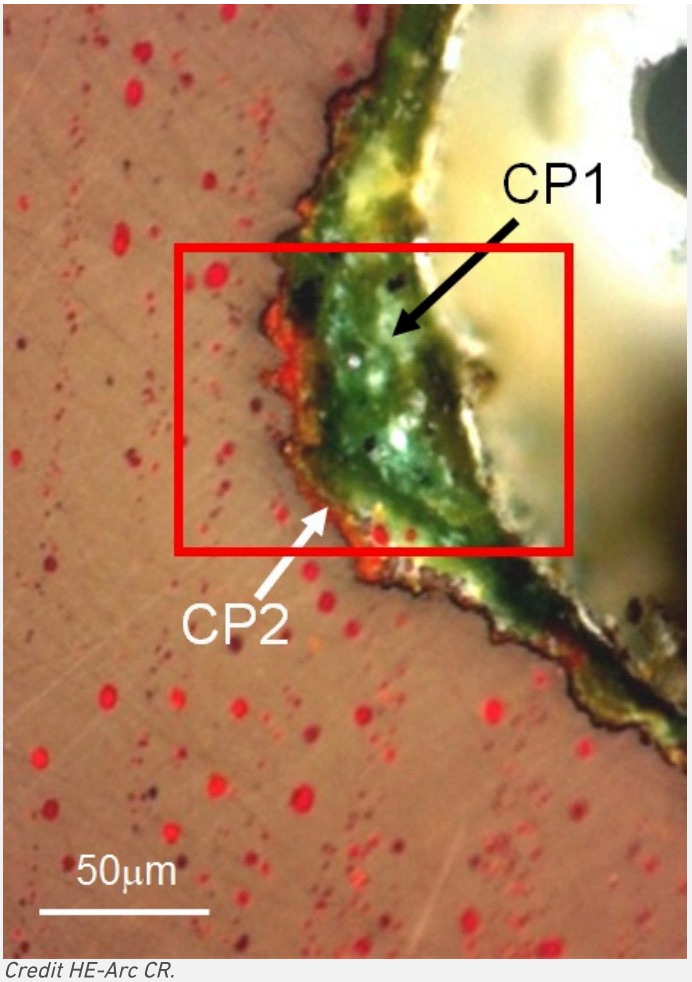
The average thickness of the corrosion crust is about 90µm, but may be thinner or thicker depending on the area of origin (Fig. 5). Under polarized light, we observe a multilayer system with a dense and thin inner red corrosion layer (CP2, probably cuprite/Cu2O) on the metal (Fig. 8) containing chlorides (Fig. 9 and Table 3). This is followed by bands of heterogeneous green corrosion products (CP1, possibly copper chloride / sulphate / carbonate). This outer corrosion layer is contaminated with atmospheric components (Si, Al, Cl, C and O and perhaps gypsum particles (CaSO4)) (Fig. 9).

Fig. 8: Micrograph of the metal sample from Fig. 3 (rotated by 90°) and corresponding to the stratigraphy of Fig. 4, polarised light. Metal with red copper oxide inclusions. The black particles in the green corrosion layer are quartz inclusions. The area selected for elemental chemical distribution (Fig. 9) is marked by a red rectangle,

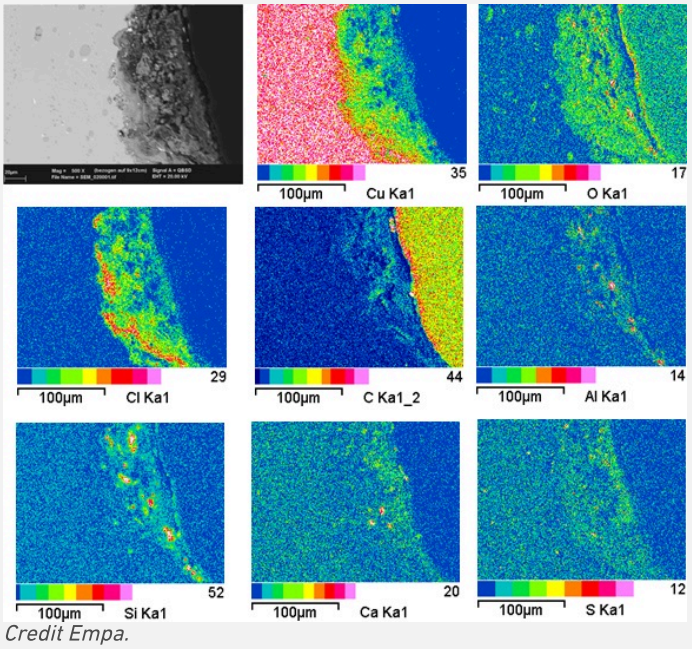
Table 2: Chemical composition (mass %) of the inclusions (light-grey and white in Fig. 9) in the metal. Method of analysis: SEM/EDS, Laboratory of Analytical Chemistry, Empa.

Fig. 9: SEM image, BSE-mode, and elemental chemical distribution of the selected area of Fig. 8. Method of examination: SEM/EDS, Laboratory of Analytical Chemistry, Empa,
