CURVED PIN OR TANG FK 2670.20 – TIN BRONZE – LATE BRONZE AGE – SWITZERLAND

Artefact name Curved pin or tang FK 2670.20

Authors Marianne. Senn (EMPA, Dübendorf, Zurich, Switzerland) & Christian. Degrigny (HE-Arc CR, Neuchâtel, Neuchâtel, Switzerland)

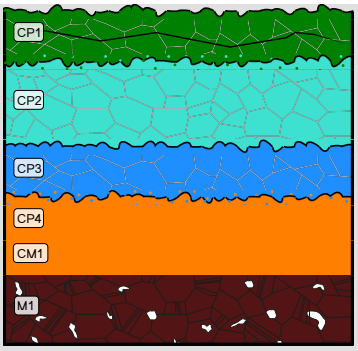
Fig. 4: Stratigraphic representation of the sample taken from the curved pin or tang in cross-section (dark field) using the MiCorr application. The characteristics of the strata are only accessible by clicking on the drawing that redirects you to the search tool by stratigraphy representation. This representation can be compared to Fig. 7, Credit HE-Arc CR.
