TANG FRAGMENT OF A KNIFE HR-6246 - TIN BRONZE - LATE BRONZE AGE - SWITZERLAND

Artefact name Tang fragment of a knife HR-6246

Authors Marianne. Senn (EMPA, Dübendorf, Zurich, Switzerland) & Christian. Degrigny (HE-Arc CR, Neuchâtel, Neuchâtel, Switzerland)

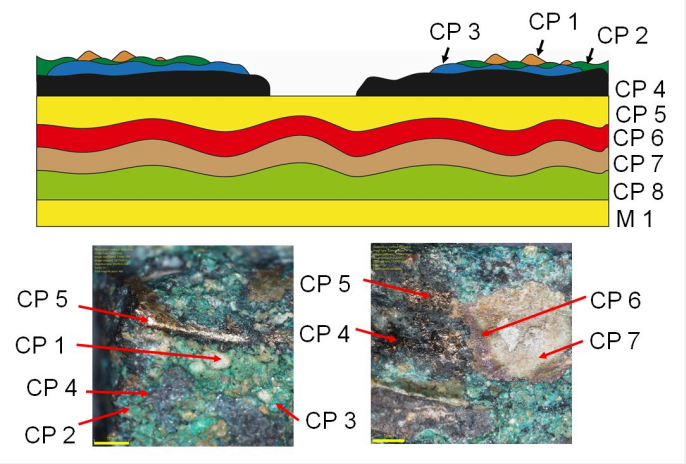
The schematic representation below gives an overview of the corrosion layers encountered on the tang from a first visual macroscopic observation.

Fig. 6: Stratigraphic representation of the tang fragment under binocular and location of the strata,

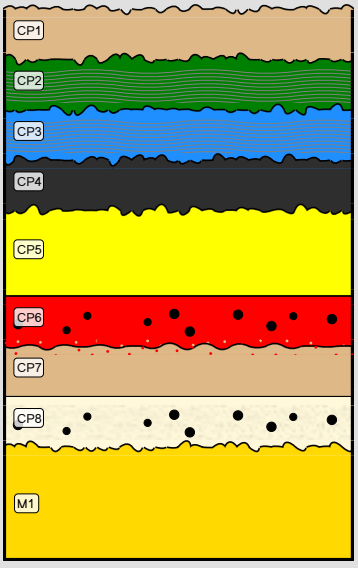
Fig. 7: Stratigraphic representation of the tang fragment under binocular using the MiCorr application. The characteristics of the strata are only accessible by clicking on the drawing that redirects you to the search tool by stratigraphy representation, Credit HE-Arc CR.

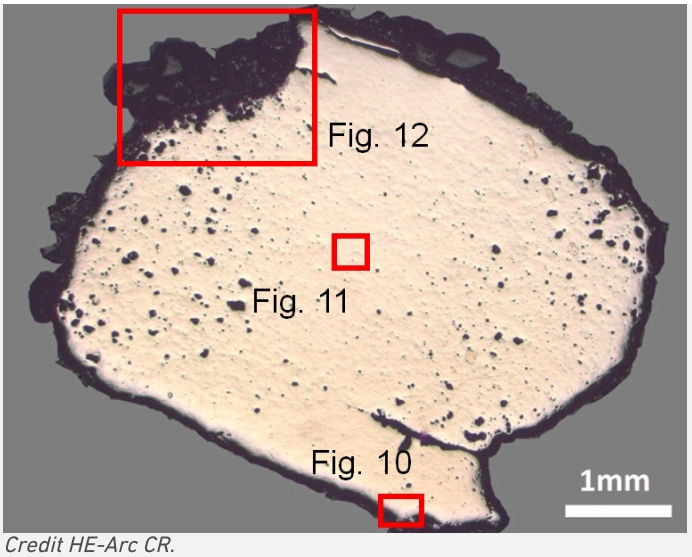
Fig. 8: Micrograph of the cross-section of the sample taken from the tang fragment showing the location of Figs. 10 to 12,

Description of sample	The cross-section corresponds to a lateral cut (Fig. 4). The surface is covered with a thick corrosion crust (Fig. 8).
Alloy	Tin Bronze
Technology	Cold worked after annealing
Lab number of sample	MAH 87-197
Sample location	Musées d'art et d'histoire, Genève, Geneva
Responsible institution	Musées d'art et d'histoire, Genève, Geneva
Date and aim of sampling	1987, metallography and corrosion characterisation

The remaining metal is a tin bronze (Table 1) with high porosity and large cracks both on the left and right edges of the sample (Fig. 8). The metal contains small, elongated copper sulphide (Table 2) and Pb inclusions that are oriented parallel to the cracks. Near the metal surface, slip lines are outlined by the development of intergranular corrosion (Fig. 10). The etched metal shows small, elongated grains with slip lines (Fig. 11). Annealing is visible in areas near the surface. The average hardness of the metal is HV1 145, but significant variations are observed, depending on where the measurements are taken.

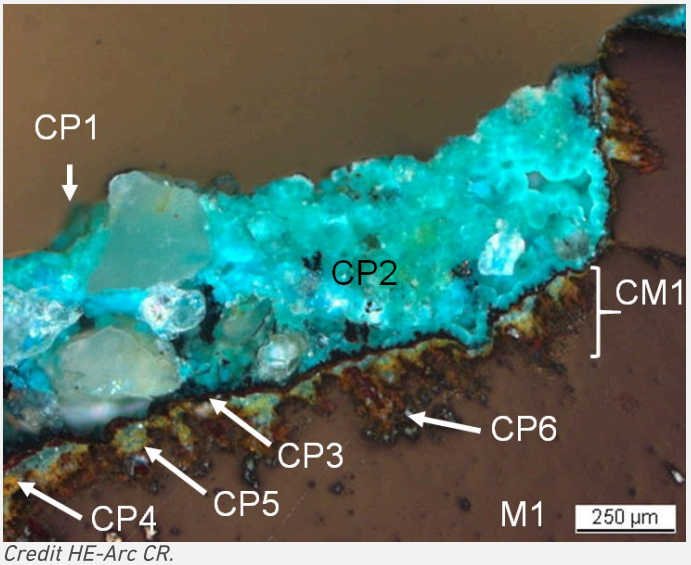
The corrosion crust has a thickness between 0.1mm and 0.7mm (Fig. 3). In bright field (Fig. 12), one can observe that the metal has been replaced by light-grey corrosion products. Adjacent to the metal is a thick, heterogeneous, dark-grey layer with a band of light-grey corrosion products. In polarised light (Fig. 13), all corrosion products which were previously light-grey appear brown-green-yellow, the dark-grey layer turquoise. The elemental chemical distribution of the SEM images (Figs. 14 and 15) reveals that the inner corrosion products are Sn-rich whereas the adjacent band is Cu and S-rich (Fig. 16). The outer layer contains large inclusions (quartz and others, Si, Al and Na, see Figs. 15-16) and is most probably composed of malachite/Cu2(CO3)(OH)2 (only Cu and O are detected – Fig. 16). S is distributed throughout this layer. XRD analyses indicated the presence of posnjakite/Cu4SO4(OH)6H2O, chalcocite/CuS and djurleïte/Cu1.93S (Schweizer 1994).

Fig. 12: Micrograph of the metal sample from Fig. 8 (detail), unetched, bright field. The inner light-grey corrosion products extend into the metal surface (in pink) and appear as a line within the dark-grey corrosion layer,

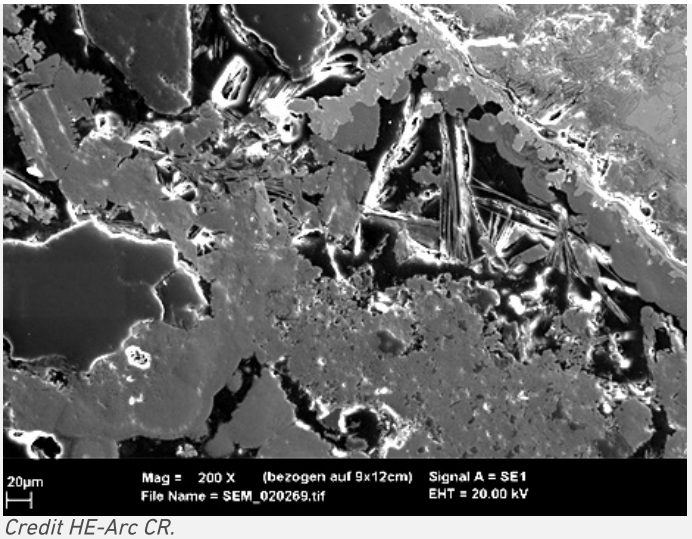
Fig. 14: SEM image (detail of Fig. 12), SE-mode. From bottom to top right: the thick, porous outer corrosion layer, the light-grey band and the remaining metal,

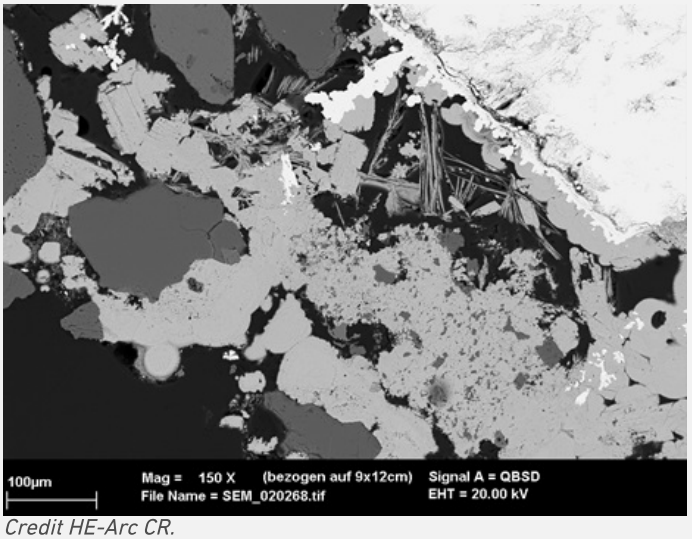
Fig. 15: SEM image, similar to Fig. 14, BSE-mode,

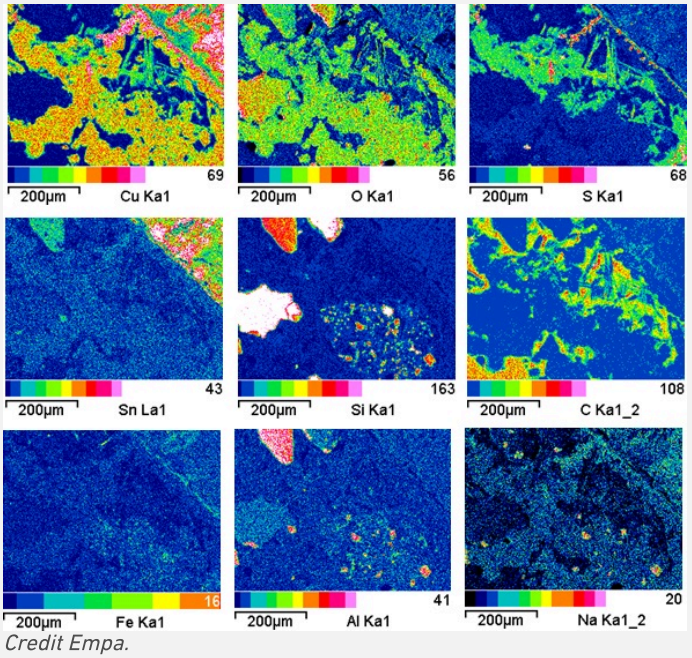
Fig. 16: EDS elemental chemical distribution of the SEM image of Fig. 14. Method of examination: SEM/EDS, Laboratory of Analytical Chemistry, Empa,

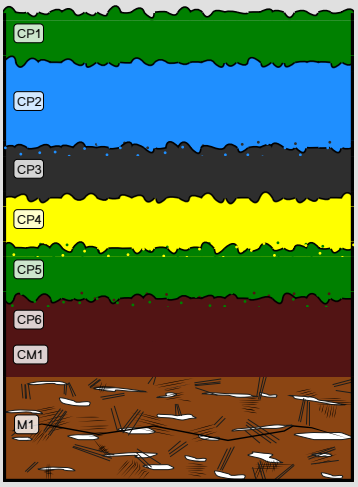
Fig. 9: Stratigraphic representation of the sample taken from the tang fragment in cross-section (dark field) using the MiCorr application. The characteristics of the strata are only accessible by clicking on the drawing that redirects you to the search tool by stratigraphy representation. This representation can be compared to Fig. 13, Credit HE-Arc CR.

Corrosion products CP2 to CP5 observed under binocular corresponds to CP1 to CP4 under cross-section. Other CPs are more difficult to compare.
