ROUND BRACELET WITH UNIFORM INCLINED INDENTATIONS B3482 – LEADED BRONZE – LATE BRONZE AGE – SWITZERLAND

Artefact name	Round bracelet with uniform inclined indentations B3482
Authors	Marianne. Senn (EMPA, Dübendorf, Zurich, Switzerland) & Christian. Degrigny (HE-Arc CR, Neuchâtel, Neuchâtel, Switzerland)
Url	/artefacts/691/

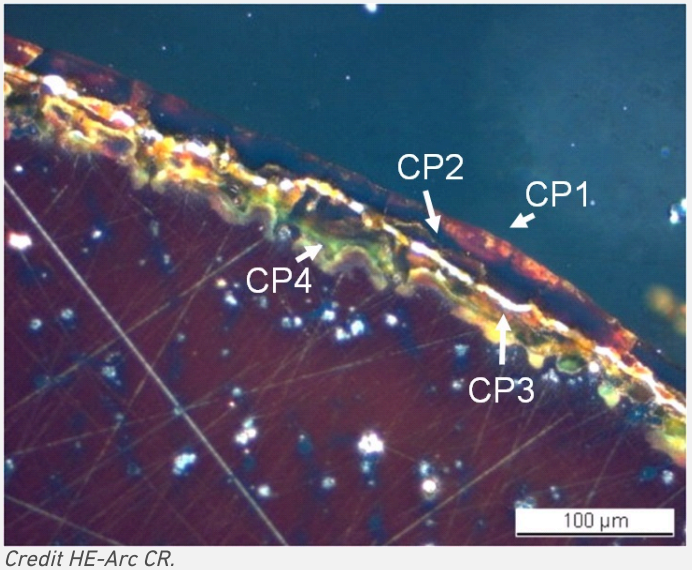
The interface between the metal and corrosion products is irregular (Fig. 5). The corrosion crust has an average thickness of 70µm and is composed of two layers separated by a large fissure (Fig. 5). In bright field, the inner layer includes remnant metal (Sn-rich eutectoid phase, Figs. 5 and 7) and is dark-grey (Fig. 5) while in polarised light it is orange-brownish (CP3, Fig. 8). This Cu depleted layer is rich in Sn, Fe, Si and O (Table 3 and Fig. 8). At the metal - inner layer interface a corrosion product (CP4, light-grey in bright field, greenish in polarised light) shows a slight increase in Cu and Sn content but a decrease of the Fe content (Table 3). In bright field, the outer dense layer is light-grey (CP2, Fig. 5) while in polarised light it appears black with superimposed red to orange areas (CP1, Fig. 8). It is depleted of Cu and richer in Fe. The Sn content is variable but increases in the top brown areas (Table 3 and Fig. 9).

Fig. 7: SEM image of the metal sample (detail of Fig. 5, reversed picture), SE-mode. From bottom right to top left: the metal, the inner and outer corrosion layers separated by a large fissure. The red arrow indicates a remnant of the Sn-rich alpha-delta eutectoid,

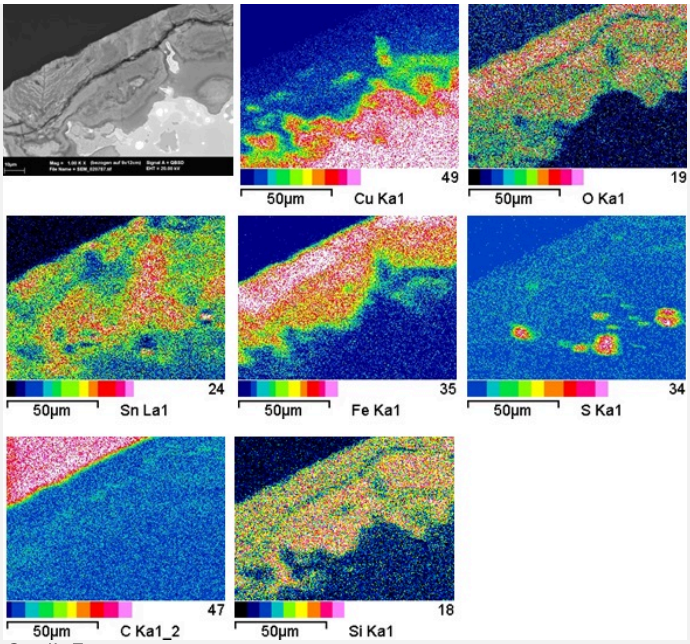
Fig. 9: SEM image, BSE-mode, and elemental chemical distribution of the area of Fig. 7. The S mapping includes the copper sulphide and Pb inclusions, because of a peak interference. Method of examination: SEM/EDS, Laboratory of Analytical Chemistry, Empa,

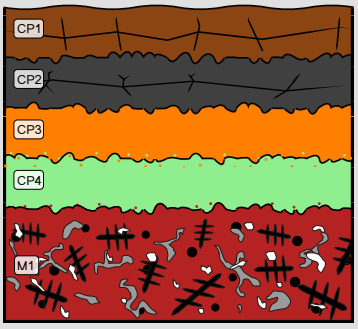
Fig. 4: Stratigraphic representation of the sample taken from the bracelet with uniform inclined rib in cross-section (dark field) using the MiCorr application. The characteristics of the strata are only accessible by clicking on the drawing that redirects you to the search tool by stratigraphy representation. This representation can be compared to Fig. 8, Credit HE-Arc CR.
