ROUND BRACELET WITH UNIFORM INCLINED INDENTATIONS B3482 – LEADED BRONZE – LATE BRONZE AGE – SWITZERLAND

Artefact name	Round bracelet with uniform inclined indentations B3482
Authors	Marianne. Senn (EMPA, Dübendorf, Zurich, Switzerland) & Christian. Degrigny (HE-Arc CR, Neuchâtel, Neuchâtel, Switzerland)
Url	/artefacts/691/

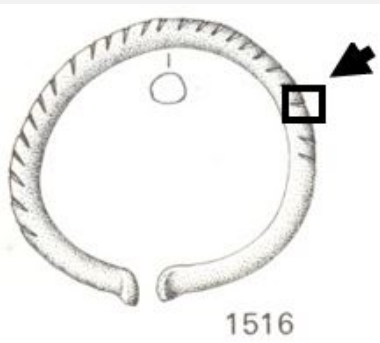
Fig. 2: Location of sampling area,

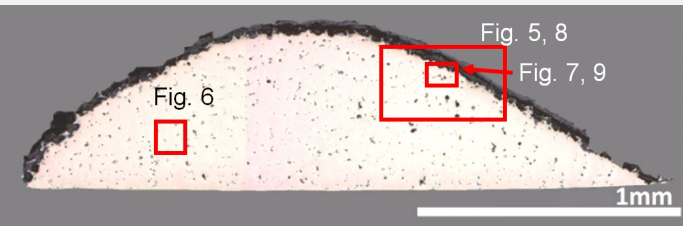
Fig. 3: Micrograph of the cross-section of the sample taken from the bracelet with uniform inclined rib showing the location of Figs. 5 to 9,

Description of sample	The sample is a section from the central part of the bracelet (Fig. 2). Its dimensions are: L = 2.5mm and W = 0.65mm. The corrosion layer is relatively thin (Fig. 3).
Alloy	Leaded Bronze
Technology	As-cast
Lab number of sample	MAH 77-110-5
Sample location	Musées d'art et d'histoire, Genève, Geneva
Responsible institution	Musées d'art et d'histoire, Genève, Geneva
Date and aim of sampling	1977 and 1991, study of the corrosion layer, metal composition

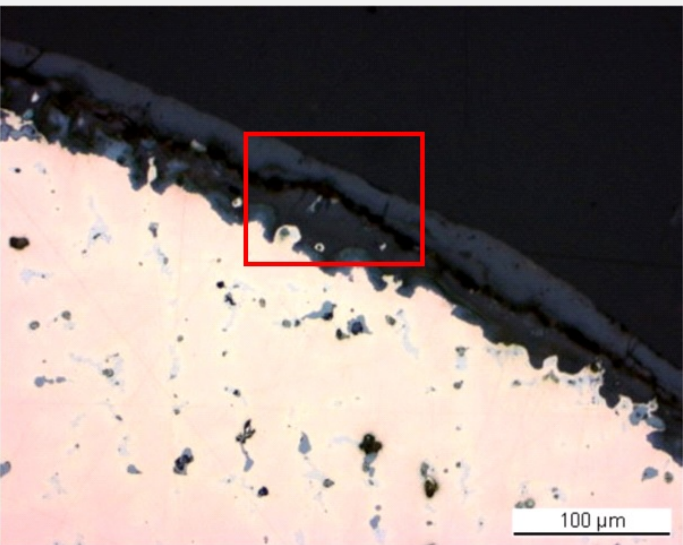
The remaining metal is a porous leaded bronze (Fig. 5 and Table 1). In bright field dark-blue copper sulphide (Fig. 5, Table 2) and tiny dark-grey Pb inclusions (Fig. 5) can be seen. The Sn-rich eutectoid alpha + delta phase appears in light-blue (Fig. 5) and incorporates Pb-rich inclusions. The etched leaded bronze has the dendritic structure of an as-cast metal (Fig. 6) with an average hardness HV1 90. After etching the inclusions have turned darker (Fig. 6) while the eutectoid phase appears whiter.

Fig. 5: Micrograph of the metal sample from Fig. 3 (detail), unetched, bright field. In pink the metal with porosity (black), light-blue the alpha-delta eutectoid, dark-grey lead inclusions and dark-blue copper sulphide inclusions. The rectangle marks the detail image of Fig. 7,

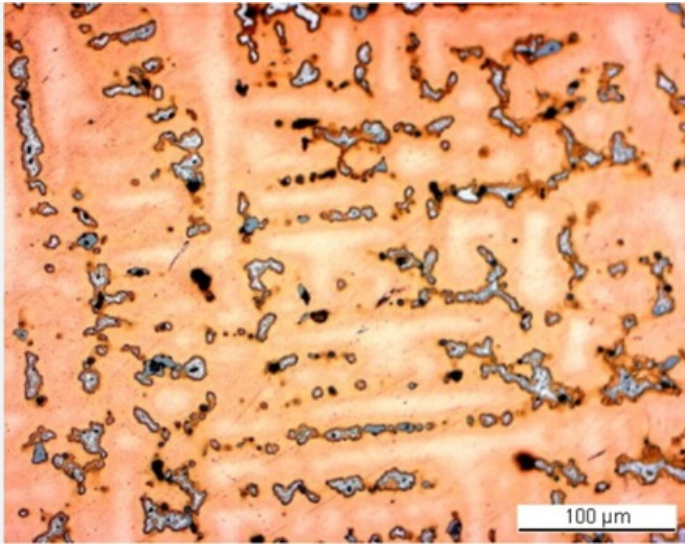
Fig. 6: Micrograph of the metal sample from Fig. 3 (detail), etched, bright field. The leaded bronze has the dendritic structure of an as-cast metal with the Sn-rich eutectoid alpha + delta phase appearing in white at the dendrites borders,

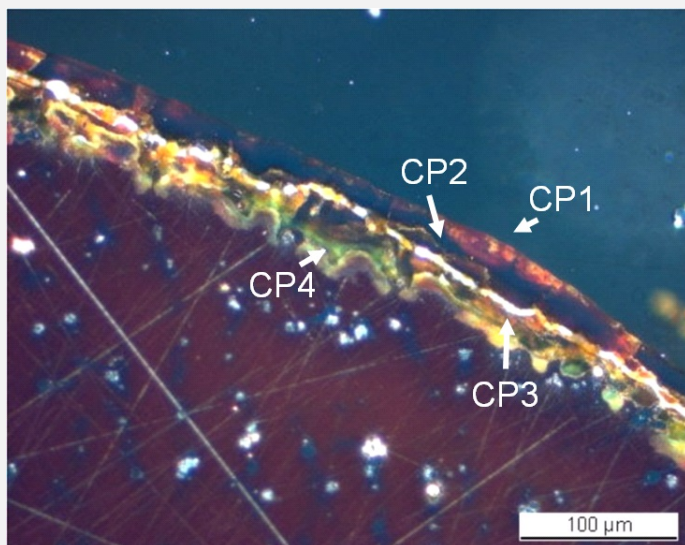
The interface between the metal and corrosion products is irregular (Fig. 5). The corrosion crust has an average thickness of 70µm and is composed of two layers separated by a large fissure (Fig. 5). In bright field, the inner layer includes remnant metal (Sn-rich eutectoid phase, Figs. 5 and 7) and is dark-grey (Fig. 5) while in polarised light it is orange-brownish (CP3, Fig. 8). This Cu depleted layer is rich in Sn, Fe, Si and O (Table 3 and Fig. 8). At the metal - inner layer interface a corrosion product (CP4, light-grey in bright field, greenish in polarised light) shows a slight increase in Cu and Sn content but a decrease of the Fe content (Table 3). In bright field, the outer dense layer is light-grey (CP2, Fig. 5) while in polarised light it appears black with superimposed red to orange areas (CP1, Fig. 8). It is depleted of Cu and richer in Fe. The Sn content is variable but increases in the top brown areas (Table 3 and Fig. 9).

Fig. 7: SEM image of the metal sample (detail of Fig. 5, reversed picture), SE-mode. From bottom right to top left: the metal, the inner and outer corrosion layers separated by a large fissure. The red arrow indicates a remnant of the Sn-rich alpha-delta eutectoid,

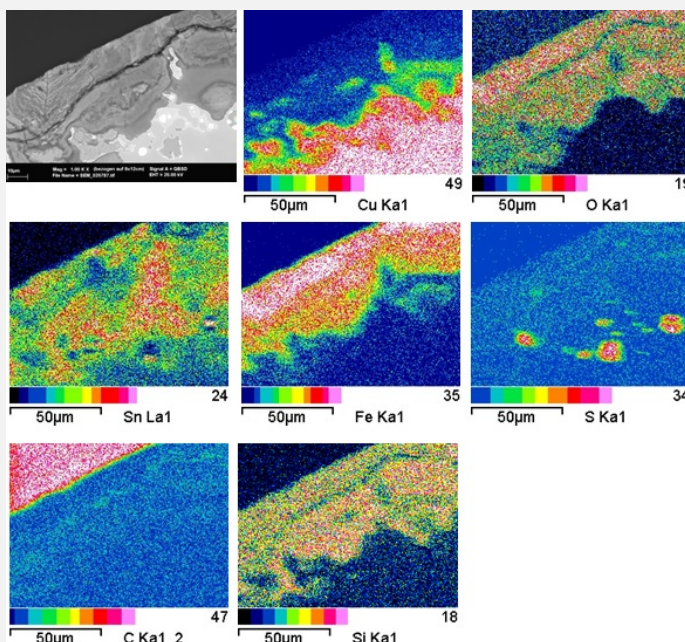
Fig. 9: SEM image, BSE-mode, and elemental chemical distribution of the area of Fig. 7. The S mapping includes the copper sulphide and Pb inclusions, because of a peak interference. Method of examination: SEM/EDS, Laboratory of Analytical Chemistry, Empa,

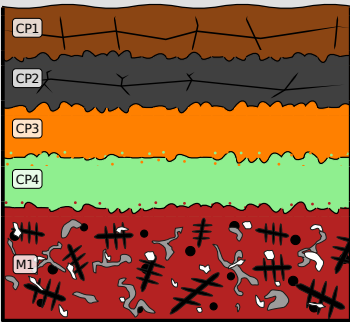
Fig. 4: Stratigraphic representation of the sample taken from the bracelet with uniform inclined rib in cross-section (dark field) using the MiCorr application. The characteristics of the strata are only accessible by clicking on the drawing that redirects you to the search tool by stratigraphy representation. This representation can be compared to Fig. 8, Credit HE-Arc CR.
