SITULA EMT09-554.665 - TIN BRONZE - IRON AGE - SWITZERLAND

Artefact name	Situla EMT09-554.665
Authors	Christian. Degrigny (HE-Arc CR, Neuchâtel, Neuchâtel, Switzerland) & Marie-Jeanne. Scholl (HE-Arc CR, Neuchâtel, Neuchâtel, Switzerland) & Valentin. Boissonnas (HE-Arc CR, Neuchâtel, Neuchâtel, Switzerland)
Url	/artefacts/692/

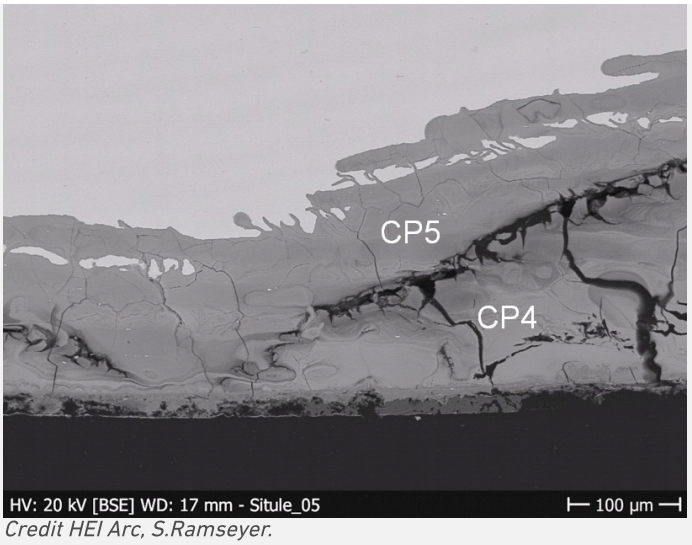
Fig. 11: SEM image, BSE-mode of the metal sample from Fig. 10 (detail) showing cleavage between the inner blue (CP5) and green (CP4) layers of Fig. 6,

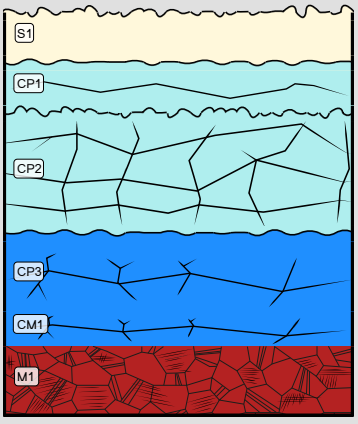
Fig. 5: Stratigraphic representation of the sample taken from the detached fragment of the situla in cross-section (dark field) using the MiCorr application. The characteristics of the strata are only accessible by clicking on the drawing that redirects you to the search tool by stratigraphy representation. This representation shows the exterior face and can be compared to Fig. 10 (bottom red rectangle), Credit HE-Arc CR, M-J.Scholl.

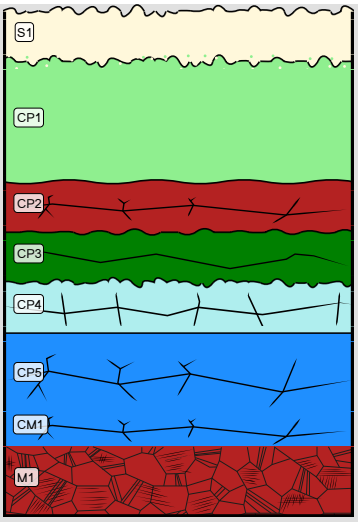
There are 2 stratigraphies (Fig. 5 corresponding to the interior face of the situla and Fig. 6 to its exterior face). The strata are similar in composition but their coding is different: CP1 to CP3 in Fig. 5 correspond to CP3 to CP5 in Fig. 6. Since the stratigraphy of Fig. 6 is more complete, the composition of each of its strata is given below.

Fig. 6: Stratigraphic representation of the sample taken from the detached fragment of the situla in cross-section (dark field) using the MiCorr application. The characteristics of the strata are only accessible by clicking on the drawing that redirects you to the search tool by stratigraphy representation. This representation shows the interior face and can be compared to Fig. 10 (top red rectangle), Credit HE-Arc CR, M-J.Scholl.

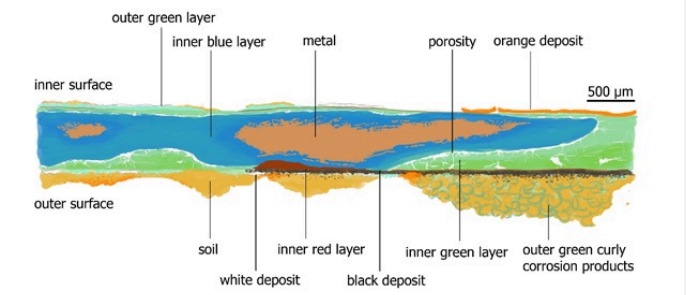
Fig. 16: Improved stratigraphic representation of the situla from visual observations and analyses,

Strata	Composition
Soil (S)	Ca, Si, Al, Fe
Black deposit (D1)	C
Orange deposit (D2)	Ferrous oxides
White deposit (D3)	Ca
Outer green curly corrosion product (CP1e)	Copper carbonates (curly malachite)
Inner red (CP2i)	Copper oxide (cuprite ?)
Outer green layer (CP3i)	Copper carbonates (malachite)
Inner green layer (CP4i)	Copper carbonates (?) + Sn
Inner blue layer (CP5i)	Copper carbonates (?) + Sn
Remnant metal phase (M)	Bronze (90%Cu, 10% Sn)

The metal structure of this low-tin bronze shows extensive cold work and multiple annealing cycles with a final cold work. The total absence of inclusions highlights a highly developed knowledge in bronze metallurgy. The metal is much corroded. Transgranular corrosion is visible. The majority of the internal corrosion products are composed of copper carbonates that have replaced much of the metal. Curly malachite has developed in clusters on the outside of the surface. This pattern is characteristic of a long-term burial period. The presence of inner enriched Sn layers shows a decuprification phenomenon (dissolution of Cu). Because of the friable nature of the inner green layer that supports the limit of the original surface, as well as its cleavage with the blue layer underneath, the original surface has become very fragile. The corrosion is thought to be of type 1 according to Robbiola et al. 1998.
