MOIL CHISEL DEV 995 762 PR – STEEL – EARLY MEDIEVAL TIMES – SWITZERLAND

Artefact name Moil chisel DEV 995 762 PR

Authors Marianne. Senn (EMPA, Dübendorf, Zurich, Switzerland) & Christian. Degrigny (HE-Arc CR, Neuchâtel, Neuchâtel, Switzerland)

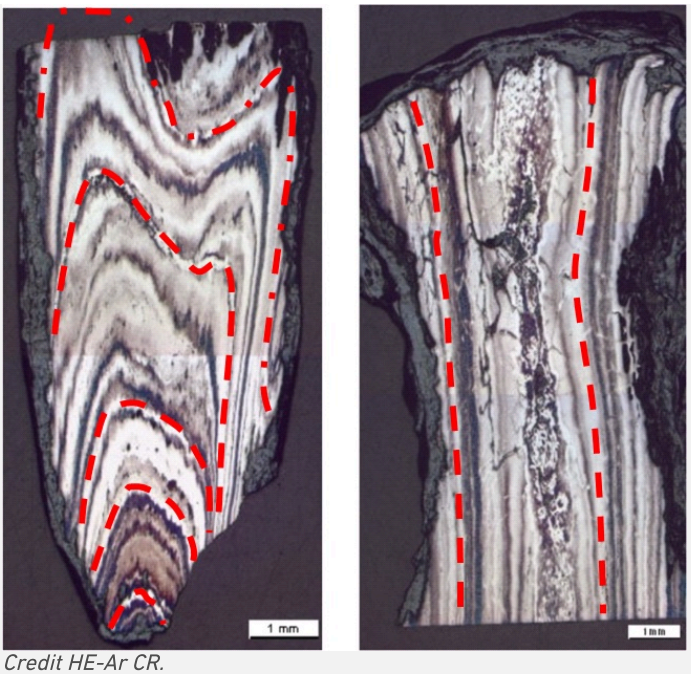
Fig. 8: Micrograph of metal samples 1 and 2, etched with Oberhoffer's reagent, bright field. The P segregation along the welding seams is outlined. The main welding seams are marked by red dotted lines,

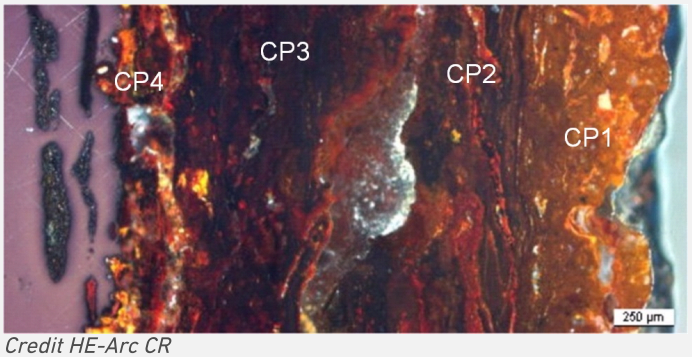
The metal - corrosion products interface is irregular (Fig. 3) and the average thickness of the corrosion crust is about 0.6mm. However, on the left side of the sample taken from the head of the chisel (Fig. 3) the corrosion crust is deeper with an average thickness of about 2mm. This area is further detailed below (Figs. 11 and 12). The corrosion crust can be divided into several layers (CP1-CP4). In bright field, and in the BSE-mode of the SEM image, darker and lighter regions are visible (Figs. 11, 13 and 14). In this area the corrosion layer contains typical trace elements of the metal (As and P, Table 3). In polarised light we see a dark-red zone in which different grey zones are included (Fig. 12). The element mapping and the analyses show that at the metal - corrosion crust interface iron chlorides occur (Figs. 13 and Table 3, CP4 in Fig. 4). Only the outer zone, which has reacted with the soil, has a different colour (orange) and incorporates many rock inclusions (Si, Al and Ca) (Fig. 14 and Table 3, CP1 in Fig. 4).

Fig. 11: Micrograph showing the metal - corrosion crust interface from Fig. 3 (reversed picture, detail), unetched, bright field. The areas selected for elemental chemical distributions (Fig. 13 (left) and Fig. 14 (right)) are marked by red rectangles,

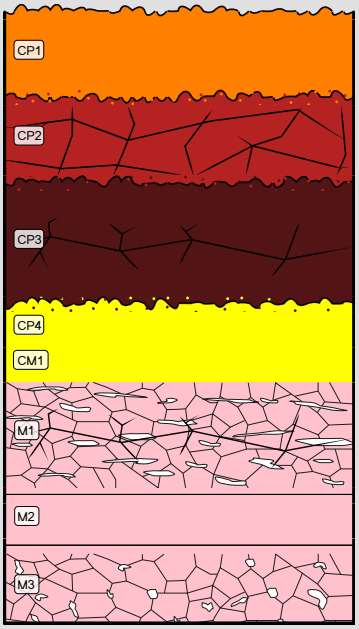
Fig. 4: Stratigraphic representation of sample 2 from the moil chisel in cross-section (dark field) using the MiCorr application. The characteristics of the strata are only accessible by clicking on the drawing that redirects you to the search tool by stratigraphy representation. This representation can be compared to Fig. 12, Credit HE-Arc CR.
