FITTING ON BACK PANEL OF A MILITARY CARRIAGE – THOMAS STEEL – MODERN TIMES – SWITZERLAND

Artefact name	Fitting on back panel of a military carriage
Authors	Marianne. Senn (EMPA, Dübendorf, Zurich, Switzerland) & Christian. Degrigny (HE-Arc CR, Neuchâtel, Neuchâtel, Switzerland)
Url	/artefacts/701/

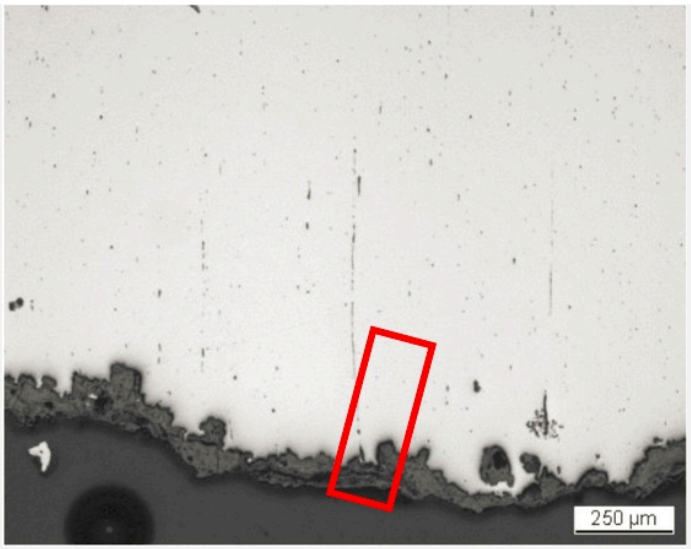
The remaining metal is a Mn-rich soft steel (C content around 0.1 mass%) containing manganese sulphide inclusions with a varying Fe content (Tables 1 and 2). The numerous inclusions form parallel rows (Fig. 5). This orientation is typical for hot rolled metal. After etching with Oberhoffer's reagent, three main welding seams (P-rich) become visible (Fig. 6). Near the surface they are also outlined by corrosion (Figs. 5 and 11). After nital etching, the metal shows a ferritic structure with tertiary cementite and lamellar pearlite at the grain boundaries (Figs. 7 and 8). The grains are small with an ASTM grain size of 10 and are recrystallized due to annealing after hot rolling. The average hardness of the metal is HV1 165. The hardness is slightly high for such a structure and this is due to the Mn content of the metal. The chemical composition, especially the Mn content and the presence of carbo-nitrides (not analysed here), is typical for Thomas steel.

Fig. 5: Micrograph of the metal sample from Fig. 3 (rotated by 270°, detail), unetched, bright field. We observe the metal including welding seams outlined by corrosion products and MnS inclusions. The area selected for elemental chemical distribution (Fig. 11) is marked by a red rectangle,

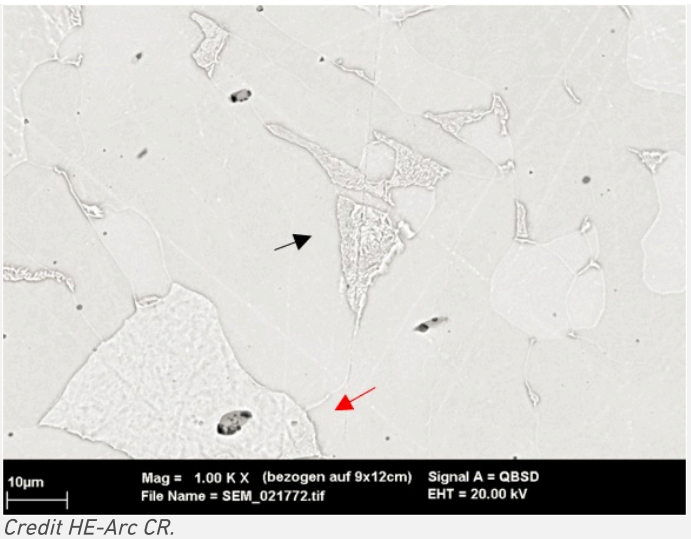
Fig. 8: SEM image of the metal sample from Fig. 3 (detail), BSE-mode, nital etched, bright field. The white ferrite grains contain lamellar pearlite (black arrow) and lenticular grey MnS inclusions (red arrow) in between the grain boundaries,

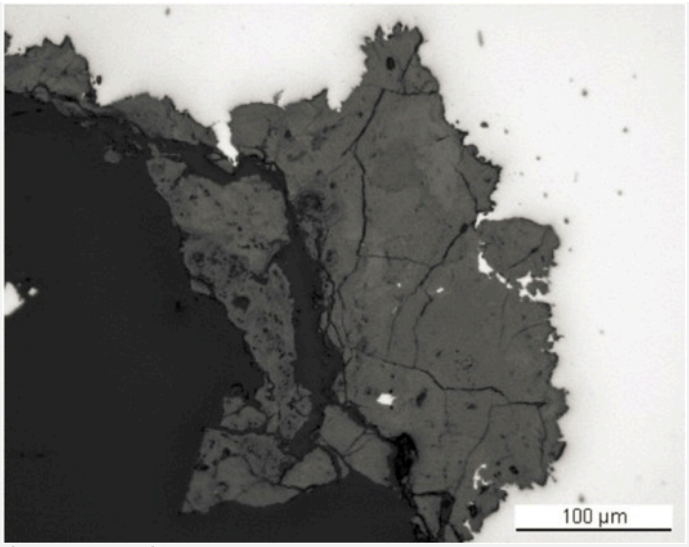
The average thickness of the corrosion products is about 80µm (Figs. 5 and 9). In bright field they appear grey, marbled and heavily cracked (Fig. 9). Under polarised light, the corrosion products appear orange to dark-brown (Fig. 10). At the metal - corrosion products interface they are dark-brown (CP3). The middle part (CP2) is red-orange and the outer part is bright orange (CP1). The elemental mapping of the corrosion layers shows no distinctive stratification, but areas near the metal - corrosion crust interface (CP3) as well as the top surface of the corrosion layer (CP1) seem to have a lower O content (Fig. 11). The O content indicates the presence of iron hydroxides (Table 3). Soil materials (such as rock fragments and dust) are found in the welding seams near the surface.

Fig. 9: Micrograph showing the metal - corrosion crust interface from Fig. 3 (rotated by 270°, detail), unetched, bright field. We observe in white the metal, in grey the corrosion products and in black the resin,

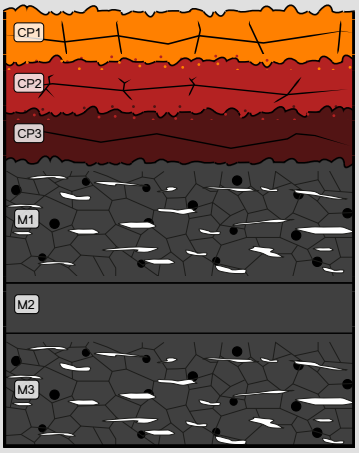
Fig. 4: Stratigraphic representation of the sample taken from the fitting in cross-section (dark field) using the MiCorr application. The characteristics of the strata are only accessible by clicking on the drawing that redirects you to the search tool by stratigraphy representation. This representation showing for the metal part a welding seam (M2) can be compared to Fig. 10, Credit HE-Arc CR.
