FITTING ON BACK PANEL OF A MILITARY CARRIAGE – THOMAS STEEL – MODERN TIMES – SWITZERLAND

Artefact name	Fitting on back panel of a military carriage
Authors	Marianne. Senn (EMPA, Dübendorf, Zurich, Switzerland) & Christian. Degrigny (HE-Arc CR, Neuchâtel, Neuchâtel, Switzerland)
Url	/artefacts/701/

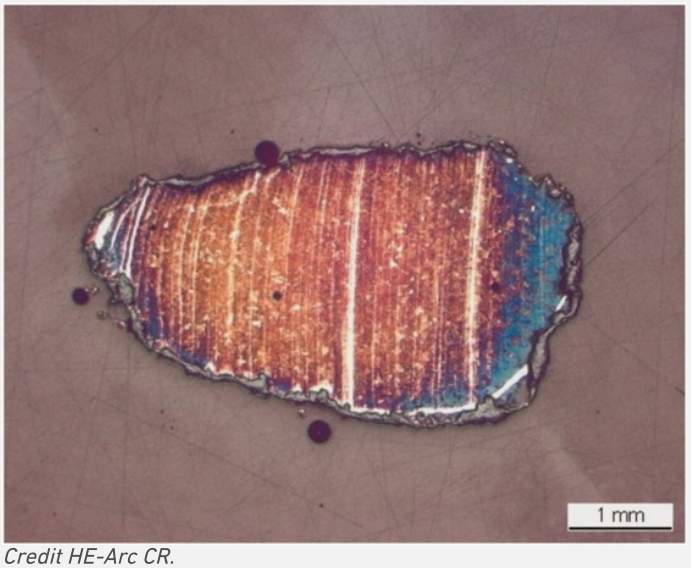
Fig. 6: Micrograph of the metal sample from Fig. 3, etched with Oberhoffer's reagent, bright field. We observe three P-rich welding seams in white,

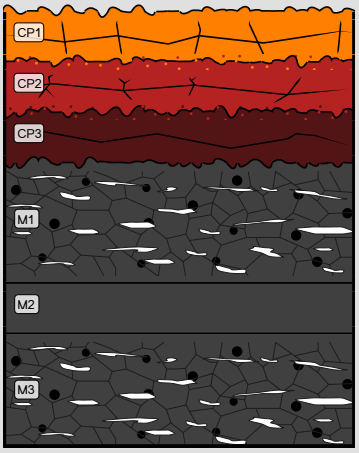
Fig. 4: Stratigraphic representation of the sample taken from the fitting in cross-section (dark field) using the MiCorr application. The characteristics of the strata are only accessible by clicking on the drawing that redirects you to the search tool by stratigraphy representation. This representation showing for the metal part a welding seam (M2) can be compared to Fig. 10, Credit HE-Arc CR.
