FRAGMENT OF THE SUPPORT STRUCTURE OF AN ENGINE VHS-404 - GREY CAST IRON - MODERN TIMES

Artefact name	Fragment of the support structure of an engine VHS-404
Authors	Marianne. Senn (EMPA, Dübendorf, Zurich, Switzerland) & Christian. Degrigny (HE-Arc CR, Neuchâtel, Neuchâtel, Switzerland)
Url	/artefacts/702/

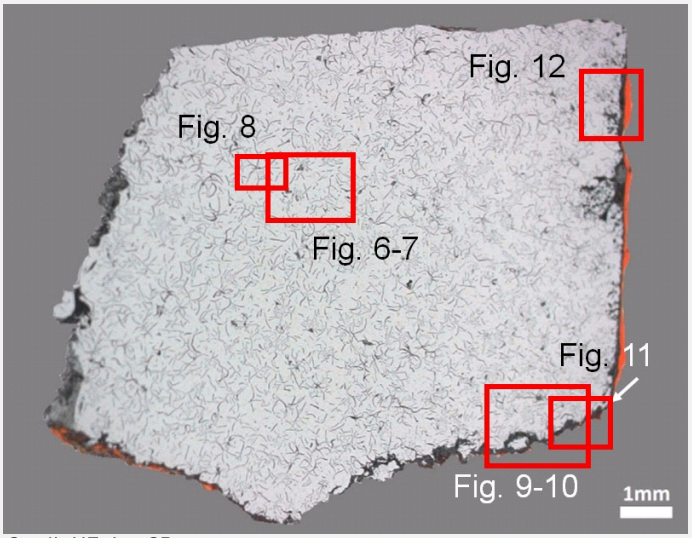
Fig. 3: Micrograph of the cross-section of the fragment showing the location of Figs. 5 to 12,

Description of sample	The sample is a cross-section through the fragment of the support structure of the engine (Fig, 3). Dimensions: Lmax = 10mm; Wmax = 10mm.
Alloy	Grey cast iron
Technology	As-cast
Lab number of sample	VHS-G-1
Sample location	Empa (Marianne Senn)
Responsible institution	Swiss Museum of Transport, Luzern, Lucerne
Date and aim of sampling	07/09/2009 metallography

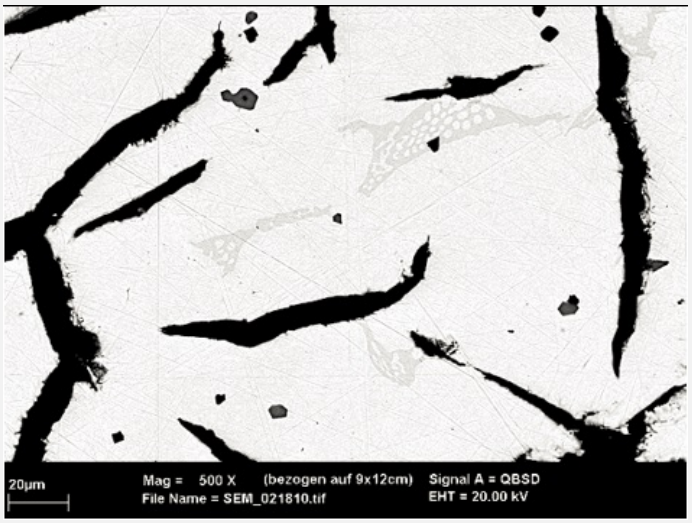
The remaining metal is a high P and Si grey cast iron with elevated Mn and V contents (Tables 1 and 2). The structure contains black graphite flakes and graphite nodules (Fig. 5) as well as angular grey manganese sulphide inclusions which can contain a dark alumina-rich centre (Fig. 5 and Table 1). The graphite flakes are irregular and vary in size. At low magnification the flakes are evenly spread over the entire surface with a tendency to form clusters. Some porosity is noticeable. Under SEM, in the BSD-mode, an additional eutectic phase is visible (Fig. 6). After etching one can see how the graphite is surrounded by alpha-iron in a pearlite matrix (Figs. 7 and 8). The lamellar pearlite includes steadite (Fe_3P) and manganese sulphide (MnS) inclusions. According to the cast iron diagram after Maurer (Bargel and Schulze 2008, 257), the structure is typical for a hypoeutectic pearlitic grey cast iron (C content <4.3 mass%, Si content ca. 2.0 mass%) including pearlite, steadite and graphite. The slow cooling rate and the higher Si level have favoured the formation of graphite. The high P content favours the growth of interconnected networks of steadite. The average hardness of the metal is HV1 160. This hardness is only approximate. Normally cast iron hardness is determined with a Brinell test, but due to the small size of the sample this could not be carried out. The calculated HB is about 150.

Fig. 5: Micrograph of the metal sample from Fig. 3 (inverted picture, detail), unetched, bright field. We observe graphite flakes and irregular nodules in black and the metal in white. The small grey spots are manganese sulphide inclusions,

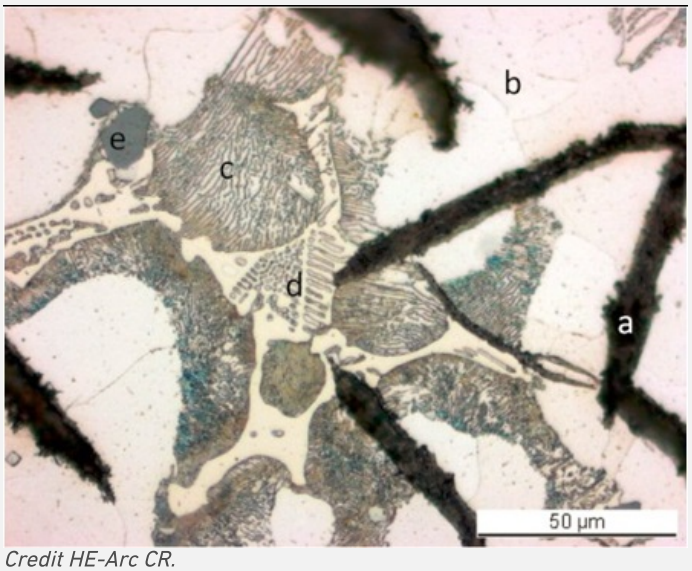
Fig. 8: Micrograph of the metal sample from Fig. 3 (detail), etched, bright field. The structure is composed of graphite (a), ferrite (b), pearlite (c), steadite (d) and MnS inclusions (e),

Microstructure	Graphite lamellars + pearlite + ferrite + steadite (Fe3P)
First metal element	Fe
Other metal elements	C, P, Ti, V, Mn

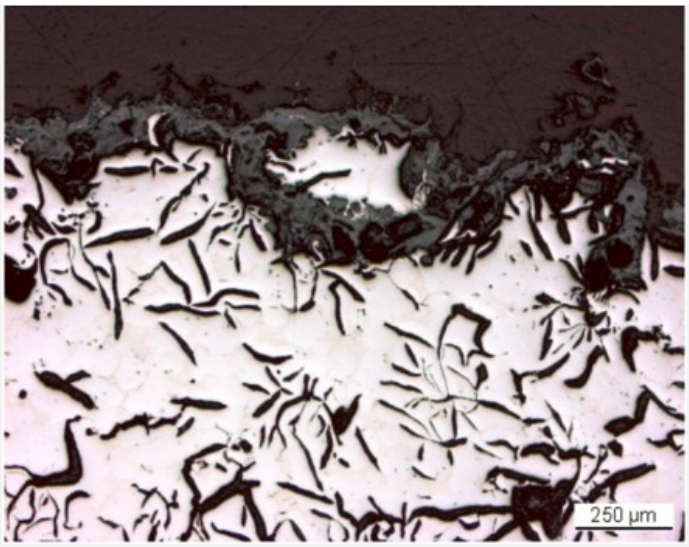
The thin corrosion crust (CP1) is limited to three sides of the sample and some remains of a paint coating (orange) are visible (Fig. 3). In bright field, the corrosion crust appears light-grey (Fig. 9), under polarised light-orange (Fig. 10). It is mainly composed of iron oxides (Table 3 and Fig. 11). The Pb and Ba-rich paint system has been applied directly onto the oxidized Fe, Si and Mn-rich casting skin (Fig. 12). The paint layer is probably an anodic inhibitor made from minium (red lead) with a barium sulphate filler. Because of the interference of Pb with S in the EDS spectra S is difficult to detect.

Elements	O	Mg	Si	P	S	Mn	Fe	Ba	Pb	Total
Inner light-grey corrosion layer (Fig. 12)	20	<	<	<	<	1.3	76	<	<	98
Dark-grey casting skin (Fig. 12)	27	<	14	<	<	21	33	<	<	95
Paint system (Fig. 12)	20	<	<	<	<	<	<	18	55	93
Grey corrosion layer (Fig. 11)	35	<	1.1	<	0.6	<	59	<	<	97

Table 3: Chemical composition (mass %) of the corrosion layer (from Figs. 11 and 12). Method of analysis: SEM/EDS, Laboratory of Analytical Chemistry, Empa.

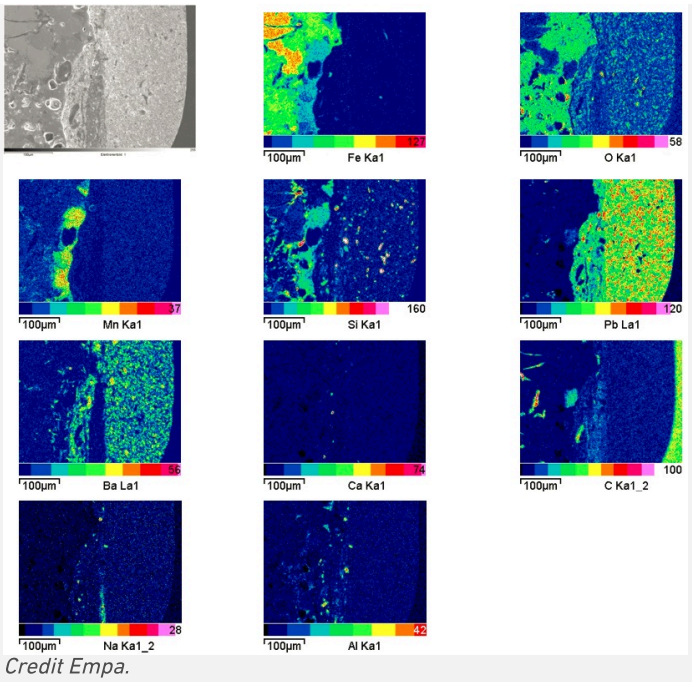
Fig. 12: SEM image, SE-mode, and elemental chemical distribution of the selected area from Fig. 3 (detail). Method of examination: SEM/EDS, Laboratory of Analytical Chemistry, Empa,
