MILITARY ID TAG 5668-MXX-1008-1 - ZN PB ALLOY - MODERN TIMES - FRANCE

Artefact name	Military ID tag 5668-MXX-1008-1
Authors	Christian. Degrigny (HE-Arc CR, Neuchâtel, Neuchâtel, Switzerland) & Marie-Jeanne. Scholl (HE-Arc CR, Neuchâtel, Neuchâtel, Switzerland) & Valentin. Boissonnas (HE-Arc CR, Neuchâtel, Neuchâtel, Switzerland)
Url	/artefacts/706/

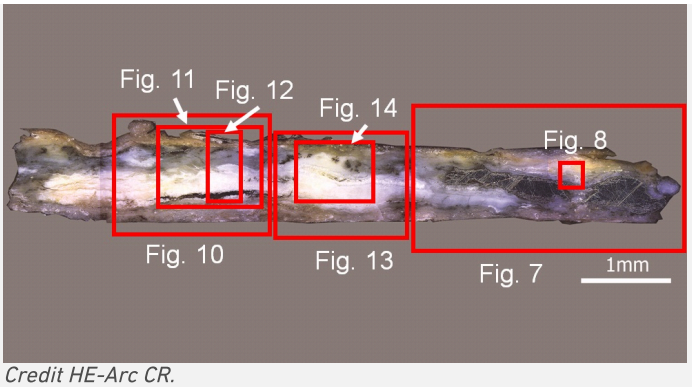
Fig. 4: Micrograph of the cross-section of fragment b of the military tag showing the location of Figs. 7, 8 and 10 to 14. Unetched, dark field, 50x,

Description of sample	This sample was cut out of fragment b in Fig. 1. The cross-section shows the entire thickness of the plate (L = 8 mm, W= 1 mm). The corrosion goes through the whole metal thickness but a metallic core remains (Figs. 4 and 7).
Alloy	Zn Pb Alloy
Technology	Cold worked (laminated)
Lab number of sample	None
Sample location	HE-Arc CR, Neuchâtel, Neuchâtel
Responsible institution	Pôle d'Archéologie Interdépartemental Rhénan, Sélestat, Alsace
Date and aim of sampling	2013, metallography and chemical analyses

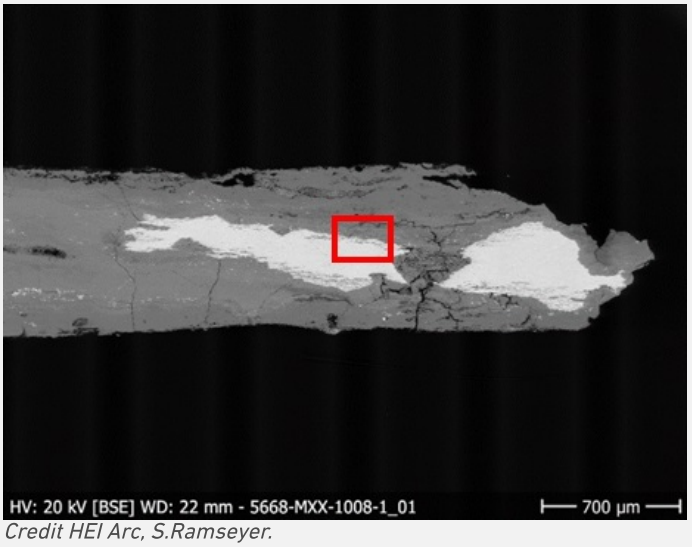
The remaining metal is a zinc alloy (Table 1) containing 1.8% in weight lead. Lead appears in the metal in the form of small flattened white Pb inclusions (Fig. 8), confirming the manufacturing technique, namely lamination. The etched metal does not show any specific microstructure (Fig. 9).

Fig. 7: SEM image of the cross-section, from Fig. 4 (detail), BSE-mode. Note the presence of Pb inclusions all through the thickness of the heavily cracked corrosion layers. The SEM image of Fig. 8 is marked by a rectangle,

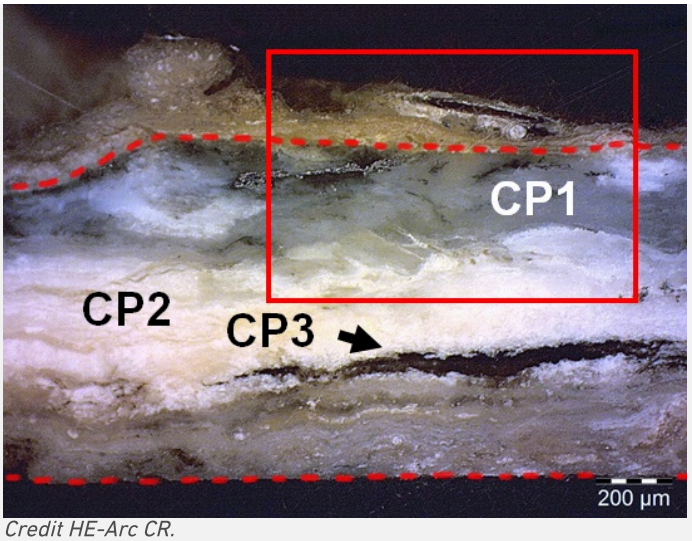
The corrosion structure is multi-layered: several corrosion products overlap. However they are not all continuous layers, since some of them are isolated. Most of the corrosion products layers show structural voids (up to 100 µm thick) and some cracks inside. Three layers can be distinguished (Figs. 5 or 6 - only Fig. 5 is detailed below - and 10) which have the same elements but in different proportions (Figs. 11, 12 and table 2):

Fig. 10: Micrograph of the cross-section, from Fig. 4 (detail) and corresponding to the stratigraphy of Fig. 5, unetched, dark field, 50x. View of the inner layers and the limit of the original surface (red line). We can see that the interfaces between the different layers are not well defined: some of the white corrosion product is found inside the inner grey layer. The micrograph of Fig. 11 is marked by a rectangle,

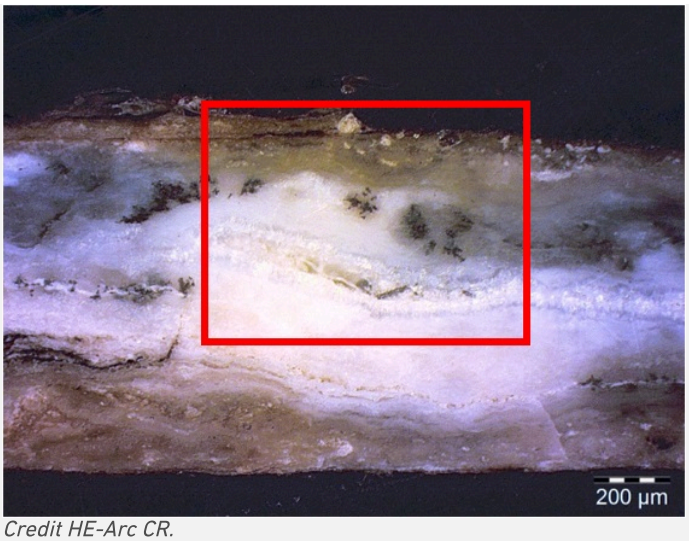
- Inner grey layer – CP1 (up to 1 mm thick) is a translucent, compact layer and constitutes most part of the corrosion products. Corroded metal appears inside this layer as lead inclusions within a black corrosion product (Figs. 13 and 14). Sulphur has also been detected by SEM-EDS inside this layer, near the surface, where the colour turns into grey-orange (zinc sulfide or sulphates but to be confirmed, table 2).

Table 2: Chemical composition of the different corrosion layers from Fig. 13. Method of analysis: SEM-EDS, Lab of Electronic Microscopy and Microanalysis, IMA (Néode) (+++: high concentration, ++ medium concentration, + low concentration, nd: not-detected).

Fig. 13: Micrograph of the cross-section, from Fig. 4 (detail), unetched, dark field, 50x. The micrograph of Fig. 14 is marked by a rectangular,

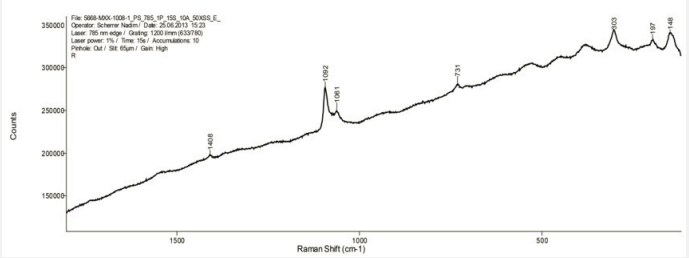
The inner grey layer (CP1, Figs. 5 and 10) has been identified by FTIR as a zinc carbonate (smithsonite), mixed with other unidentified corrosion products. Raman spectra seems to confirm it (Fig. 15). The exact composition of the inner white layer (CP2) is unknown. It shows a bluish fluorescence under UV light and has been identified by FTIR as a mixture of zinc oxides and carbonates, that could be zinc hydroxycarbonates (hydrozincite). Raman spectroscopy shows also a mixture of carbonates and other corrosion products (Fig. 16). The inner black layer (CP3) is a zinc carbonate as well, identified by FTIR and Raman spectroscopy (Fig. 17) appearing as a vein between layers of grey and white (Fig. 10).

Fig. 15: Raman spectrum of the inner grey layer (CP1, ZnCO3 – smithsonite?). Settings: laser wavelength 532nm, acquisition time 10s, one accumulation, filter D2 (0.75-0.8mW), hole 500, slit 80, grating 600. Method of analysis: Raman spectroscopy, Art Technological Laboratory, Departement Conservation HKB,

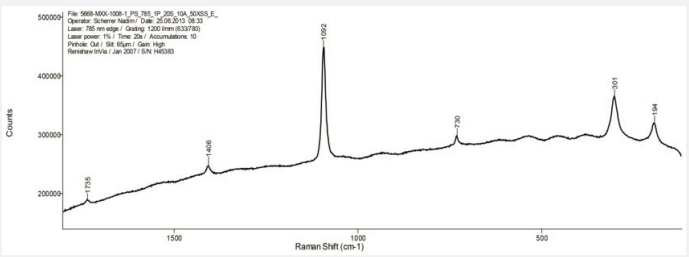
Fig. 17: Raman spectrum of the inner black layer (zinc carbonate?). Settings: laser wavelength 532nm, acquisition time 10s, one accumulation, filter D2 (0.75-0.8mW), hole 500, slit 80, grating 600. Method of analysis: Raman spectroscopy, Art Technological Laboratory, Departement Conservation HKB,

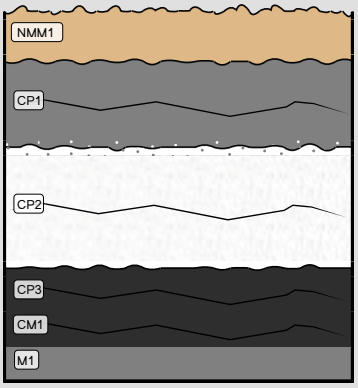
Fig. 5: Stratigraphic representation of fragment b of the military tag in cross-section (dark field) using the MiCorr application. The characteristics of the strata are only accessible by clicking on the drawing that redirects you to the search tool by stratigraphy representation. This representation can be compared to Fig. 10, Credit HE-Arc CR, M-J.Scholl.

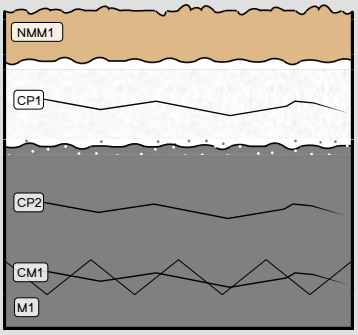
Fig. 6: Stratigraphic representation of fragment b of the military tag in cross-section (dark field) using the MiCorr application. The characteristics of the strata are only accessible by clicking on the drawing that redirects you to the search tool by stratigraphy representation. This representation is different from Fig. 10 due to the inversion of CP1 and CP2. Furthermore, CP3 is not represented, Credit HE-Arc CR, M-J.Scholl.

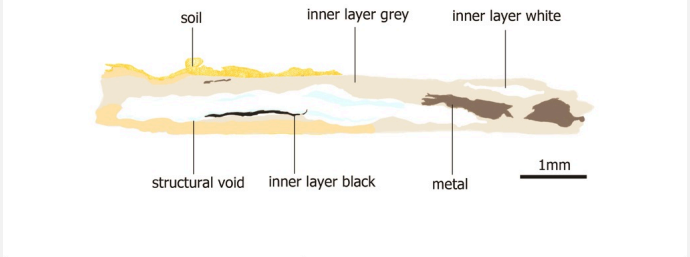
Strate	Composition
Soil (S)	Elements from soil, organic elements
Grey corrosion product (CP1)	Zinc carbonate (smithsonite) + S
White corrosion product (CP2)	Zinc hydroxycarbonate + mixture of CP
Black corrosion product (CP3)	Zinc carbonate
Corroded metal (CM)	
Metal (M)	Zn-Pb

Fig. 16: Improved representation of the stratigraphy of corrosion layers of the military tag from visual observations and analyses,
