ARMATURE FROM A CLOCK MOVEMENT MIH IV-212 – ZN AL SN CU ALLOY – MODERN TIMES

Artefact name	Armature from a clock movement MIH IV-212
Authors	Marianne. Senn (EMPA, Dübendorf, Zurich, Switzerland) & Christian. Degrigny (HE-Arc CR, Neuchâtel, Neuchâtel, Switzerland)
Url	/artefacts/707/

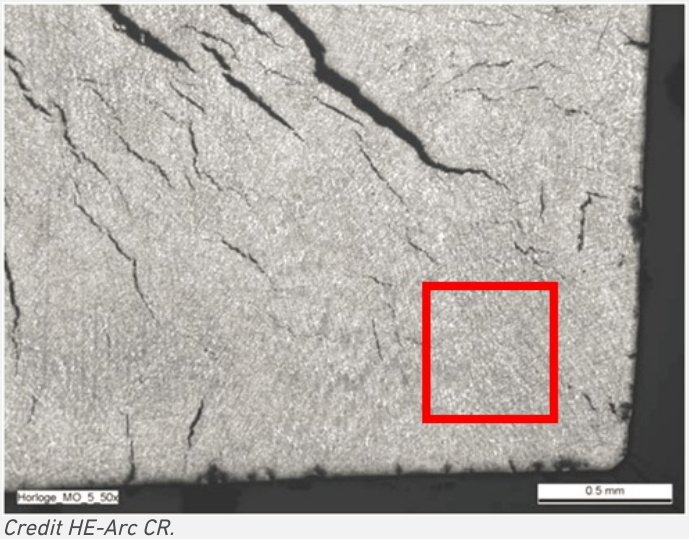
The metal is a Zn-Al-Sn-Cu alloy (Table 1) with an average hardness of HV1 105. A fine dendritic structure is observed (Fig. 5) which consists of clearly separated Zn, Al-Cu and Sn-rich phases (Figs. 6 and 7). Pb is associated with Sn but also forms tiny nodules.

Metal	67	17	11	4	<1	99

Table 1: Chemical composition (mass %) of the metal (oxygen not shown). Method of analysis: SEM/EDS, Lab of Electronic Microscopy and microanalysis, IMA (Néode), HEI Arc.

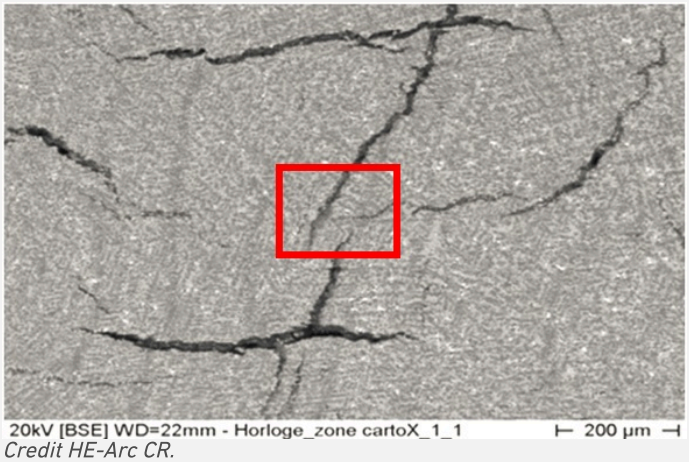
Fig. 8: Micrograph showing the metal - "corrosion products" interface from Fig. 3 (reversed picture, detail), unetched, bright field. We observe in white the metal matrix and dark-grey the adhering material,

Fig. 9: Micrograph of the metal sample, detail from Fig. 8 (reversed and rotated by 90°), unetched, bright field. A dendritic structure is visible. The area selected for elementary mapping (Fig. 10) is marked by a rectangle,
