SHOE NAIL 2637 1370.B. - HYPOEUTECTOID STEEL - ROMAN TIMES - SWITZERLAND

Artefact name	Shoe nail 2637 1370.B.
Authors	Christian. Degrigny (HE-Arc CR, Neuchâtel, Neuchâtel, Switzerland) & Valentin. Boissonnas (HE-Arc CR, Neuchâtel, Neuchâtel, Switzerland) & Vincent Chappuis. (HE-Arc CR, Neuchâtel, Neuchâtel, Switzerland)
Url	/artefacts/708/

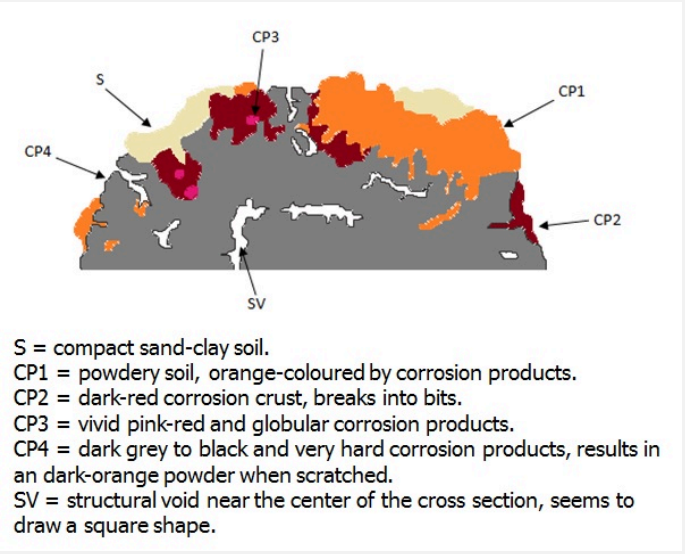
The schematic representation below gives an overview of the corrosion layers encountered on the nail from a first visual macroscopic observation.

Fig. 3: Preliminary stratigraphy of the corrosion layers based on the observation of a broken nail,

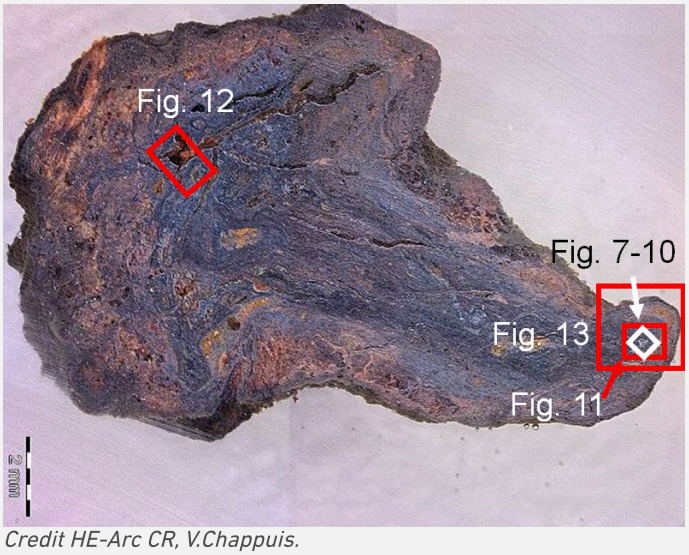
Fig. 4: Micrograph of the cross-section of the nail showing the location of figs. 7 to 13,

The metal is heavily corroded and the thickness of the corrosion crust is irregular, varying from 0.8 to 3.8mm, with an average of about 2mm. The corrosion has replaced most of the metal (Fig. 4). Between corrosion layers the limit of the original structure is visible. Some leather fibers seem to be preserved as pseudomorphic structures in voids of the metal core (POM1, Figs. 11 and 12). The carbon mapping (Fig.13) shows the presence of carbon in these areas. This can also be due to the penetration of the mounting resin in the cracks.

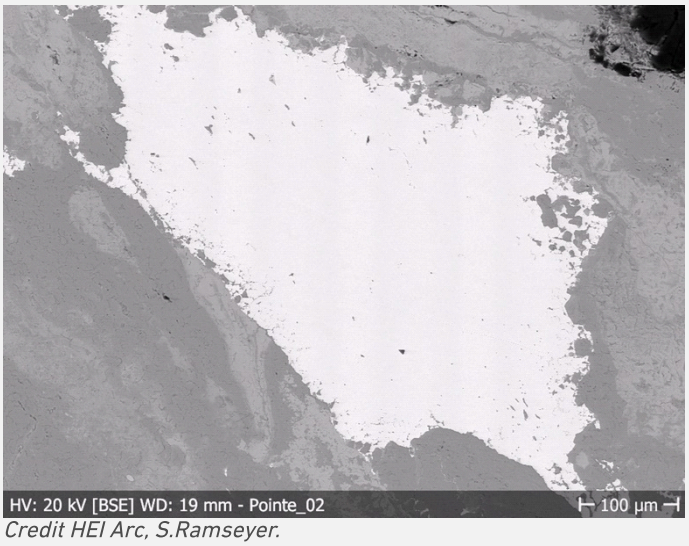
The remaining metal is an hypoeutectoid steel (Fig. 7 and 8), containing Fe, Si and O slags inclusions (possibly fayalite FeO,SiO2), and consisting of less than 1% of the total volume of the highly mineralized nail. After Nital etching, it shows intergranular corrosion on one of its sides (Figs. 9 and 10).

Fig. 7: SEM, BSE-mode picture of remaining metal,

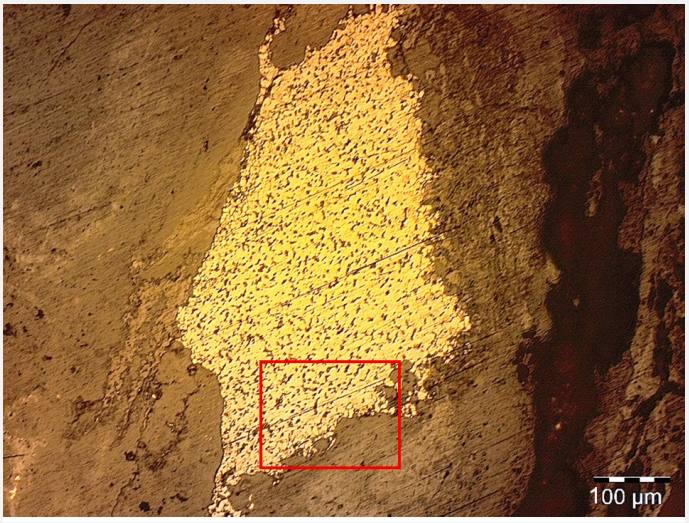
Fig. 8: SEM, BSE-mode picture of inclusions in remaining metal,

Fig. 9: Micrograph of the metal sample from Fig. 7 (detail, rotated 90°), Nital etched, bright field,

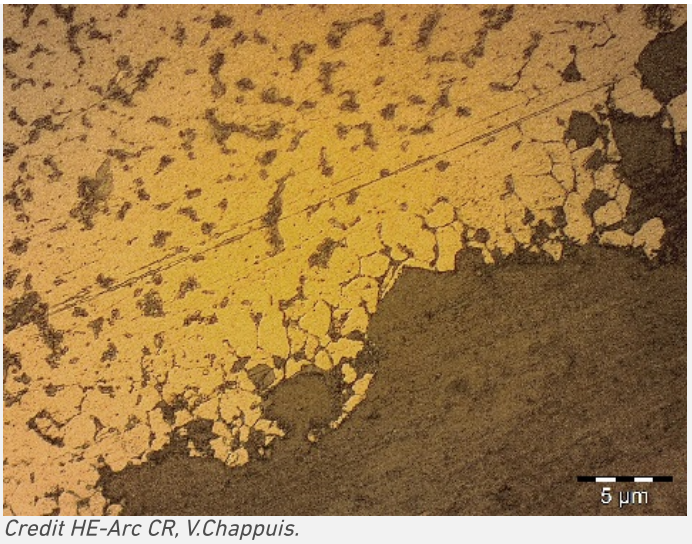
Fig. 10: Micrograph of the selected area of Fig. 9, Nital etched with no clear grain structure, bright field, Intergranular corrosion and grey phase (perlite?) are observed,

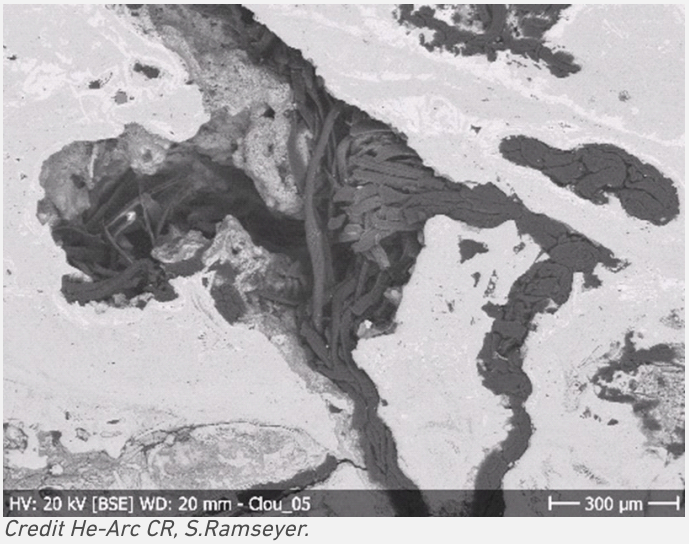
Fig. 11: Micrograph of the metal sample, bright field. The deliminated zone shows what could be leather pseudomorphic fibers filling a void,

Fig. 12: Micrograph (SEM - BSE-mode) of another void filled with fibers in the head of the nail,

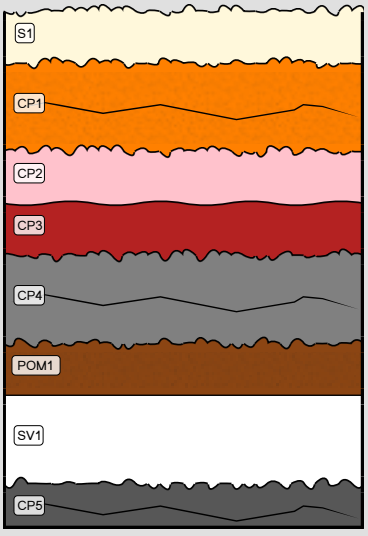
Fig. 5: Stratigraphic representation of the nail in cross-section (dark field) using the MiCorr application. The characteristics of the strata are only accessible by clicking on the drawing that redirects you to the search tool by stratigraphy representation. This representation can be compared to Fig. 14, Credit HE-Arc CR, V.Chappuis.

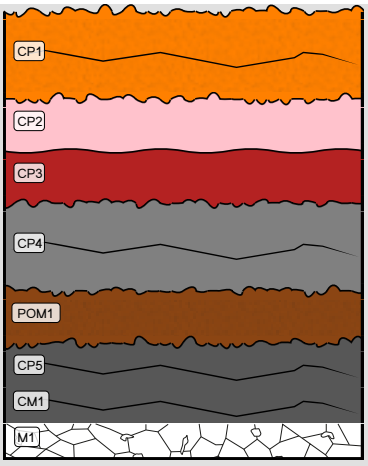
Fig. 6: Stratigraphic representation of the nail in cross-section (dark field) using the MiCorr application. The characteristics of the strata are only accessible by clicking on the drawing that redirects you to the search tool by stratigraphy representation. This representation can be compared to Fig. 14, Credit HE-Arc CR, V.Chappuis.

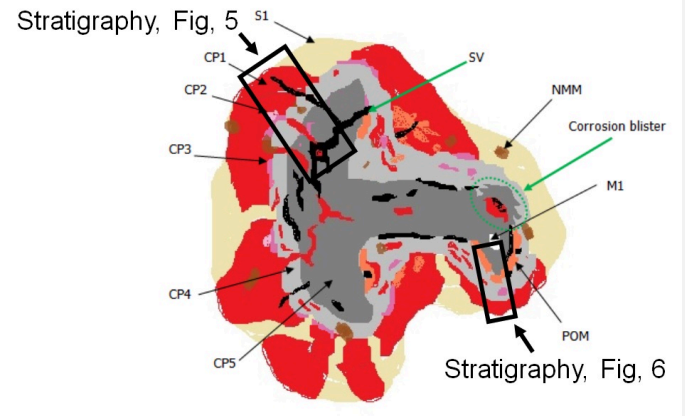
The schematic representation of corrosion layers of Fig. 3 integrating additional information based on the analyses carried out is given in Fig. 14. The following strata were identified:

SV = structural void, present as fissures that either pass through the different layers, or are present at corrosion interfaces, especially at the CP4/CP5 interface. The void is 0.1 to 0.3mm thick and partially filled with POM in the outer layers.

Fig. 14: Improved stratigraphic representation of the nail from visual observations and analyses and visualization of the two stratigraphies of Figs, 5 and 6,
