BUST OF AN APPLIQUE 2005.054.F00265.1 – QUARTERNARY BRONZE ALLOY – ROMAN TIMES – SWITZERLAND

Artefact name Bust of an applique 2005.054.F00265.1

Authors Christian. Degrigny (HE-Arc CR, Neuchâtel, Neuchâtel, Switzerland) & Marie. Arnautou (HE-Arc CR, Neuchâtel, Neuchâtel, Switzerland) & Valentin. Boissonnas (HE-Arc CR, Neuchâtel, Neuchâtel, Switzerland)

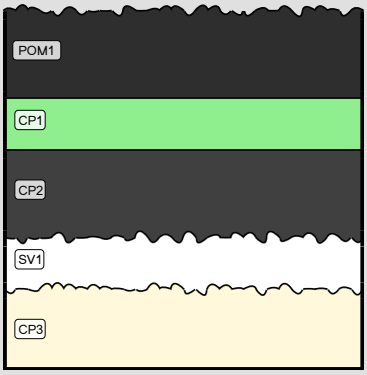
Fig. 6: Stratigraphic representation of the bust under binocular using the MiCorr application. The characteristics of the strata are only accessible by clicking on the drawing that redirects you to the search tool by stratigraphy representation. This representation can be compared to Fig. 5, Credit HE-Arc CR, C.Degrigny.

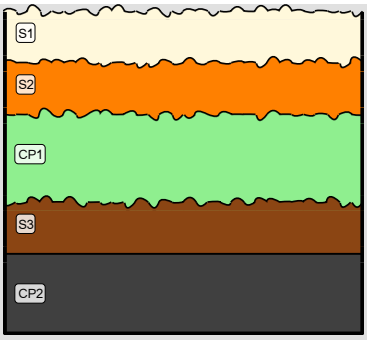
Fig. 7: Stratigraphic representation of the bust under binocular using the MiCorr application. The characteristics of the strata are only accessible by clicking on the drawing that redirects you to the search tool by stratigraphy representation. This representation can be compared to Fig. 5, Credit HE-Arc CR, C.Degrigny.

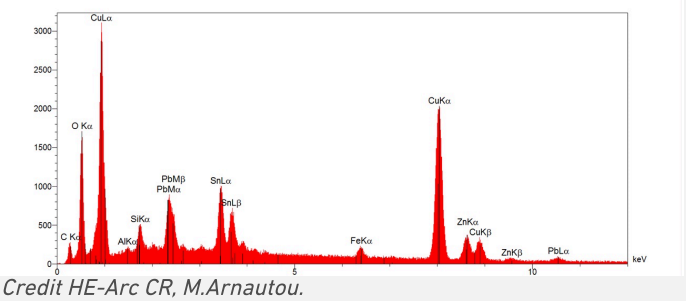
The entire surface of the bust is covered by a dark grey layer (CP2) directly attached to the remaining metal (Fig. 3). The surface analyses (Table 1) performed on the bust have revealed a high amount of Cu, as well as Pb, Sn and Zn. These are elements which can be constituents of the alloy, while elements in minor amount such as Al, Si and Fe are likely to originate from the environment. The qualitative analysis carried out on the dark patina by SEM/EDS (Fig. 8) confirms the XRF results (Table 1), showing the same elements and the presence of O, which probably correspond to copper oxide (cuprite Cu2O or tenorite CuO). The dark patina is covered by an adherent green corrosion layer (CP1) which has developed in scattered clusters (probably copper carbonate). The clusters have a surface area of 2 mm2 to 2 cm2, and have a thickness of 0.5 to 5 millimeters. In some places, the green corrosion layer has formed in the porous blisters of the dark layer (Fig. 5). Charcoal might be found locally (POM1) as well as different sediments: S1 (discontinuous and brown), S2 (mixed with fine and coarse sand grains) and S3 (scattered homogeneous brown layer).

Table 1: Chemical composition of the dark-grey patina of the selected areas of Fig.2 (red squares). Method of analysis: HE-Arc portable XRF.
