ROOF GUTTER ELEMENT – ZN ALLOY – MODERN TIMES – FRANCE

Artefact name	Roof gutter element
Authors	Christian. Degrigny (HE-Arc CR, Neuchâtel, Neuchâtel, Switzerland) & Mathea. Hovind (University of Oslo, Department of archaeology, conservation and history (IAKH-UiO), Oslo, Oslo, Norway)
Url	/artefacts/713/

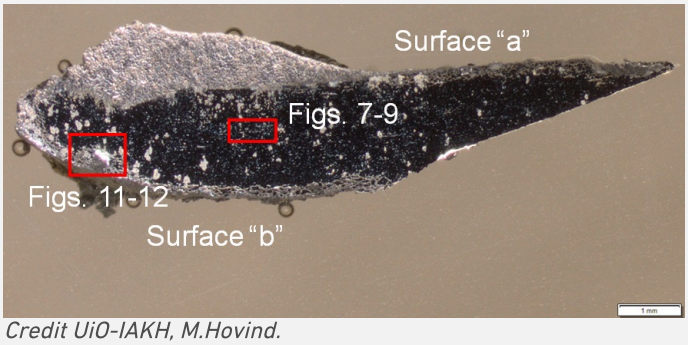
Captions	Description
D1	Remains of lead solder.
S1	Light brown and porous soil. Located only on surface "b".
CP1	Light grey to white, thin and adherent layer. Located on both surfaces.
M1	Intact metal. Submetallic and light grey in colour.

Fig. 3: Schematic presentation of the artefact (a cross-section of the metal) based on visual macroscopic observation. CP = corrosion product, D = deposit, M = metal, S = soil,

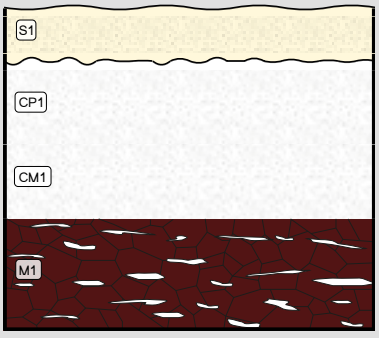
Fig. 5: Stratigraphic representation of the sample taken from the roof gutter (surface "b") in cross-section (dark field) using the MiCorr application. The characteristics of the strata are only accessible by clicking on the drawing that redirects you to the search tool by stratigraphy representation. This representation can be compared to Figs. 11 and 12, Credit UiO-IAKH, M.Hovind.
