DOMED CAP NUT - ZN AL SN CU ALLOY - MODERN TIMES - FRANCE

Artefact name Domed cap nut

Authors Christian. Degrigny (HE-Arc CR, Neuchâtel, Neuchâtel, Switzerland) & Mathea. Hovind (University of Oslo, Department of archaeology, conservation and history (IAKH-UiO), Oslo, Oslo, Norway)

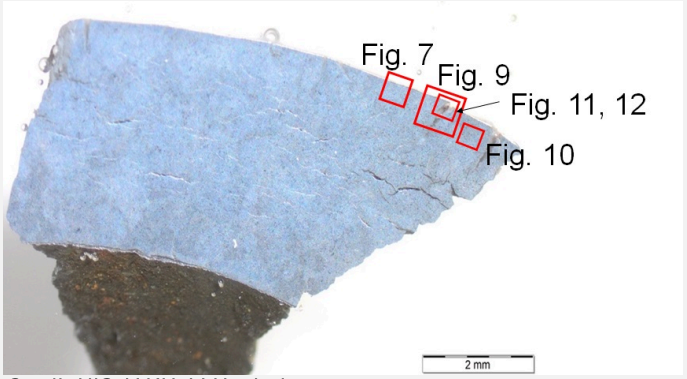
Fig. 4: Micrograph of the cross-section of the sample taken from the domed cap nut showing the locations of Figs. 7 and 9-12,

Description of sample	The sample is a cross section of the metal, representative of the domed cap nut. It shows external cracks extending from the metal surface and into its structure in addition to internal cracks, visible as thin lines along its longitudinal axis (Fig. 4).
Alloy	Zn Al Sn Cu Alloy
Technology	None
Lab number of sample	NZC2018 (Ni/Zn Cap, sampled in 2018)
Sample location	HE-Arc CR, Neuchâtel, Neuchâtel
Responsible institution	Haute Ecole Arc Conservation-Restauration
Date and aim of sampling	March 2018, study of corrosion stratigraphy and chemical analyses

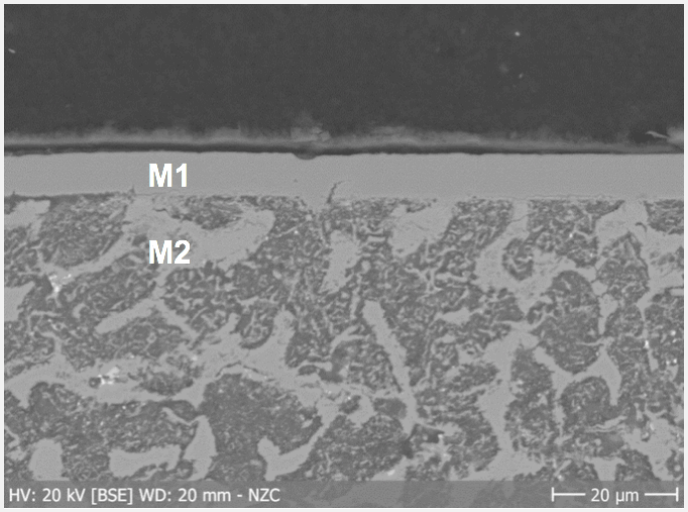
The metal of the domed cap nut (M2) consists of a Zn/Al/Pb/Cu/Sn alloy (Table 1) externally covered by a nickel-based plating (M1) (Figs. 7 and 8) containing some cobalt (Co). The bulk metal (M2) has a dendritic microstructure appearing light grey in bright field, while the interdendritic phase appears white (Fig. 9). The latter is Zn-rich, while the dendritic phase consists of approximately equal amounts of Zn and Al (Table 2, Fig. 11). Observation in SEM (BSE-mode) reveals the presence of Pb-nodules, visible as white irregular spots with a scattered distribution, in addition to opaque grey patches which are rich in Al and Fe (Fig. 10).

Fig. 7: SEM-image (BSE-mode) of a selected area from Fig. 4 (detail), showing the metal plating (M1) and the bulk metal (M2),

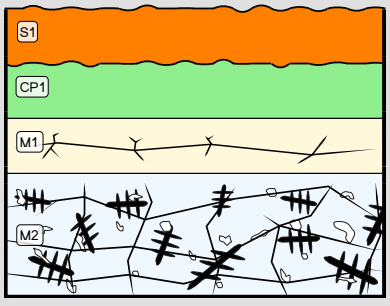
Fig. 5: Stratigraphic representation of the sample taken from the domed cap nut in cross-section (dark field) using the MiCorr application. The characteristics of the strata are only accessible by clicking on the drawing that redirects you to the search tool by stratigraphy representation. Stratigraphy representative of an area with intact metal plating (M1). S1 represents Fe-polluted soil while CP1 is a green translucent corrosion product, Credit UiO-IAKH, M.Hovind.
