VOTIVE FIGURE OF A BAT IVB4168 – GILDED BRASS – MODERN TIMES

Artefact name Votive figure of a bat IVb4168

Authors Christian. Degrigny (HE-Arc CR, Neuchâtel, Neuchâtel, Switzerland) & Naima. Gutknecht (HE-Arc CR, Neuchâtel, Neuchâtel, Switzerland) & Valentin. Boissonnas (HE-Arc CR, Neuchâtel, Neuchâtel, Switzerland)

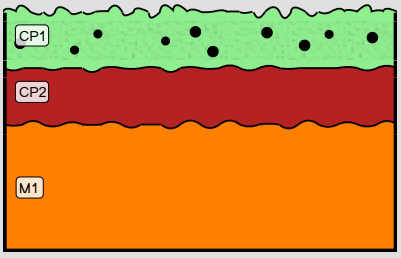
Fig 5: Stratigraphic representation 1 under binocular from Fig. 4 using the MiCorr application. The characteristics of the strata are only accessible by clicking on the drawing that redirects you to the search tool by stratigraphy representation, Credit HE-Arc CR, N.Gutknecht.
