COOKING POT HANDLE FRAGMENT V.008.2/2948.1. - LEADED BRONZE - ROMAN TIMES - SWITZERLAND

Artefact name Cooking pot handle fragment V.008.2/2948.1.

Authors Christian. Degrigny (HE-Arc CR, Neuchâtel, Neuchâtel, Switzerland) & Lucile. Ruynat (HE-Arc CR, None) & Valentin. Boissonnas (HE-Arc CR, Neuchâtel, Neuchâtel, Switzerland)

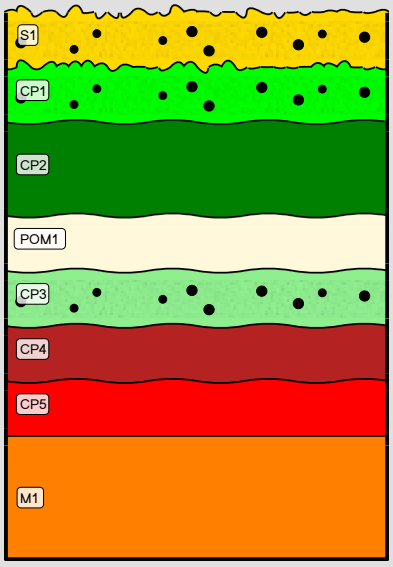
Fig. 4: Stratigraphic representation of the cooking pot handle fragment under binocular using the MiCorr application (to be compared to Fig. 3). The stratum SV1 is missing because it is integrated in CP2 and it was not possible to represent it in MiCorr while POM1 and POM2 are merged as POM1. The characteristics of the strata are only accessible by clicking on the drawing that redirects you to the search tool by stratigraphy representation, Credit HE-Arc CR, L.Ruynat.
