RAIN GUTTER FRAGMENT – GREY CAST IRON – MODERN TIMES – FRANCE

Artefact name Rain gutter fragment

Authors Christian. Degrigny (HE-Arc CR, Neuchâtel, Neuchâtel, Switzerland) & Mathea. Hovind (University of Oslo, Department of archaeology, conservation and history (IAKH-UiO), Oslo, Oslo, Norway)

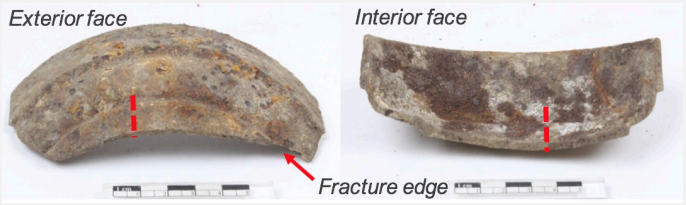
Fig. 1: Rain gutter fragment, exterior and interior faces (to the left and right, respectively),

Description of the artefact Rain gutter fragment (Fig. 1), possibly part of the extension of a roof drain pipe. Both the exterior and interior surfaces are covered by heterogeneous corrosion crusts. The underlying metal seems however to be well preserved, including features such as a difference in thickness etc.
Dimensions: L = 55mm; W (interior) = 120mm; Tmax. = 6mm; WT = 176g.

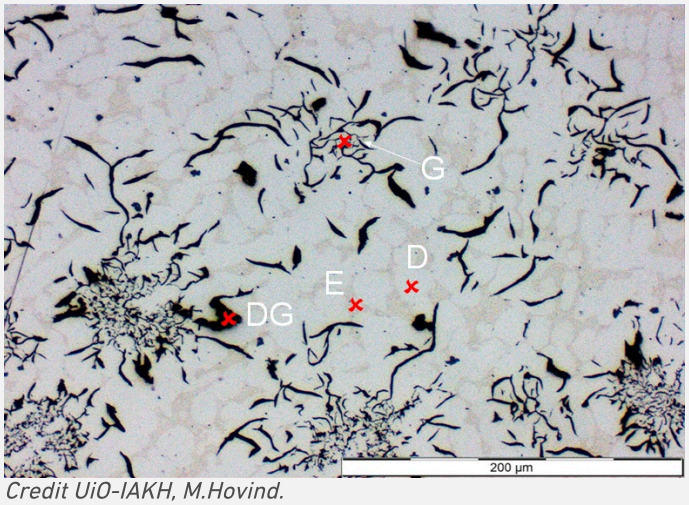
The metal is a P-rich grey cast iron with Si and Mn (Fig. 5). Its microstructure is characterized by evenly distributed graphite flakes in a matrix composed of dendrites and an interdendritic eutectic phase (Fig. 6). What appears to be irregular graphite flakes / porosity is in fact deformed graphite flakes; graphite is soft and prone to destruction by smearing and/or preferential removal during polishing (Scott 1991).

The dendrites appear light grey under polarized light, while the eutectic phase appear light brown (Fig. 6). The eutectic phase is rich in Fe and P and contains small amounts of C and Si, whereas the dendritic phase contains much less P (Table 1).

Fig. 6: Micrograph of the metal sample from Fig. 4 (detail). Unetched, bright field. Graphite flakes (G) in black, the dendrites (D) in light grey and the eutectoid phase (E) in light brown. Deformed graphite (DG) flakes are visible as irregular black inclusions,

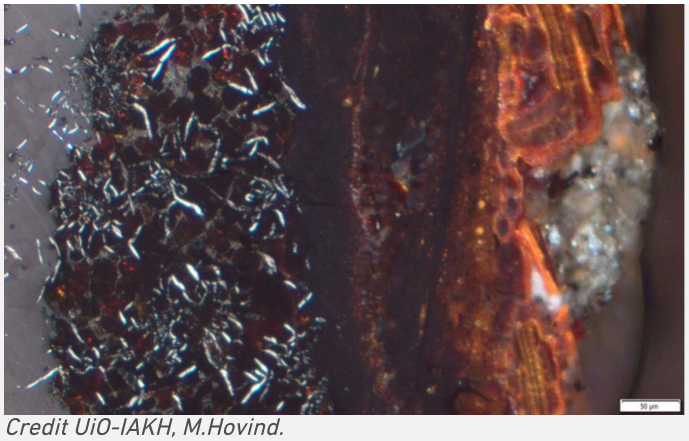
The interior face (Figs. 2 and 4) shows similar characteristics but does not include a white layer similar to NMM1. The fracture edge however (Figs. 2, 4 and 8), shows a more complex stratigraphy consisting of a dense product layer which can be further divided into two individual strata (CP3 and CP2), superimposed by a porous corrosion crust appearing orange under polarized light (CP1) (Fig. 9). The corroded metal (CM1) is located just beneath CP3 and contains remnants of the P-rich eutectic phase (Figs. 8-10). The M/CP ratio (metal to corrosion products) is rather high, implying extensive internal corrosion. Furthermore, cracks are traversing the whole corrosion layers – indicating a fragilization of the structure. As for the composition of the corrosion products CP1, CP2 and CP3, they all contain Fe and O (Fig. 10). A marbling effect within CP2 and CP3 indicates a variation in the concentration of Fe and O (particularly visible in bright field - Fig. 8). The white deposit (D1 in Figs. 8 and 9) might originate from exposure to calcareous water (Table 2). The presence of exogenous elements such as Si, Ca, Al, Na and O (Table 2) was confirmed by elemental mapping (Fig. 10).

Fig. 8: Micrograph of the metal sample from Fig. 4 (detail), unetched, bright field. Stratigraphy of the fracture edge, to be compared to Fig. 12 and from left to right: intact metal (M1) in white, followed by preferentially corroded metal (CM1) and dense product layers (CP3 and CP2) in various shades of grey. CP1 is slightly porous and covered by grain-like particles (D1). The area selected for elemental chemical distribution (Fig. 12) is marked by a red rectangle,

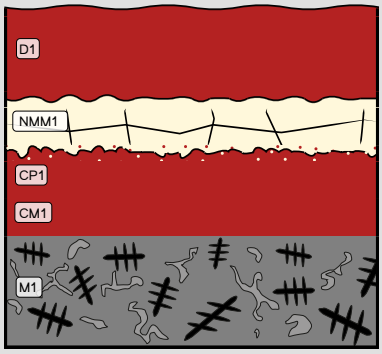
The exterior face (Figs. 2, 4 and 7) consists of a white / light yellow cracked layer (NMM1 in Fig. 7) superimposed by a layer of deposit mixed with orange-red corrosion products (D1 in Fig. 7). Local analysis by SEM-EDS (Table 2) revealed that the white / light yellow layer is rich in Ba, O, S, Fe, C and Zn. It has a chemical composition similar to Lithopone (BaSO4,ZnS), a preparatory paint layer. Fe is probably a contamination from the superimposed porous deposit / corrosion product D1 (Table 2). The latter (D1) is Fe- and O-rich and contains Si, Al and some Ca, in addition to a range of elements (K, P, Na, Cl, S and Ti) present in minor amounts (Table 2). A thin layer of corrosion products (CP1) is located just beneath the paint layer, appearing dark grey under polarized light (Fig. 7). This layer is followed by a corroded metal phase (CM1). Their exact composition was not analyzed but is likely to correspond to the corroded metal phase of the fracture edge, described below.

Fig. 11: Stratigraphic representation of the sample taken from the rain gutter fragment in cross-section (dark field) using the MiCorr application. The characteristics of the strata are only accessible by clicking on the drawing that redirects you to the search tool by stratigraphy representation. This representation can be compared to Fig. 7 (exterior surface). CP1 corresponds to CP2 in Fig. 3, Credit UiO-IAKH, M.Hovind.

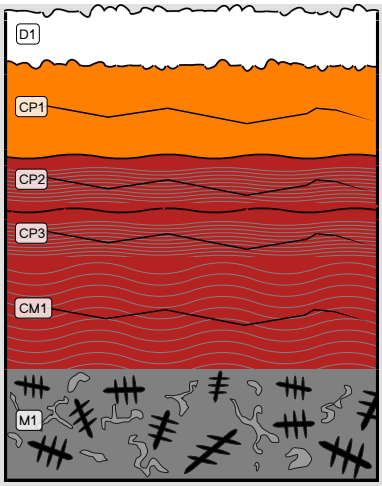
Fig. 12: Stratigraphic representation of the sample taken from the rain gutter fragment in cross-section (dark field) using the MiCorr application. The characteristics of the strata are only accessible by clicking on the drawing that redirects you to the search tool by stratigraphy representation. This representation can be compared to Figs. 8 and 9 (fracture edge). D1 corresponds to D3 in Fig. 3, Credit UiO-IAKH, M.Hovind.

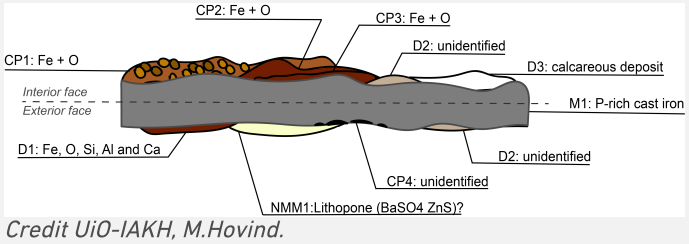
Fig. 13: Improved stratigraphic representation of the rain gutter fragment based on analysis from cross-section and visual microscopic observation,

The rain gutter fragment is a grey cast iron with a microstructure consisting of graphite flakes and a P-rich eutectic phase. The corrosion layers of the exterior surface contains a preparatory paint layer, located beneath a layer of iron corrosion products mixed with soil. It seems likely that the cast iron gutter has been covered with a protective paint layer (e.g. Lithopone) to slow down the rate of atmospheric corrosion. The presence of Lithopone reinforces the suggested dating of the artefact (20th century) as this pigment was developed and used from the 1880s and onwards (Lithopone 2007). However, it seems that the protective layer has none or only very limited effect as (pitting) corrosion is present also in these areas.

The corrosion layers consist mainly of Fe and O, indicating atmospheric corrosion with presence of only a very small amount of contaminants/pollution. The scattered white deposit is possibly originating from exposure to calcareous water as it is localized mainly on the interior face of the fragment, where rain water would hit the metal before entering the ground.
