RAIN GUTTER FRAGMENT – GREY CAST IRON – MODERN TIMES – FRANCE

Artefact name Rain gutter fragment

Authors Christian. Degrigny (HE-Arc CR, Neuchâtel, Neuchâtel, Switzerland) & Mathea. Hovind (University of Oslo, Department of archaeology, conservation and history (IAKH-UiO), Oslo, Oslo, Norway)

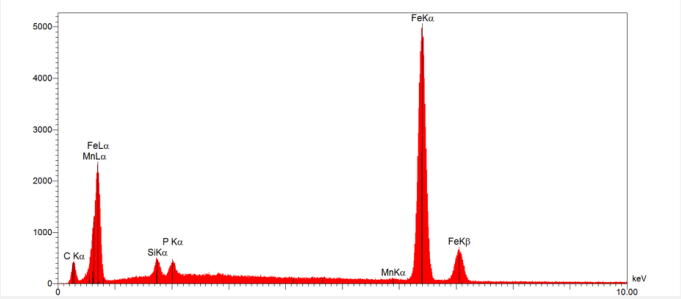
Elements mass % Phase	Fe	C	P	Si
Eutectic phase	78	7	14	0.5
Dendritic phase	91	5	0.5	3

Table 1: Chemical composition of the matrix (eutectic and the dentritic phase). Method of analysis: SEM-EDS. Lab. of Electronic Microscopy and Microanalysis, Néode, HEI Arc, credit MiCorr_HEI Arc, C.Csefalvay.

* The value is the calculated average of three analyses of the same feature, but in different areas.

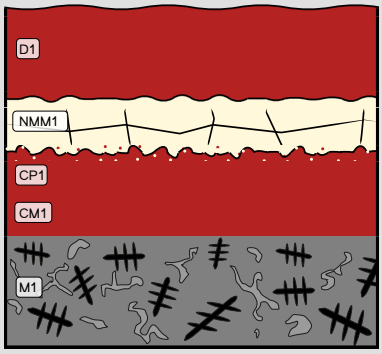
Fig. 11: Stratigraphic representation of the sample taken from the rain gutter fragment in cross-section (dark field) using the MiCorr application. The characteristics of the strata are only accessible by clicking on the drawing that redirects you to the search tool by stratigraphy representation. This representation can be compared to Fig. 7 (exterior surface). CP1 corresponds to CP2 in Fig. 3, Credit UiO-IAKH, M.Hovind.

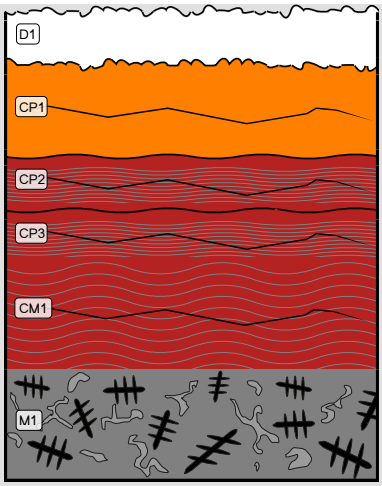
Fig. 12: Stratigraphic representation of the sample taken from the rain gutter fragment in cross-section (dark field) using the MiCorr application. The characteristics of the strata are only accessible by clicking on the drawing that redirects you to the search tool by stratigraphy representation. This representation can be compared to Figs. 8 and 9 (fracture edge). D1 corresponds to D3 in Fig. 3, Credit UiO-IAKH, M.Hovind.
