ROOF GUTTER ELEMENT – ZN ALLOY – MODERN TIMES – FRANCE

Artefact name	Roof gutter element
Authors	Christian. Degrigny (HE-Arc CR, Neuchâtel, Neuchâtel, Switzerland) & Mathea. Hovind (University of Oslo, Department of archaeology, conservation and history (IAKH-UiO), Oslo, Oslo, Norway)
Url	/artefacts/880/

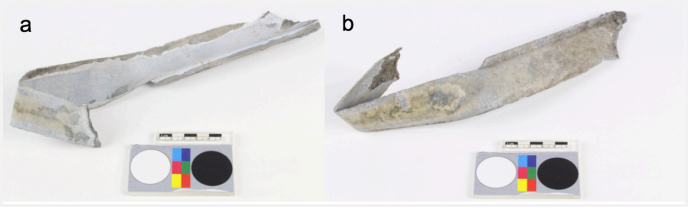
Fig. 1: Roof gutter element having different appearances on each of its surfaces: "a" on the left and "b" on the right,

Description of the artefact	A roof gutter element with remains of lead solder (Fig. 1). Its surfaces are covered by a white, strongly adherent oxide layer. Surface “b” is slightly darker in colour than surface “a” due to the presence of soil particles. Dimensions: L = 265mm; W = 47mm; T = 1mm; WT = 93g.
Type of artefact	Architectural element
Origin	Château de Germolles, Mellecey, Bourgogne, France
Recovering date	Unknown
Chronology category	Modern Times
chronology tpq	1900 A.D.
chronology taq	2000 A.D.
Chronology comment	19th-20th century
Burial conditions / environment	Outdoor atmosphere
Artefact location	HE-Arc CR, Neuchâtel, Neuchâtel
Owner	Château de Germolles, Mellecey, Bourgogne
Inv. number	None
Recorded conservation data	N/A

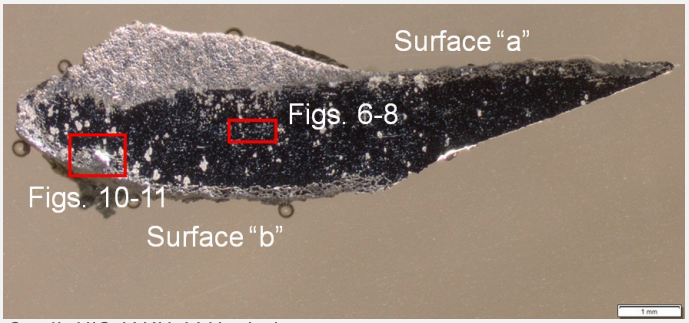
Fig. 4: Micrograph of the sample taken from the roof gutter showing the locations of Figs. 6-8 and 10-11. The uppermost area (in white) is remains of solder, while the zinc metal appears dark grey to black (the white patches are due to secondary oxidation of the sample),

A cross-section (Fig. 4) was cut out where the metal is at an angle of approximately 90° to the flat surface. Its upper edge corresponds to surface "a" and contains remains of solder, while the lower edge corresponds to surface "b".

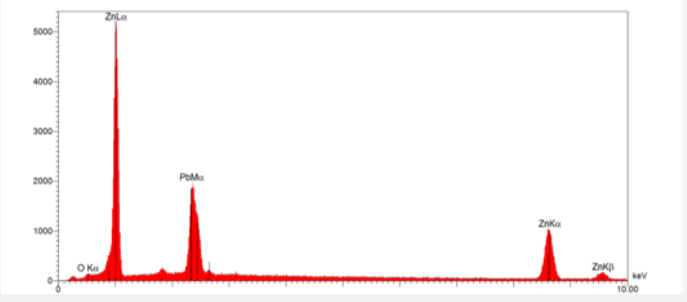
Fig. 8: SEM-image (BSE-mode) of the metal sample from Fig. 4 (detail) showing the white elongated inclusions,

Fig. 9: SEM-EDS spectrum showing the composition of the elongated inclusions from Fig. 8. Method of analysis: SEM-EDS. Lab. of Electronic Microscopy and Microanalysis, Néode, HEI Arc,

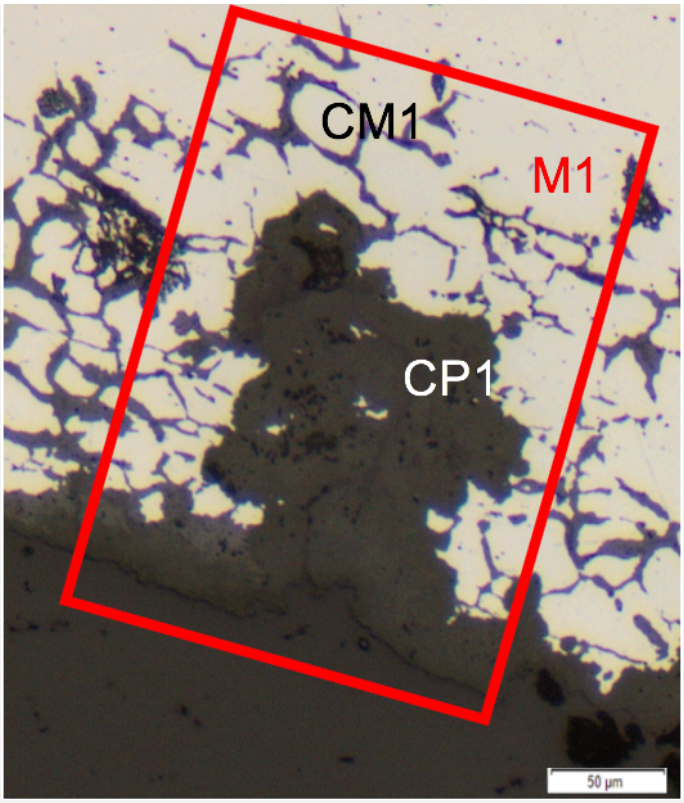
The metal is suffering from intergranular corrosion visible as a white corrosion product (CP1) located within crevices and along the grain boundaries (Figs. 10 and 11). The porous and powdery corrosion product (CP1) appears dark grey in bright field (Fig. 10) and white-grey under polarized light (Fig. 11). It consists of Zn and O (Table 1). The external corrosion product (CP1) contains some S (and not Pb as suggested by Table 1 and Fig. 13) which is probably due to atmospheric pollution. The structural composition of the corrosion product was determined by crystallographic analysis (XRD) to consist of a mixture of zincite (ZnO) and pure zinc (Zn) (Table 2, Fig 12). Mapping of the corroded area by SEM-EDS displays a similar composition but shows additionally the presence of Cl in some of the veins of the corroded metal (Fig. 13). S1 (soil material) is found on the very top of CP1.

Fig. 10: Micrograph of the metal sample from Fig. 4 (detail). Unetched, bright field. The corrosion product (CP1) is located at the surface of the metal and in its crevices. Intergranular corrosion (CM1) is visible as thin grey lines in between the metal grains (M1). The corrosion structure is to compare to the stratigraphy representation of Fig. 14. The area selected for elemental chemical distribution (Fig. 13) is marked by a red rectangle,

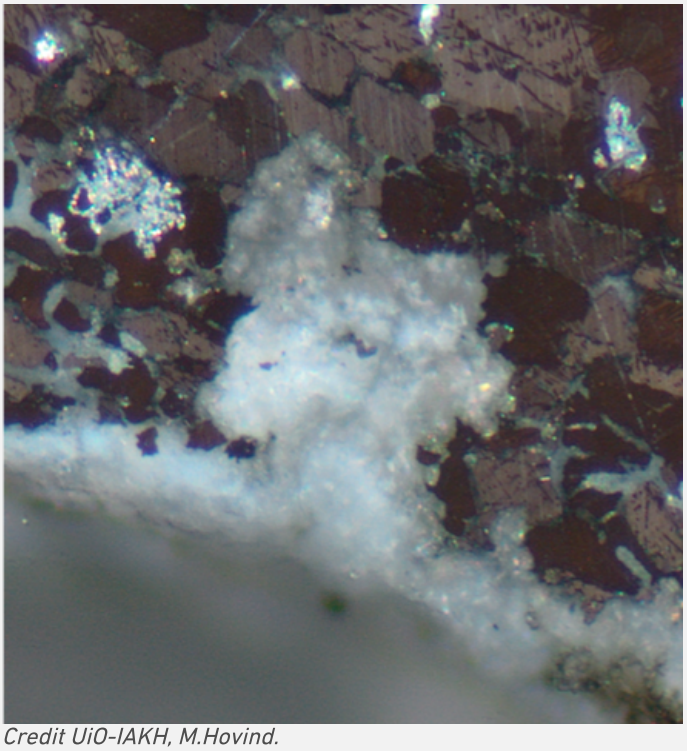
Fig. 11: Micrograph similar to Fig. 10 but under polarized light, the corrosion product (CP1) and the corroded metal (CM1) appear white,

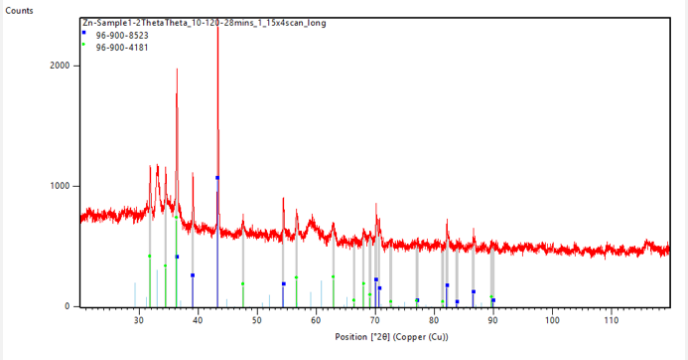
Table 2: Summary of the results from the crystallographic analysis of the white corrosion product (CP1). A representative spectrum is given in Fig. 12. Method of analysis: XRD. Center of X-ray Analytics, Empa-Swiss Federal Laboratories for Materials Science and Technology (Dübendorf), credit MiCorr_Empa, Z.Balogh-Michels. *The results are based on the analysis of two powder samples from different areas (see Fig. 2 for sample locations).

Fig. 12: XRD-spectrum for the analysis of powder sample 1. Ref. 96-900-8523 (in blue) corresponds to pure zinc and 96-900-4181 (in green) to zincite (ZnO),

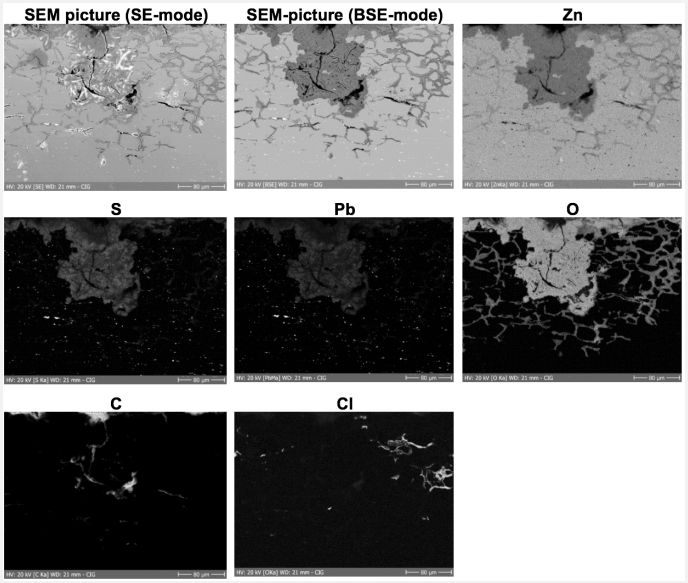
Fig. 13: SEM image and elemental chemical distribution of a selected area of Fig. 10 (rotated almost 180° and reversed). Method of analysis: SEM-EDS. Lab. of Electronic Microscopy and Microanalysis, Néode, HEI Arc,

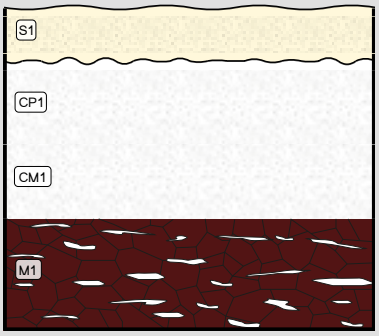
Fig. 14: Stratigraphic representation of the sample taken from the roof gutter (surface "b") in cross-section (dark field) using the MiCorr application. The characteristics of the strata are only accessible by clicking on the drawing that redirects you to the search tool by stratigraphy representation. This representation can be compared to Figs. 10 and 11, Credit UiO-IAKH, M.Hovind.
