ROOF GUTTER ELEMENT – ZN ALLOY – MODERN TIMES – FRANCE

Artefact name	Roof gutter element
Authors	Christian. Degrigny (HE-Arc CR, Neuchâtel, Neuchâtel, Switzerland) & Mathea. Hovind (University of Oslo, Department of archaeology, conservation and history (IAKH-UiO), Oslo, Oslo, Norway)
Url	/artefacts/880/

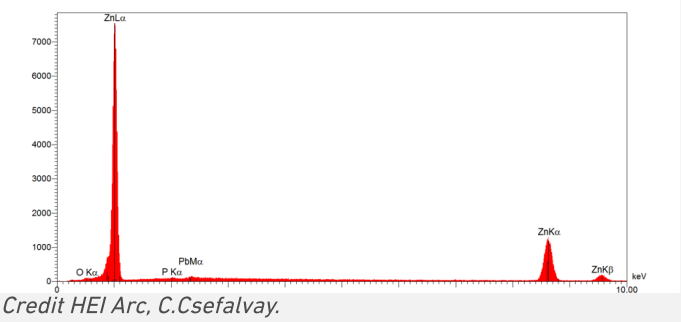
The roof gutter element is composed of Zn with P and Pb at lower concentrations (Fig. 5). The latter is probably originating from the solder that was applied to adjoin several metal sheets for the roof gutter.

Fig. 5: Chemical composition of the metal. Method of analysis: SEM-EDS. Lab. of Electronic Microscopy and Microanalysis, Néode, HEI Arc,

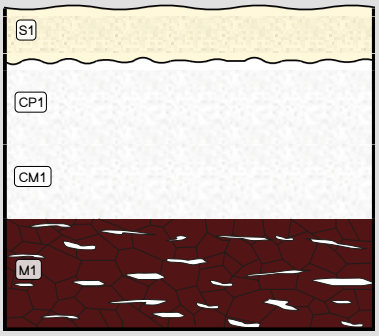
Fig. 14: Stratigraphic representation of the sample taken from the roof gutter (surface "b") in cross-section (dark field) using the MiCorr application. The characteristics of the strata are only accessible by clicking on the drawing that redirects you to the search tool by stratigraphy representation. This representation can be compared to Figs. 10 and 11, Credit UiO-IAKH, M.Hovind.
