IRON-BASED BAR - FE ALLOY - MODERN TIMES - FRANCE

Artefact name	Iron-based bar
Authors	Christian. Degrigny (HE-Arc CR, Neuchâtel, Neuchâtel, Switzerland) & Mathea. Hovind (University of Oslo, Department of archaeology, conservation and history (IAKH-UiO), Oslo, Oslo, Norway)
Url	/artefacts/881/

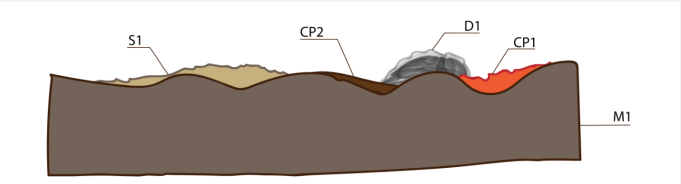
Fig. 3: Preliminary stratigraphy of the corrosion structure based on visual microscopic observation,

The schematic representation below (Fig. 3) gives an overview of the corrosion layers encountered on the object from a first visual macroscopic observation.

Captions	Description
S1	Light brown soil with a porous and friable consistency.
D1	Black, powdery deposit. Very loosely bound to the surface. Probably charcoal.
CP2	Dark brown and strongly adherent corrosion crust. Almost uniform in appearance - except in areas where it is disturbed by corrosion blisters.
CP1	Bright to dark orange corrosion products.
M1	Remaining metal. Dark grey to brown and matte in appearance. Highly irregular surface with dark pits ranging from approximately 1 – 5 mm in diameter.

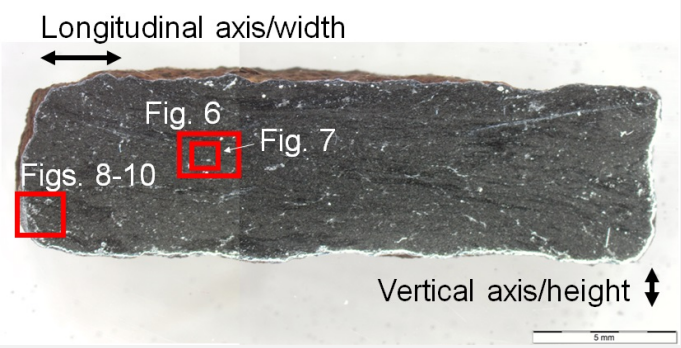
Fig. 4: Micrograph of the cross-section of the iron-based bar with location of Figs. 6-10,

Description of sample	A rectangular section (Fig. 4) was cut out from the tip of the iron bar. Its longitudinal axis corresponds to the width of the iron bar while the height/thickness of the bar is represented by the vertical axis.
Alloy	Fe Alloy
Technology	Puddled iron
Lab number of sample	WIB2018 (Wrought Iron Bar sampled in 2018)
Sample location	HE-Arc CR, Neuchâtel, Neuchâtel
Responsible institution	HE-Arc CR, Neuchâtel, Neuchâtel
Date and aim of sampling	March 2018, study of corrosion stratigraphy and chemical analyses

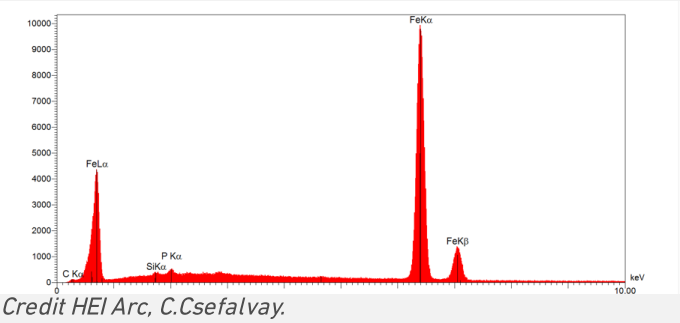
The metal is a wrought iron consisting of Fe, with some P and C (Fig. 5). The presence of Si is due to slag inclusions. The inclusions appear elongated* (Fig. 7) and filled with phases appearing light grey, medium grey and dark grey both in

Fig. 5: EDS-spectrum showing the chemical composition of the metal (M1). The surface area analyzed was approx. 2*2 mm. Method of analysis: SEM-EDS. Lab. of Electronic Microscopy and Microanalysis, Néode, HEI Arc,

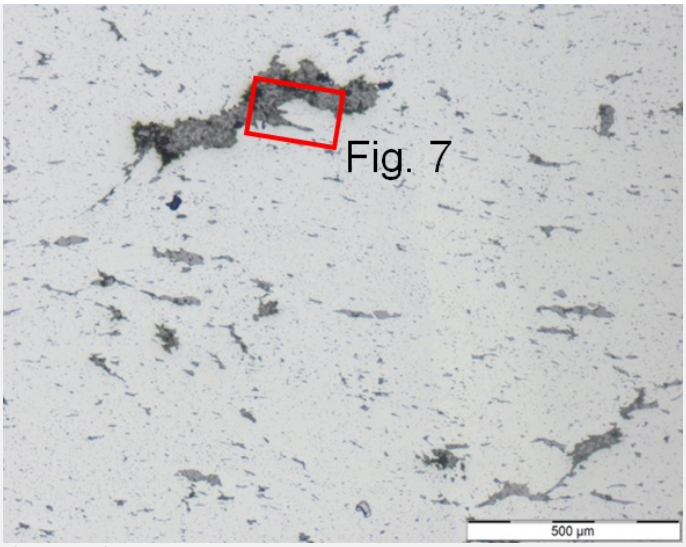
Smaller inclusions/nodules are evenly distributed throughout the metal (Fig. 6 and 7). They appear dark grey and have a composition similar to the dark grey phase in the elongated inclusions (Table 1).

Fig. 6: Micrograph of the metal sample from Fig. 4 (detail), unetched, bright field. The microstructure of the metal with slag inclusions and the location of Fig. 7,

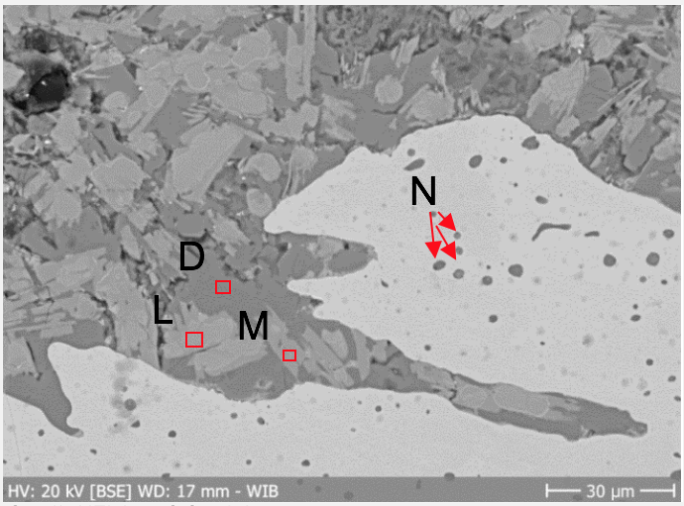
bright field and in SEM in BSE-mode (Figs. 6 and 7). Local analysis by SEM-EDS (Table 1) revealed that the light grey phase consists mainly of Fe and O with some C and has a composition similar to Wüstite (FeO). The medium grey phase has a similar composition but contains more P and C in addition to Si (Table 1). This phase is probably Wüstite in a Fe-P matrix. The dark grey phase corresponds to the glassy matrix and contains significally higher concentrations of Si and P, in addition to the usual Fe and O (Table 1). The relatively high Si-content indicates that this phase might be Fayalite (FeSiO4) in a Fe-P matrix.

Fig. 7: SEM-image (BSE-mode) of the selected area from Fig. 6 (detail). The different phases in the slag inclusions are clearly visible: L = light grey phase, M = medium grey phase, D = dark grey phase/matrix, N = nodules,

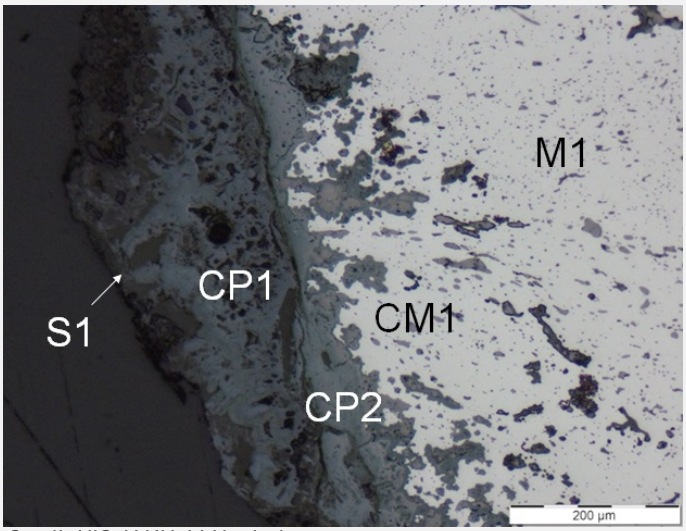
The corrosion crust is typical of exposure of iron to the atmosphere: it is relatively thick and consists of two layers: CP1 and CP2. The latter is a dense product layer appearing light grey under both bright field and polarized light (Figs. 8 and 9). The outermost layer (CP1) is a porous crust, appearing dark grey under bright field and bright orange under polarized light (Figs. 8 and 9). The corroded metal (CM1) appears as isolated areas of corrosion within the sound metal.

Fig. 8: Micrograph of the metal sample from Fig. 4 (detail), unetched, bright field to be compared to the stratigraphy representation of Fig. 11,

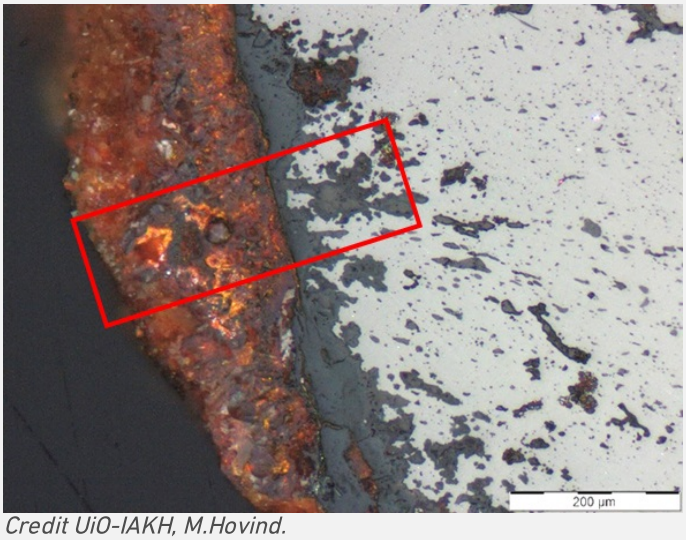
Fig. 9: Micrograph similar to Fig. 8, but under polarized light. CP1 in orange, CP2 and the corroded metal phase (CM) appear dark grey. The selected area for elemental chemical distribution (Fig. 10) is marked by a red rectangle,

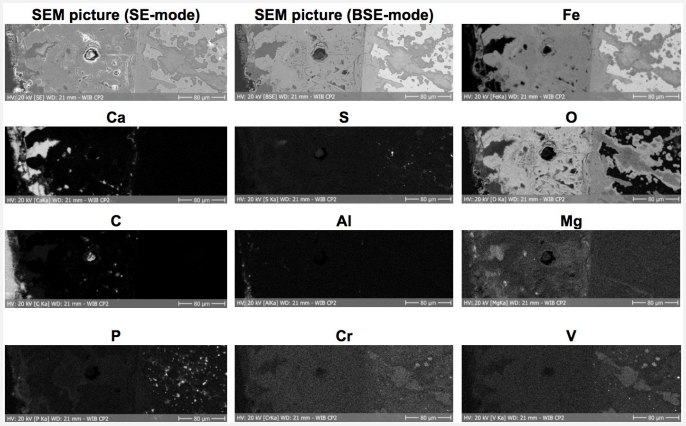
The composition of the corrosion products shows a varying content of Fe and O throughout the crust with an increasing O-content towards the surface of the corrosion layer CP1 (Table 2). Elemental mapping by SEM-EDS (Fig. 10) shows that Ca and Mg are present in cracks which penetrates the outer corrosion crust (CP1). These elements are probably exogenous and could originate from the soil (S1) that is covering the metal surface.

Fig. 10: SEM image and elemental chemical distribution of the selected area from Fig. 9. Method of analysis: SEM-EDS. Lab. of Electronic Microscopy and Microanalysis, Néode, HEI Arc,

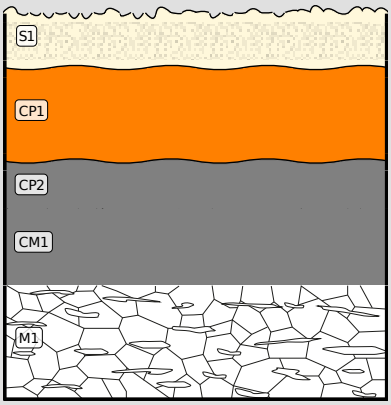
Fig. 11: Stratigraphic representation of the iron-based bar in cross-section (dark field) using the MiCorr application. The characteristics of the strata are only accessible by clicking on the drawing that redirects you to the search tool by stratigraphy representation. This representation can be compared to Figs. 8 and 9, Credit UiO-IAKH, M.Hovind.

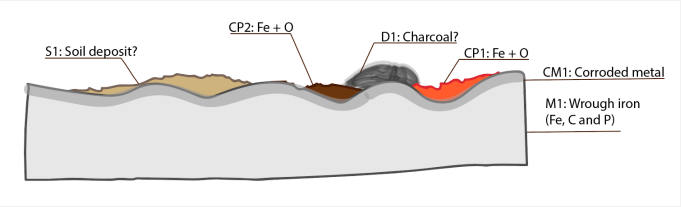
Fig. 12: Improved stratigraphic representation of the iron-based bar based on analyses from cross-section and visual microscopic observation, CP = corrosion product, D = deposit, M = metal S = soil, CM = corroded metal,

The corrosion products on the surface of the iron bar are typical for iron exposed outdoors with varying contents of Fe an O in addition to a layer of Ca-containing soil.
