DOMED CAP NUT - ZN AL SN CU ALLOY - MODERN TIMES - FRANCE

Artefact name Domed cap nut

Authors Christian. Degrigny (HE-Arc CR, Neuchâtel, Neuchâtel, Switzerland) & Mathea. Hovind (University of Oslo, Department of archaeology, conservation and history (IAKH-UiO), Oslo, Oslo, Norway)

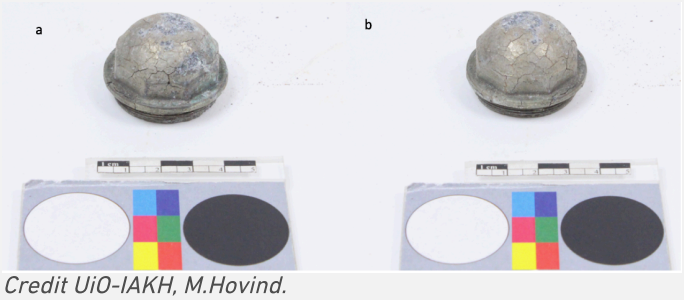
Fig. 1: Octogonal domed cap nut. Profile "a" and "b", to the left and right, respectively,

Description of the artefact A domed cap nut made of a cast alloy with a metallic plating (Fig. 1). Its shape is octagonal and the inside is hollow. The plating is heavily cracked, leading to surface flaking. The metal underneath appears to be consumed by some kind of internal corrosion. Dimensions: L (ø) = 40mm; H = 28mm; T = 5mm; WT = 49g.

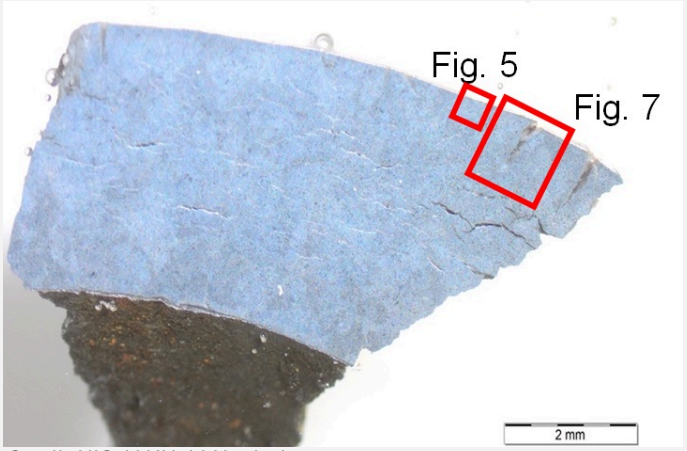
Fig. 4: Micrograph of the cross-section of the sample taken from the domed cap nut showing the locations of Figs. 5 and 7,

Description of sample	The sample is a cross section of the metal, representative of the domed cap nut. It shows external cracks extending from the metal surface and into its structure in addition to internal cracks, visible as thin lines along its longitudinal axis (Fig. 4).
Alloy	Zn Al Sn Cu Alloy
Technology	Cast and plated
Lab number of sample	NZC2018 (Ni/Zn Cap, sampled in 2018)
Sample location	HE-Arc CR, Neuchâtel, Neuchâtel
Responsible institution	HE-Arc CR, Neuchâtel, Neuchâtel
Date and aim of sampling	March 2018, study of corrosion stratigraphy and chemical analyses

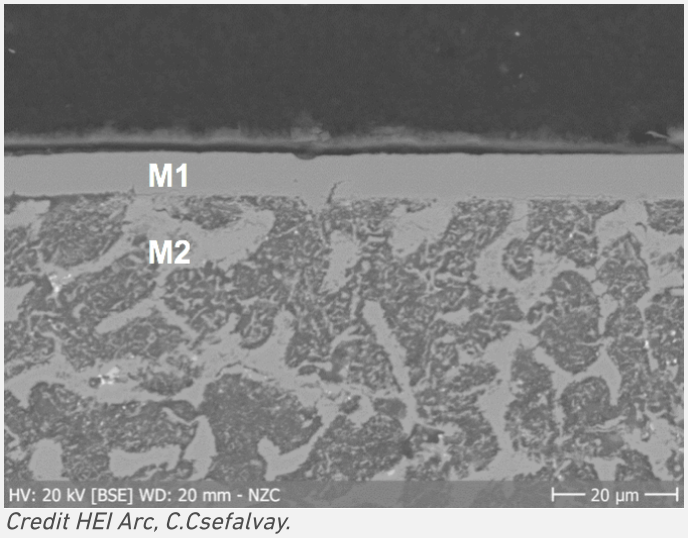
Fig. 5: SEM-image (BSE-mode) of a selected area from Fig. 4 (detail), showing the metal plating (M1) and the bulk metal (M2),

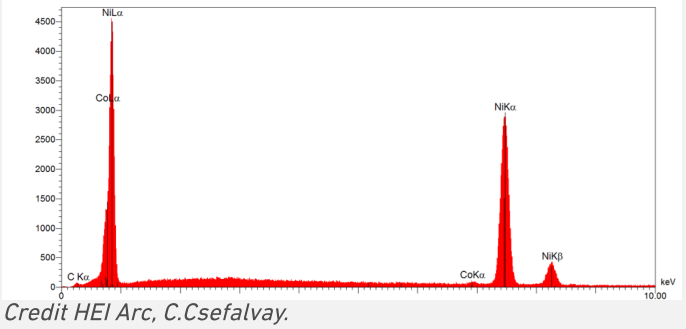
Fig. 6: EDS-spectrum showing the chemical composition of the metal plating (M1). Method of analysis: SEM-EDS. Lab. of Electronic Microscopy and and Microanalysis, Néode, HEI Arc,

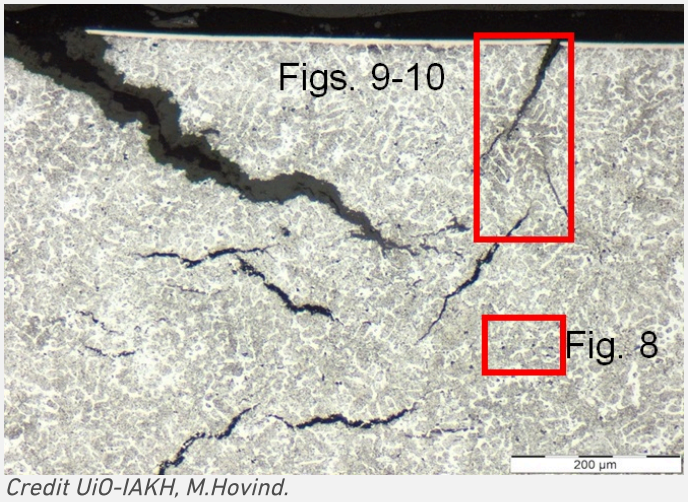
Fig. 7: Micrograph of the metal sample from Fig. 4 (detail), unetched, bright field. The dendrites appear light to dark grey while the interdendritic phase appears white. The metal is characterized by surface cracks as well as internal cracks. The lower red rectangle corresponds to Fig. 8 while the areas selected for elemental chemical distributions (Figs. 9 and 10) are marked by the upper red rectangle,

The dendritic phase is heavily oxidized compared to the interdendritic phase (Table 2 and Fig. 10). The corrosion has developed throughout the entire metal body, generating cracks (Fig. 7). The cracks are Zn and O-rich (Fig. 10) and could be composed of zinc oxide or carbonate. It could be a case of zinc pest, a corrosion phenomenon known to cause disintegration in poor quality alloys (Selwyn 2004, Zhang 2011).

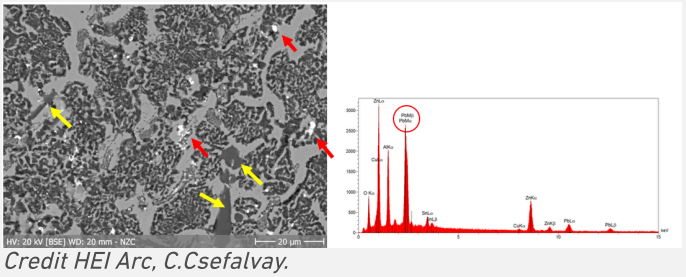
Fig. 8: SEM-image in BSE-mode (left) and EDS-spectrum (right), showing the appearance and the chemical composition of the Pb inclusions (red arrows). The inclusions appear white, the dendrites appear dark grey/black and the interdentritic phase appears grey. Grey opaque patches (yellow arrows) are Fe- and Al-rich phases,

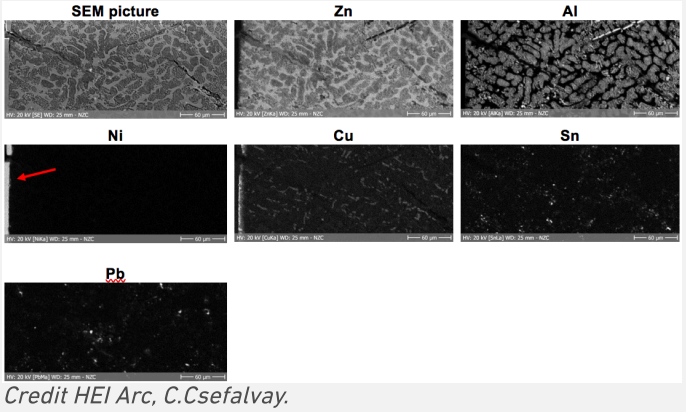
Fig. 9: SEM image and elemental chemical distribution of the selected area from Fig. 7 (rotated 270° and inversed). Method of analysis: SEM-EDS. Lab. of Electronic Microscopy and Microanalysis, Néode, HEI Arc,

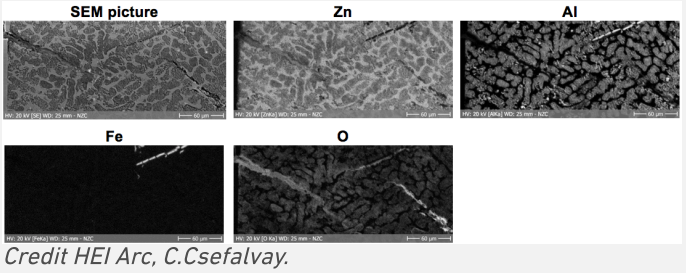
Fig. 10: SEM image and elemental chemical distribution of the selected area from Fig. 7 (rotated 270° and inversed). Method of analysis: SEM-EDS. Lab. of Electronic Microscopy and Microanalysis, Néode, HEI Arc,

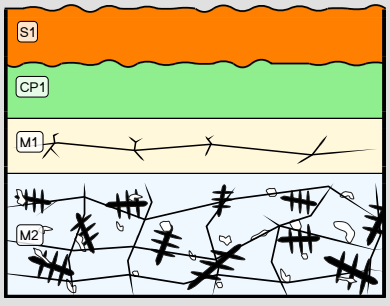
Fig. 11: Stratigraphic representation of the sample taken from the domed cap nut in cross-section (dark field) using the MiCorr application. The characteristics of the strata are only accessible by clicking on the drawing that redirects you to the search tool by stratigraphy representation. Stratigraphy representative of an area with intact metal plating (M1). S1 represents Fe-polluted soil while CP1 is a green translucent corrosion product, Credit UiO-IAKH, M.Hovind.
