# DOMED CAP NUT - ZN AL SN CU ALLOY - MODERN TIMES - FRANCE

**Artefact name** Domed cap nut

**Authors** Christian. Degrigny (HE-Arc CR, Neuchâtel, Neuchâtel, Switzerland) & Mathea. Hovind (University of Oslo, Department of archaeology, conservation and history (IAKH-UiO), Oslo, Oslo, Norway)

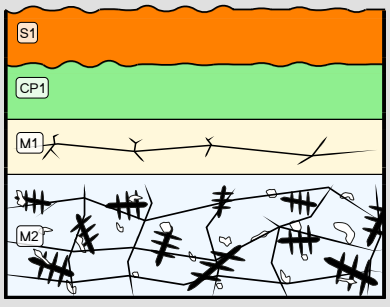
Fig. 11: Stratigraphic representation of the sample taken from the domed cap nut in cross-section (dark field) using the MiCorr application. The characteristics of the strata are only accessible by clicking on the drawing that redirects you to the search tool by stratigraphy representation. Stratigraphy representative of an area with intact metal plating (M1). S1 represents Fe-polluted soil while CP1 is a green translucent corrosion product, Credit UiO-IAKH, M.Hovind.
