BUGATTI COOLING SYSTEM PIPE – AL ALLOY – UNKNOWN – FRANCE

Artefact name	Bugatti cooling system pipe
Authors	Christian. Degrigny (HE-Arc CR, Neuchâtel, Neuchâtel, Switzerland) & Elodie. Granget (HE-Arc CR, Neuchâtel, Neuchâtel, Switzerland) & Brice. Chalançon (MNAM (Musée National de l'Automobile de Mulhouse), Mulhouse, Alsace, France)
Url	/artefacts/888/

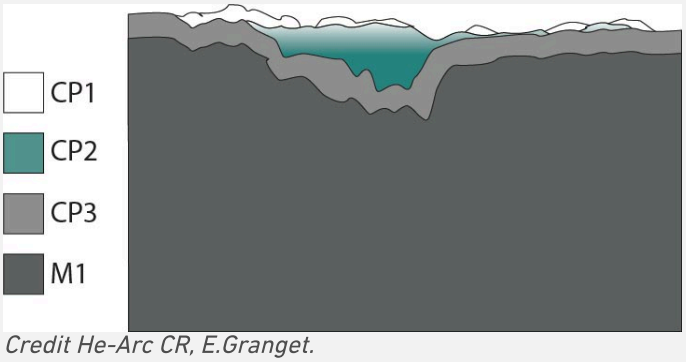
The stratum M is an aluminium alloy. Three CP strata have been identified. CP3 has a greyish mate color and is covering all of the corroded side of the pipe. Scattered over this uniform layer, blue-green (CP2) and white (CP1) spots of corrosion products can be found.

Fig. 4: Stratigraphic representation of the corrosion structure of the external surface of the water pipe from visual macroscopic observation,

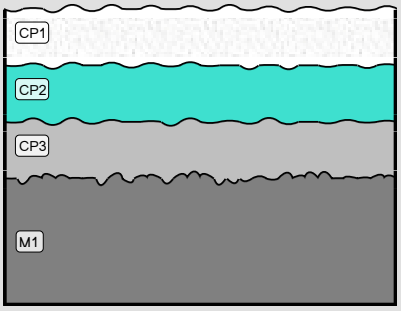
Fig. 5: Stratigraphic representation of the Bugatti water pipe observed macroscopicallly under binocular using the MiCorr application. The characteristics of the strata are only accessible by clicking on the drawing that redirects you to the search tool by stratigraphy representation. This representation can be compared to Fig. 4, Credit HE-Arc CR, E.Granget.

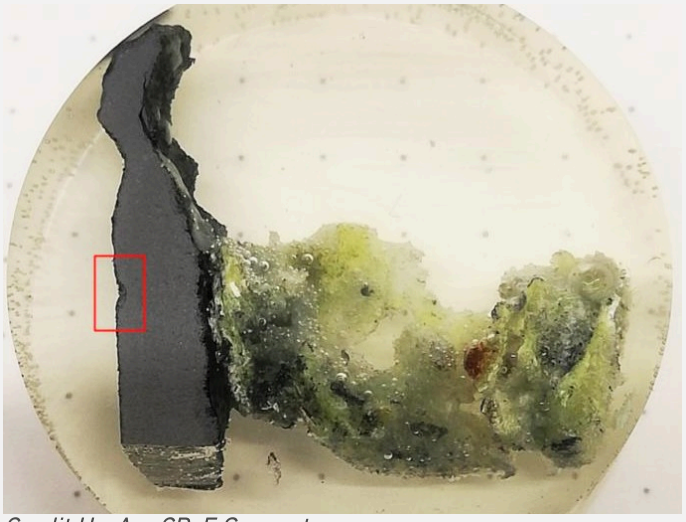
Fig. 6: Micrograph of the sample taken from the corroded exit pipe of the Bugatti water pump (Fig. 3), showing the location of Figs. 7-8 and 11 to 14 in red,

Description of sample	A radial section of the pipe has been sampled and embedded as shown on Fig.6. The cross-section shows not only the metal sampled but the accompanying thick yellow deposit that was clugging the pipe. Pitting corrosion develops all along the profile of the sample. A selected area (in red) is further investigated in Figs. 7-8 and 11-14.
Alloy	Al Alloy
Technology	Cast
Lab number of sample	None
Sample location	HE-Arc CR, Neuchâtel, Neuchâtel
Responsible institution	MNAM (Musée National de l'Automobile de Mulhouse), Mulhouse, Alsace
Date and aim of sampling	31.12.2019 - Sampled for Metallography

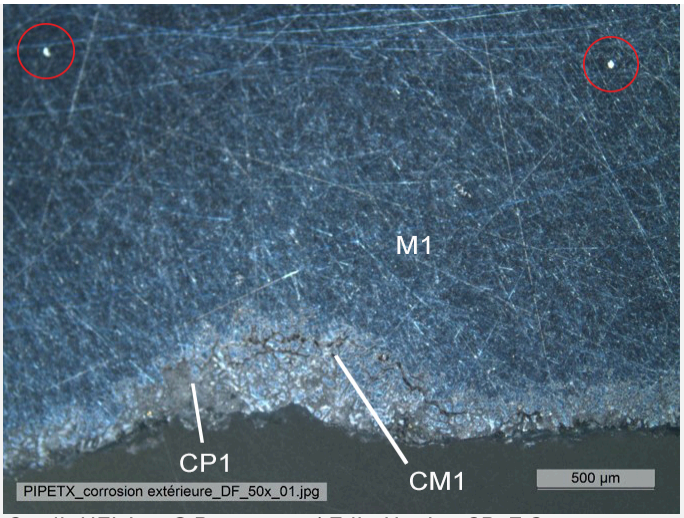
The metal is an aluminium alloy containing both Cu and Zn. It is slighly porous (Fig. 7, red circles). Its dendritic microstructure is revealed by observation in bright field (Fig. 8) and with SEM (Fig. 9).

Fig. 7: Micrograph of the selected area shown on Fig.6 (rotated by 90°), unetched, dark field with indication of pores (red circles),

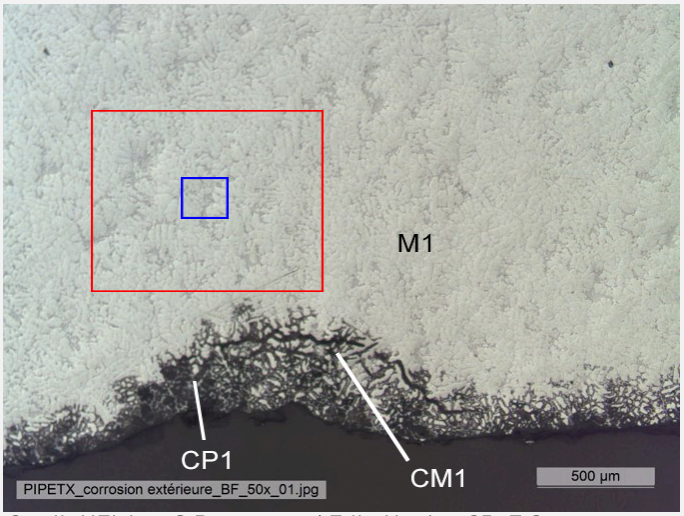
Fig. 8: Micrograph similar to Fig. 7, unetched, bright field showing the locations of Fig. 9 (in red) and Fig. 10 (in blue),

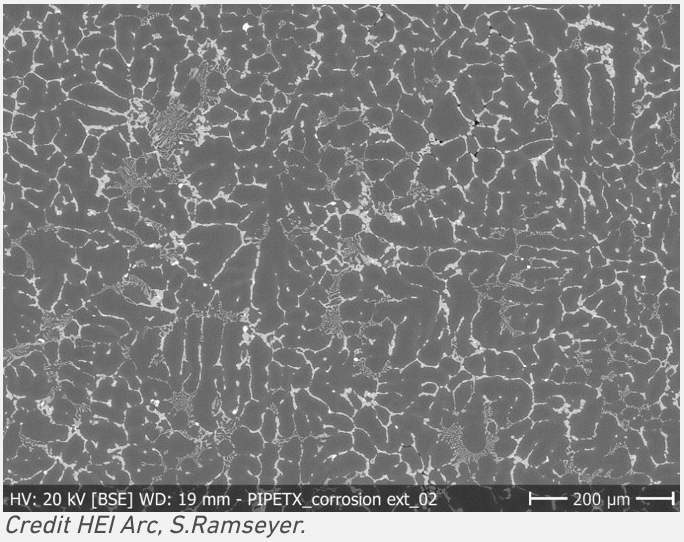
Fig. 9: SEM image (BSE mode) of the metal sample from Fig. 8 showing the microstructure of the pipe. Dark grey = main phase (Al), medium grey = interdendritic phase 1 (eutectic Al, Fe, Cu), light grey = interdendritic phase 2 (Al, Cu) and white = precipitates (Si, Sn),

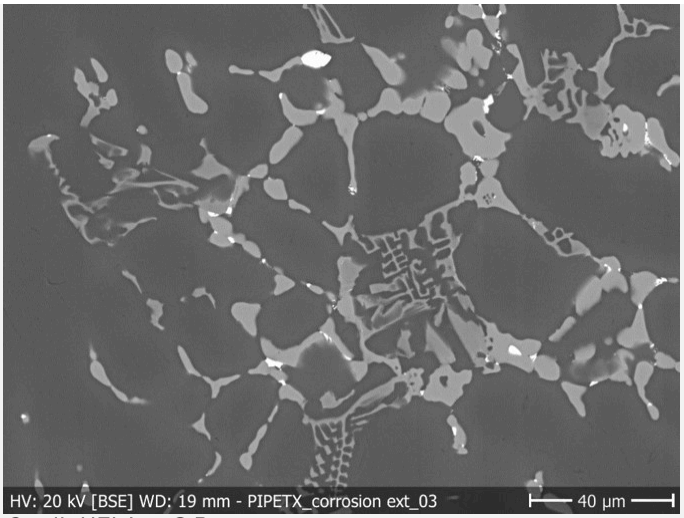
Fig. 10: Close-up image of Fig. 9,

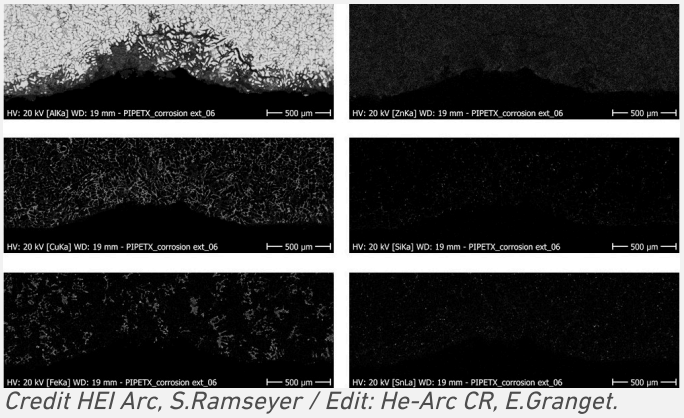
Fig. 11: SEM image and EDS elemental chemical distribution of main and interdendritic phases of the pipe. 20kV,

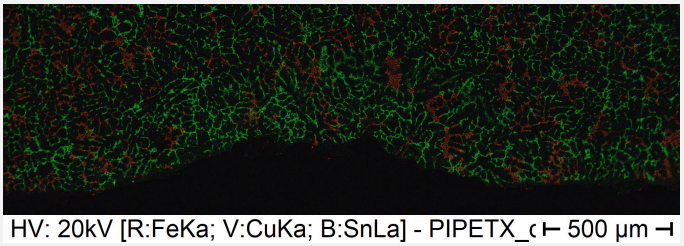
Zn is uniformely present in the alloy. There are two interdendritic phases (Fig. 12): a eutectic phase containing Al, Fe and Cu, and a second phase containing mostly Al, Cu. Additionally Sn and Si precipitates could be identified.

Fig. 12: Fe (red), Cu (green) and Sn (blue) chemical distribution of the area of Fig. 8. Method of analysis: SEM-EDS. Lab. of Electronic Microscopy and Microanalysis, Néode, HEI Arc,

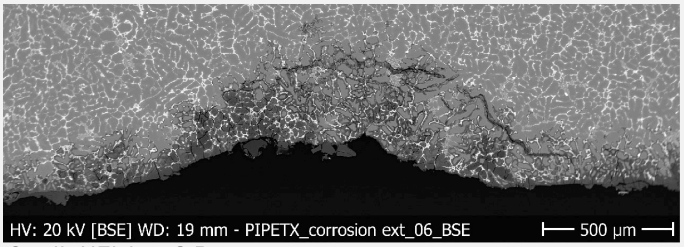
The BF and DF images (Figs. 7 and 8) show a few big cracks at the interface between CM1 and M1. The SEM image shows that they expand in a network of additional microcracks (Fig. 13). The pipe suffers from a uniform interdendritic corrosion. The Al, Cu and Zn phase is oxidising preferentially, developing then aluminium oxides, versus the interdendritic phases. In some places, pits of corrosion formed. SEM cartography showed a concentration of Cl at the base of the pit (Fig. 14: Green).

Fig. 13: SEM image of the pitting corrosion of the pipe. BSE, 20kV. Black = Cracks, Dark grey = oxydation, Medium grey = main phase, Light grey = interdendritic phase,

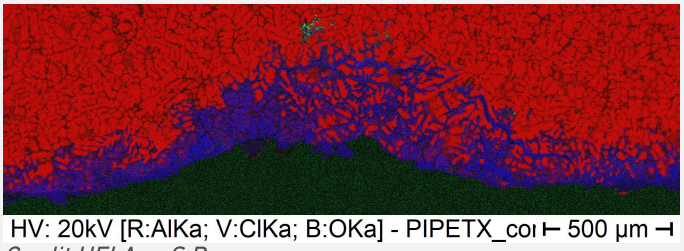
Fig. 14: SEM cartography of a pit of corrosion developing on the pipe. 20kV. Red = Al, Green = Cl, Blue = O,

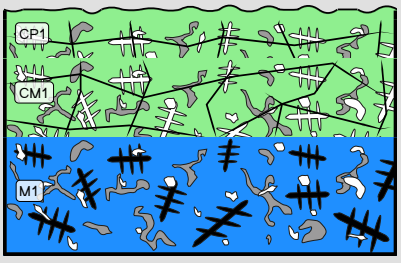
Fig. 14: Stratigraphic representation of the sample taken from the Bugatti water pipe in cross-section (dark field) using the MiCorr application. The characteristics of the strata are only accessible by clicking on the drawing that redirects you to the search tool by stratigraphy representation. This representation can be compared to Fig. 7 and 8, Credit HE-Arc CR, E.Granget.

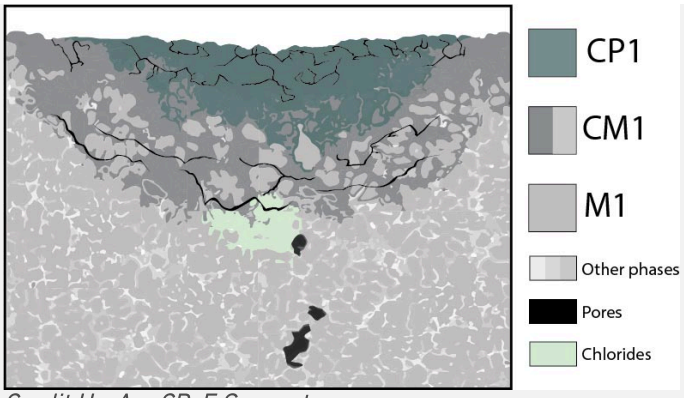
Fig. 15: Improved stratigraphic representation of the exit pipe,

The external surface shows a uniform interdendritic corrosion preferentially consuming the dentritic phase (Al, Cu, Zn). Pitting corrosion has been identified, with Cl pockets at the base of the pit.
