BRACELET WITH DRAGONFLIES IIB 4025.01 - LEADED BRONZE - LATE BRONZE AGE

Artefact name Bracelet with dragonflies IIb 4025.01

Authors Perret-Gentil. Emeline (HE-Arc, Neuchâtel, Neuchâtel, Switzerland) & Christian. Degrigny (HE-Arc CR, Neuchâtel, Neuchâtel, Switzerland)

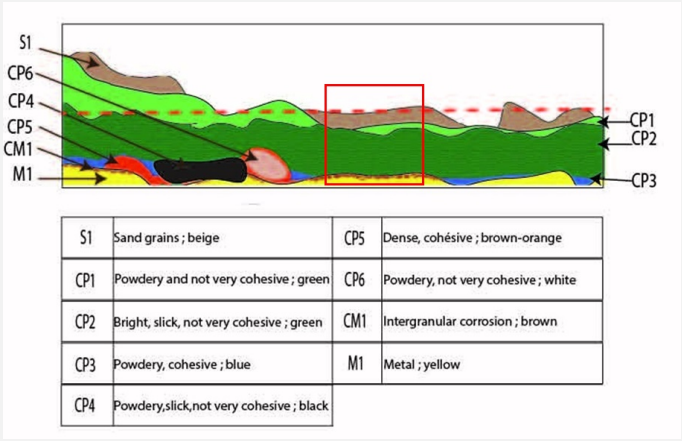
The schematic representation below gives an overview of the strata encountered on the bracelet from a first visual macroscopic observation under a binocular microscope both on the surface and section 2 exposed (Fig. 5).

Fig. 7 : Stratigraphic representation of the fractured cutting edge of the bracelet in cross-section by macroscopic observation with indication of strata of Fig. 5 and the MiCorr stratigraphy in the red rectangle (Fig. 21) built from the polished surface of section 1.

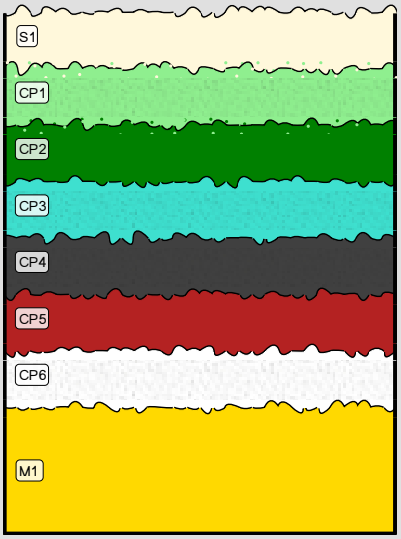
Fig. 8 : Stratigraphic representation of the bracelet under binocular from Fig. 5 (cross-section of section 2) using the MiCorr application. The characteristics of the strata are only accessible by clicking on the drawing that redirects you to the search tool by stratigraphy representation, Credit HE-Arc CR, E.Perret-Gentil.

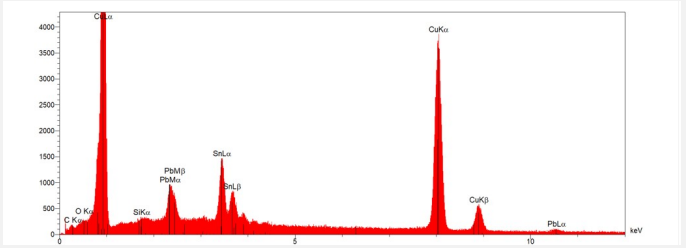
The remaining metal is a porous leaded bronze (Fig. 11) with a high concentration of Sn and Pb (Table 1 and Fig. 12). The 9% Pb concentration is due to the area analysed where Pb nodules false the result which should be more around 5%.

Table 1: Chemical composition (mass %) of the metal (from Fig. 12). Method of analysis: SEM/EDS. HE-Arc Ingénierie.

Fig. 12 : EDS spectrum of the alloy of the bracelet,

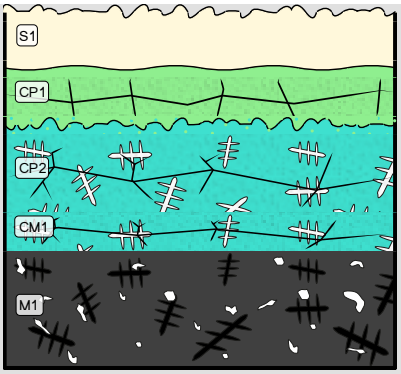
Fig. 21 : Stratigraphic representation of the bracelet in cross-section (dark field) using the MiCorr application with reference to Fig. 10. The characteristics of the strata are only accessible by clicking on the drawing that redirects you to the search tool by stratigraphy representation, Credit HE-Arc CR, E.Perret-Gentil.

The schematic representation of corrosion layers of Fig. 7 integrating additional information based on the analyses carried out is given in Fig. 22. Strata CP1 and CP2 in the stratigraphy of Fig. 8 are merged into CP1 in Fig. 21. Similarly, strata CP3 to CP6 in Fig. 8 are merged into CP2 and CM1 in Fig. 21.

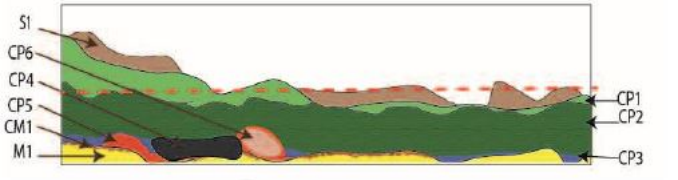
Description	Interpretation
S1	Sand grains ; beige	Sand and soil of the archaeological context
CP1	Powdery and not very cohesive ; green	Copper carbonate : malachite Cu2CO3(OH)2 (?)
CP2	Bright, slick, not very cohesive ; green	Copper carbonate : malachite Cu2CO3(OH)2 (?)
CP3	Powdery, cohesive ; blue	Copper carbonate : azurite Cu3(CO3)2(OH)2 (?)
CP4	Powdery, slick, not very cohesive ; black	(?)
CP5	Dense, cohesive ; brown-orange	Copper oxide, Cuprite Cu2O (?)
CP6	Powdery, not very cohesive ; white	Copper chloride, nantokite CuCl (?)
CM1	Intergranular corrosion ; brown	Copper oxide, Cuprite Cu2O (?)
M1	Metal	Leaded bronze with a high concentration of Sn et Pb

Fig 22 : Improved representation of the stratigraphy of corrosion layers of the bracelet from visual observations and analyses,
