FRAGMENTS OF OENOCHOE GV132-01 US26-OBJ.10 - TIN BRONZE - ROMAN TIMES - SWITZERLAND

Artefact name	Fragments of oenochoe GV132-01 US26-obj.10
Authors	Christian. Degrigny (HE-Arc CR, Neuchâtel, Neuchâtel, Switzerland) & Sandra. Gillioz (HE-Arc CR, Neuchâtel, Neuchâtel, Switzerland) & Valentin. Boissonnas (HE-Arc CR, Neuchâtel, Neuchâtel, Switzerland)
Url	/artefacts/890/

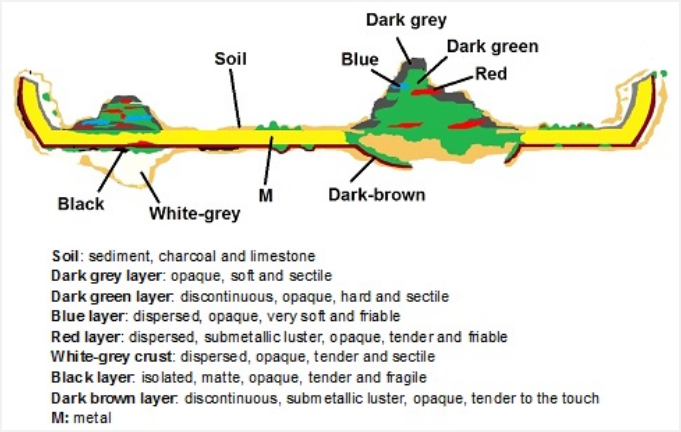
Fig. 3: Stratigraphic representation of the oenochoe base by macroscopic observation,

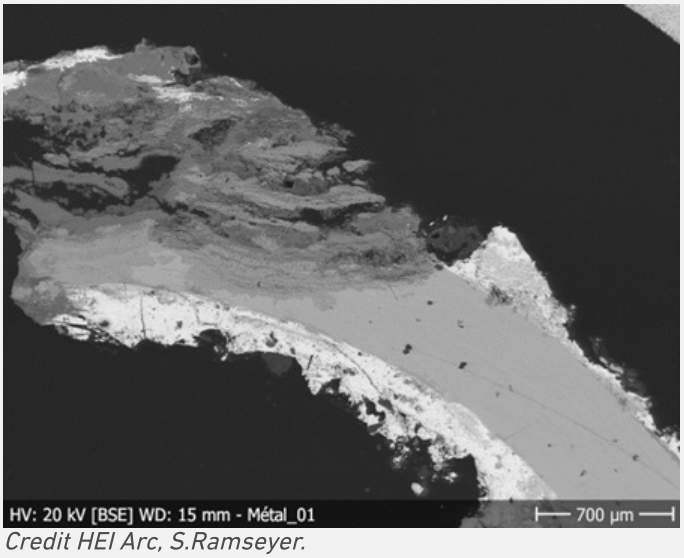
The remaining metal is a tin bronze (Table 1). The etched metal shows a structure of polygonal grains with twinned and strain lines (Fig. 8).

Fig. 5: SEM image of the metal sample (medium grey) from Fig.4 (rotated 30°), BSE-mode,

Fig. 6: Micrograph of the metal sample from Fig. 4, etched, bright field, 50x. Polygonal and twinned grains with strain lines are observed. The dotted surface is the result of over-etching,

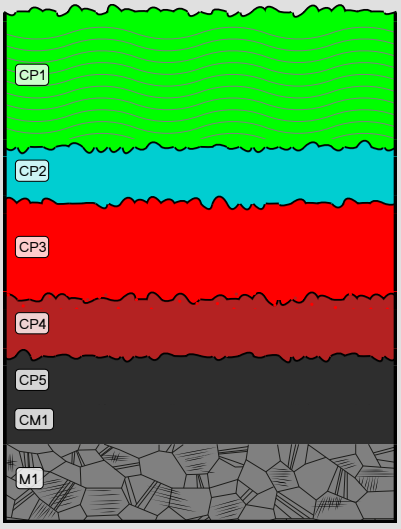
Fig. 12: Stratigraphic representation of the sample taken from the oenochoe base in cross-section (dark field) using the MiCorr application. The characteristics of the strata are only accessible by clicking on the drawing that redirects you to the search tool by stratigraphy representation. This representation can be compared to Fig. 9, Credit HE-Arc CR, C.Degrigny.

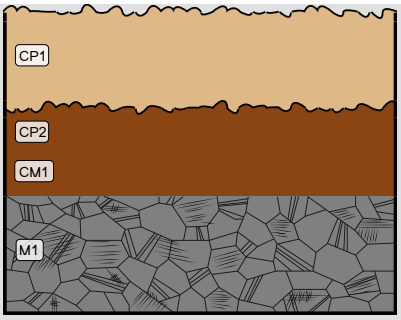
Fig. 13: Stratigraphic representation of the sample taken from the oenochoe base in cross-section (dark field) using the MiCorr application. The characteristics of the strata are only accessible by clicking on the drawing that redirects you to the search tool by stratigraphy representation. This presentation can be compared to Fig. 11, Credit HE-Arc CR, C.Degrigny.
