DEFORMED FRAGMENT OF METAL SHEET WT10-M305 - TIN BRONZE - IRON AGE - SWITZERLAND

Artefact name Deformed fragment of metal sheet WT10-M305

Authors Marianne. Senn (EMPA, Dübendorf, Zurich, Switzerland) & Christian. Degrigny (HE-Arc CR, Neuchâtel, Neuchâtel, Switzerland)

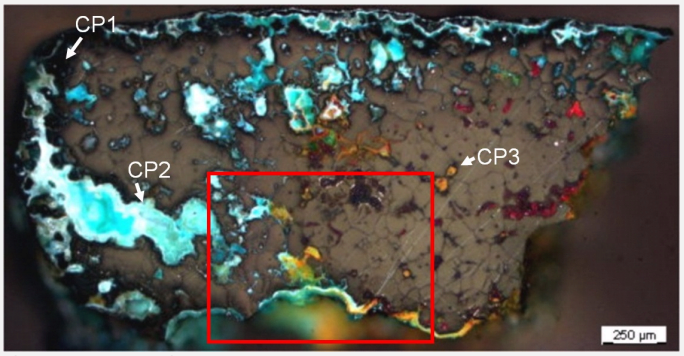
The corrosion crust varies in thickness between 60 and 150µm (Fig. 3). In bright field, it appears dark-grey (Fig. 4) and consists of two layers (CP1 and CP2). The inner layer is dark-grey and dense while the thin outer layer is slightly lighter coloured. Within the metal, the corrosion products are light-grey (CP3, Fig. 4). Under polarized light, the corrosion layer turns blue-green with dark-blue areas (Figs. 6 and 7) whereas corrosion products inside the metal are either light-blue or red-orange (Figs. 6 and 7). The red corrosion products (CP3) have the composition of cuprite/Cu2O while the orange compounds (also CP3) are enriched in Sn (Table 2). The blue-green corrosion products (CP2) both within the remaining metal and on the surface are even richer in Sn and O, and contain some P (Table 2 and Fig. 8). The thin, irregular dark-grey surface layer (CP1) is enriched in P, Fe, Si and Al (Table 2 and Fig. 8). XRD analyses of powdery particles sampled from the thin, dark surface corrosion layer (CP1) indicate the presence of tenorite/CuO and cassiterite/SnO2 (Museum report 1992). The Raman spectra of this layer (Fig. 9) confirmed the presence of tenorite.

Fig. 7: Micrograph of the metal sample (same as Fig. 4), polarised light. In black the metal. Blue-green, orange and red corrosion products are found in the porous metal and along the grain boundaries,

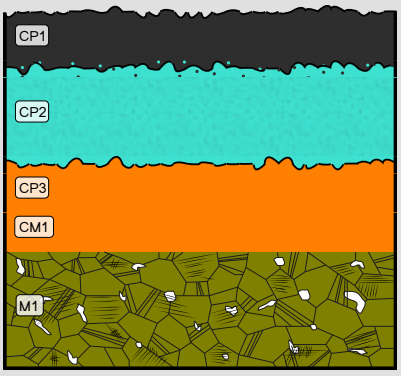
Fig. 10: Stratigraphic representation of the sample taken from the deformed fragment of metal sheet with dark green / grey patina in cross-section (dark field) using the MiCorr application. The characteristics of the strata are only accessible by clicking on the drawing that redirects you to the search tool by stratigraphy representation. This representation can be compared to Fig. 6, Credit HE-Arc CR.
