HEADREST OR HORSE BIT VFIG 2003.7 - LEADED BRONZE - MODERN TIMES

Artefact name Headrest or horse bit VFig 2003.7

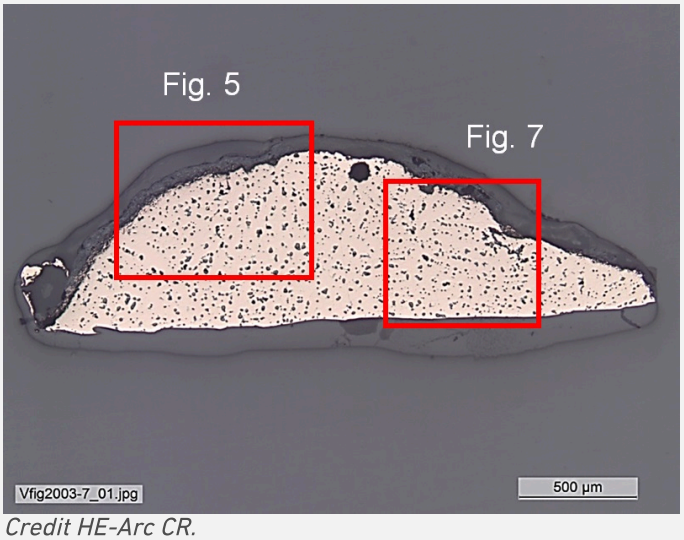
Fig. 4: Micrograph of the cross-section of sample from Fig. 2 of the headrest (or horse bit) showing the location of Figs. 5 and 7,

Description of sample	The sample was cut on the bottom of one of the plates (Fig. 2). On Fig. 4, the top and round shape of the sample is the outer part of the metal. It is covered with corrosion layers. The lower part of the sample corresponds to the cut metal with no corrosion products.
Alloy	Leaded Bronze
Technology	Cast and cold worked (with final annealing?)
Lab number of sample	None
Sample location	HE-Arc CR, Neuchâtel, Neuchâtel
Responsible institution	Bible & Orient Museum, Fribourg, Fribourg
Date and aim of sampling	2014, metallography and chemical analyses

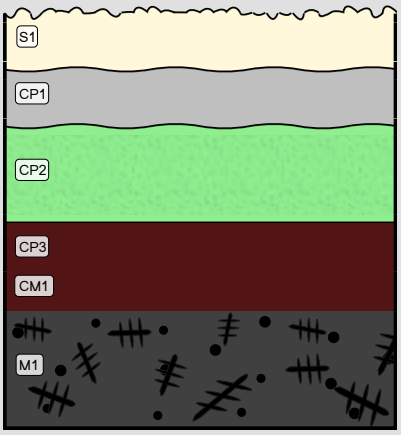
Fig. 15: Stratigraphic representation of sample from Fig. 2 of the headrest (or horse bit) in cross-section (dark field) using the MiCorr application. The characteristics of the strata are only accessible by clicking on the drawing that redirects you to the search tool by stratigraphy representation. This representation can be compared to Fig 10, Credit HE-Arc CR.
