CORRODED METAL SHEET FN 655.13.01 - FE ALLOY - MODERN TIMES - SWITZERLAND

Artefact name Corroded metal sheet FN 655.13.01

Authors Marianne. Senn (Empa, Dübendorf, Zurich, Switzerland) & Christian. Degrigny (HE-Arc CR, Neuchâtel, Neuchâtel, Switzerland)

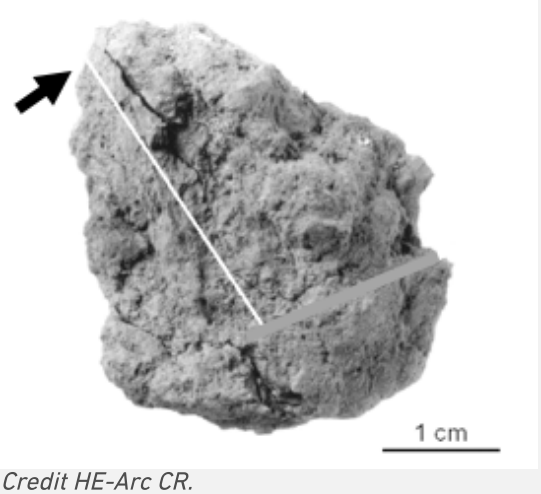
Fig. 1: Metal sheet (after Senn Bischofberger 2005, 137),

Description of the artefact Metal (iron-based) sheet with middle rib. The shape is no longer discernible (Fig. 1). The metal is covered by a thick corrosion crust. Dimensions: L = 4.5cm; WT = 35g.

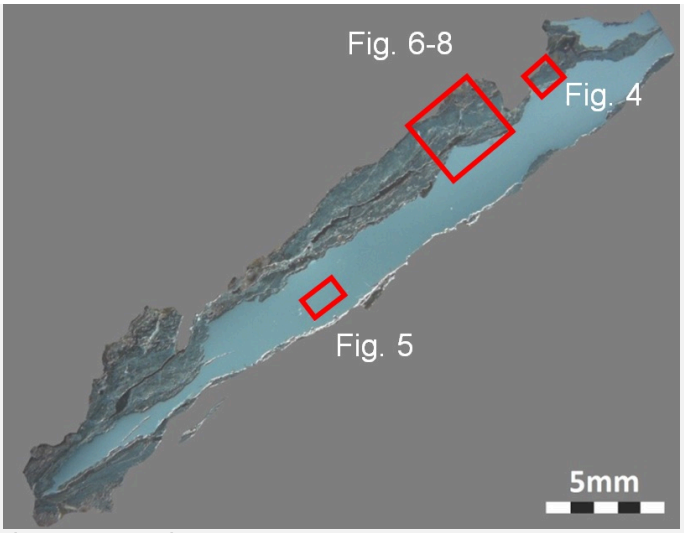
Fig. 3: Micrograph of the cross-section of the metal sheet showing the location of Figs. 4 to 8,

Description of sample	A longitudinal cut has been made through the sheet (Fig. 2). Large parts of the corrosion crust fell off during sampling (Fig. 3).
Alloy	Fe Alloy
Technology	Forged with final cold work
Lab number of sample	NEF 655
Sample location	HE-Arc CR, Neuchâtel, Neuchâtel
Responsible institution	Kantonsarchäologie, Dübendorf, Zurich
Date and aim of sampling	2000, metallography

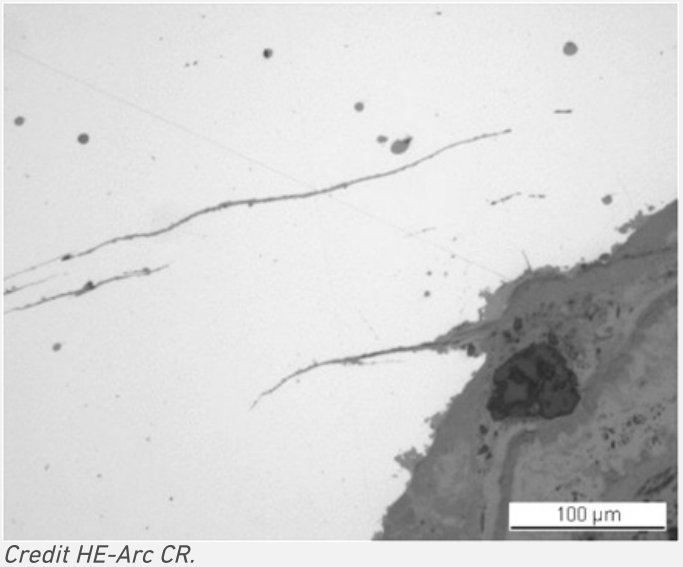
The remaining metal is an iron containing elevated (more than 1g/kg) concentrations of Co and Ni (Table 1), small round slag inclusions and cracks resulting from corrosion and deformation (Fig. 4). The composition of the round, elongated slag inclusions is similar to wüstite-FeO (Table 2). Iron reduced in the direct smelting process never contains such pure compounds and only FeO inclusions. In modern steels FeO occurs in low carbon alloys and Armco-iron (Schumann 1991, 474). After etching, the cross-section shows a heavily deformed ferritic microstructure from cold working (Fig. 6). The cracks have the same orientation as the deformation. The average hardness of the metal is HV1 195.

Fig. 4: Micrograph of metal sample from Fig. 3 (inverted picture, detail), unetched, bright field. In white the metal with round slag inclusions as well as cracks filled with corrosion products,

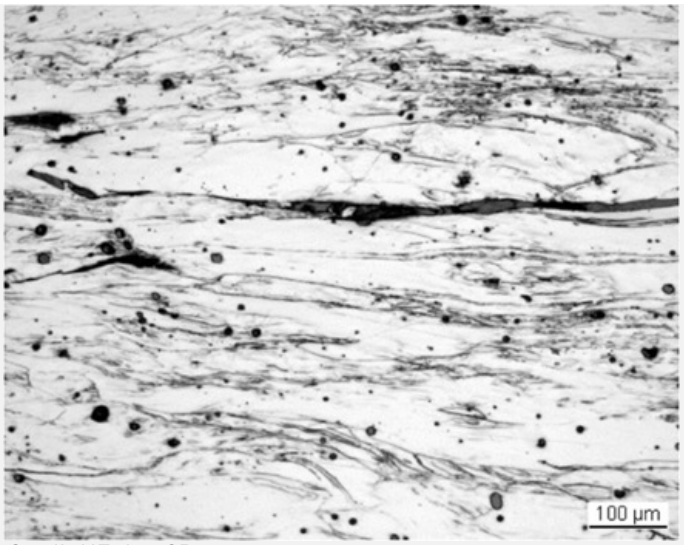
Fig. 5: Micrograph of metal sample from Fig. 3 (detail), etched, bright field. The heavily cold worked metal shows elongated grains with nearly invisible grain boundaries and cracks parallel to the grains,

Microstructure	Heavily deformed ferritic microstructure
First metal element	Fe
Other metal elements	Co, Ni

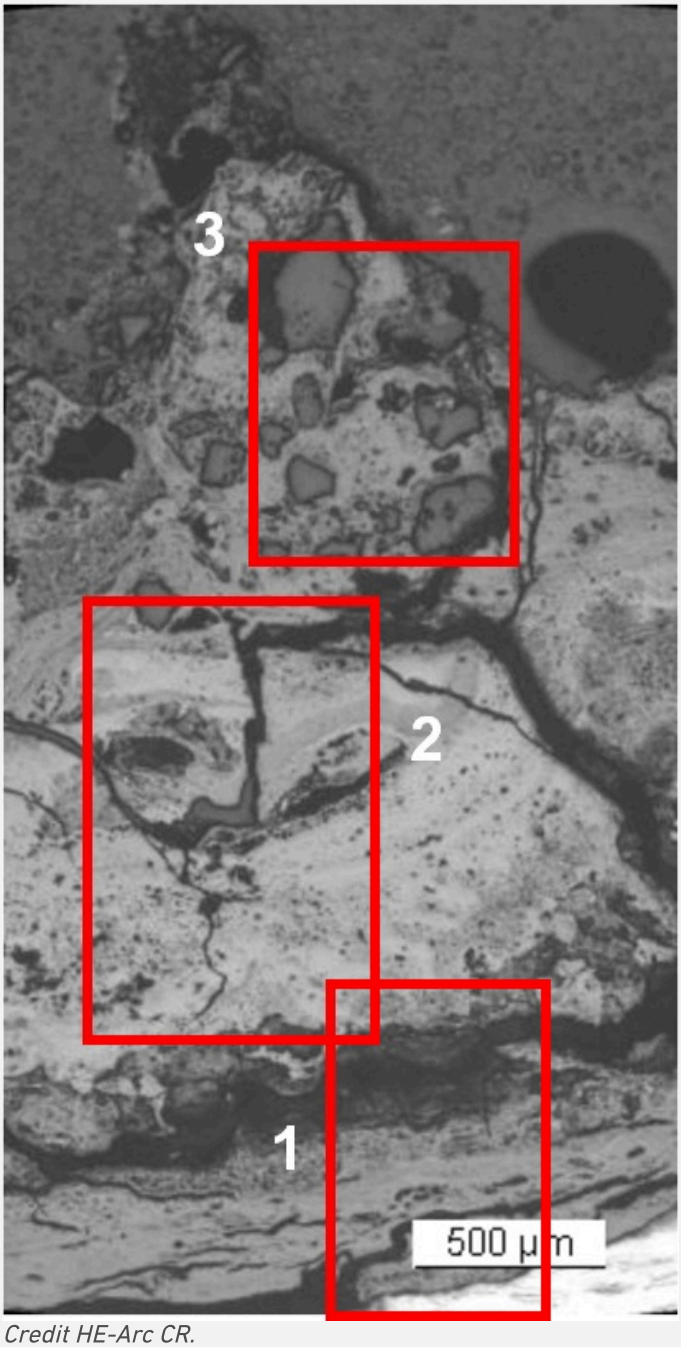
The corrosion is massive and large parts of the outer corrosion layers have been lost during the sample preparation. The heavily cracked corrosion crust represents about one third of the thickness of the sample (Fig. 3) and is located on one side of the metal (the rest having been lost during the cutting process). It does not show well defined layers. Despite this, three areas can be distinguished (Figs. 6 and 7). Adhering to the metal (area 1), we find an orange-red-brown layer enriched in Cl (CP3 in Fig. 9, Fig. 8 and Table 3). The dark or violet middle area 2 is richer in Fe (CP2 in Fig. 9). The outer area 3 is red-brown (CP1 in Fig. 9) and strongly contaminated by soil material (rock fragment inclusion and elements like Si, Al, P etc.). This layer is enriched in O (Fig. 9).

Fig. 6: Micrograph of the corrosion layer from Fig. 3 showing the metal - corrosion crust interface (detail, rotated by 45°) and corresponding to the stratigraphy of Fig. 9, unetched, bright field. The areas 1 (for CP3), 2 (for CP2) and 3 (for CP3) selected for elemental chemical distribution (Fig. 8) are marked by red rectangles,

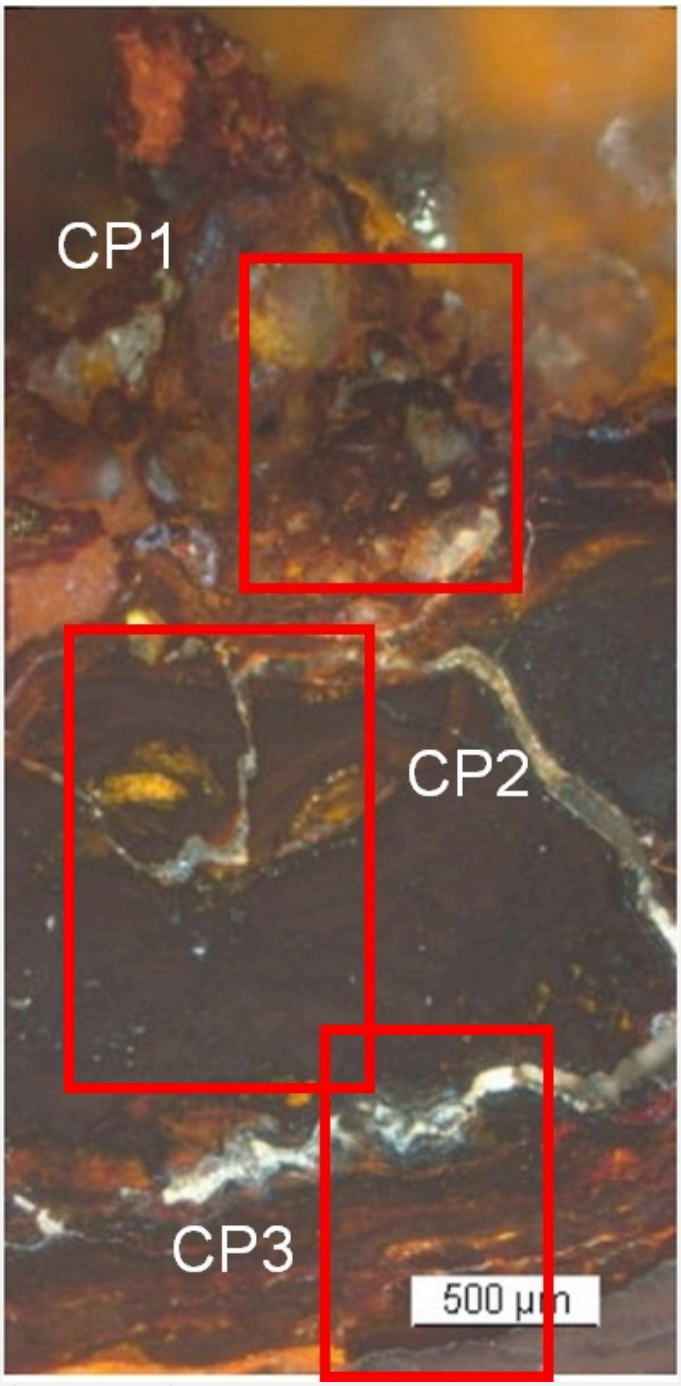
Fig. 7: Micrograph (same as Fig.6) and corresponding to the stratigraphy of Fig. 9, polarised light. The inner layer (CP3) is red-brown, area 2 is brown-violet (CP2) and the outer brown area contains rock fragment inclusions (CP1),

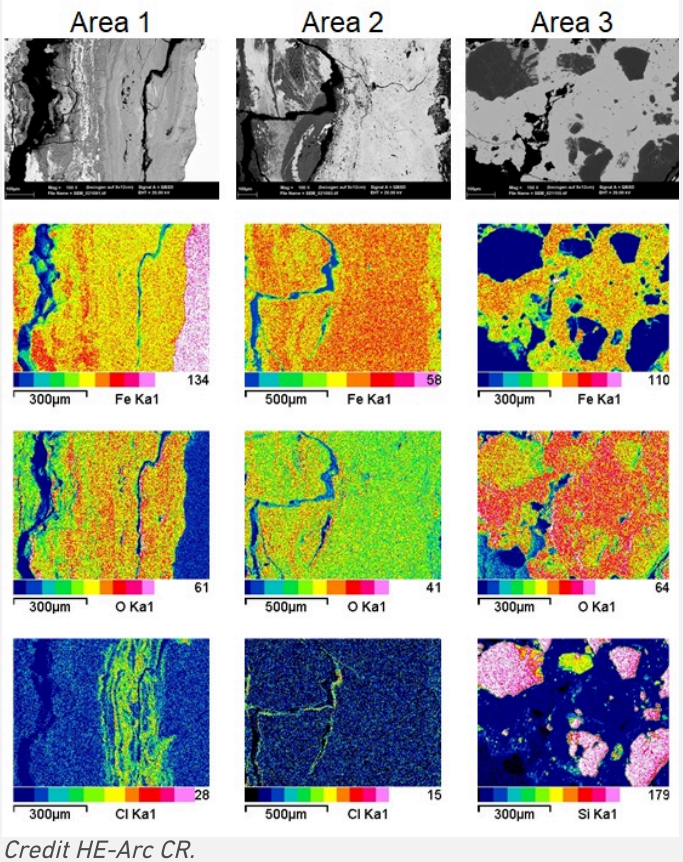
Fig. 8: SEM images, BSE-mode, and elemental chemical distribution of the selected areas from Figs. 6 and 7 (reversed picture rotated by 270°, details). First column: mapping on area 1 (CP3) where an inner layer enriched in Cl appears near the metal surface. 2nd column: area 2 (CP2) where iron oxides prevail. 3rd column: area 3 (CP1) where the outer O-rich layer includes rock fragments rich in Si. Method of examination: SEM/EDS, Lab. Anal. Chem. Empa,

This iron-based sheet is entirely cold worked and hard compared to an annealed metal. The corrosion is massive and masks the shape of the object. The presence of Cl adjacent to the metal surface indicates that the corrosion front is potentially active. The very thick top corrosion layers may have slowed down the corrosion. The object was mentioned as being Roman in Senn Bischofberger 2005, however the chemical composition of the slag inclusions shows that it is a product of the 20th century AD which has been accidentally introduced into a Roman layer.

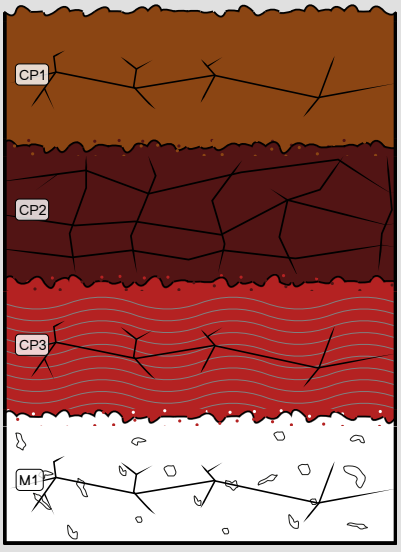
Fig. 9: Stratigraphic representation of the iron-based sheet in cross-section (dark field) using the MiCorr application. The characteristics of the strata are only accessible by clicking on the drawing that redirects you to the search tool by stratigraphy representation. This representation can be compared to Figs. 7, Credit HE-Arc CR.
