WEDGE PART OF AN ALTAR CROWN SUSPENSION – P-RICH IRON AND HYPOEUTECTOID STEEL – MODERN TIMES – SWITZERLAND

Artefact name	Wedge part of an altar crown suspension
Authors	Marianne. Senn (Empa, Dübendorf, Zurich, Switzerland) & Christian. Degrigny (HE-Arc CR, Neuchâtel, Neuchâtel, Switzerland)
Url	/artefacts/895/

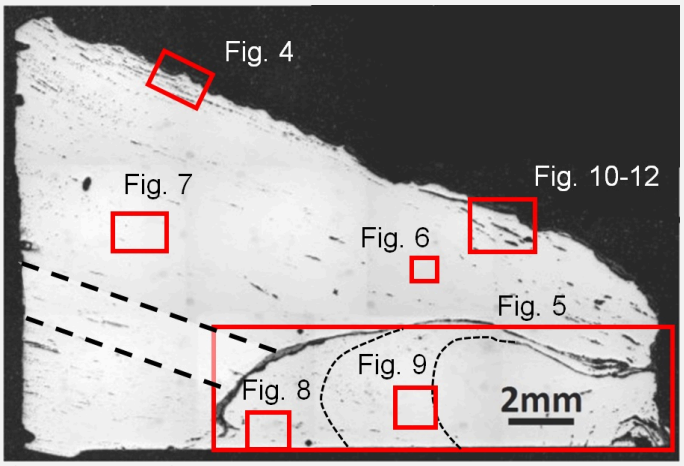
Fig. 3: Micrograph of the cross-section of the sample taken from the wedge part showing the location of Figs. 4 to 12. Steel areas are delimited by black dotted lines,

Description of sample	This sample is a section from the end of the wedge part (Fig. 2). The corrosion crust appears on the top side on Fig. 3.
Alloy	P-rich iron and hypoeutectoid steel
Technology	Annealed after (hot) rolling
Lab number of sample	RHE1-NR
Sample location	Haute École Arc Neuchâtel, Neuchâtel
Responsible institution	IWT (Naila Hadzic), Wallisellen, Zurich
Date and aim of sampling	January 2008, material testing and security report

The remaining metal (M1) is a P-rich iron (0.3-0.45 mass%) with two zones (M3) consisting of soft, hypoeutectoid steel (C content 0.2 mass%) (Fig. 3 and Table 1). The P-rich iron contains many elongated slag inclusions of various sizes forming parallel rows (Figs. 3 and 4). The number of slag inclusions is higher than in bloomery iron and their distribution is typical for rolled metal. A crack, partially filled by hammer scale and corrosion products, indicates a poor quality welding seam (Fig. 3). Below the inclusions the curve produced by forging is highlighted. In good quality wrought iron slag inclusions are small, uniformly distributed and have identical compositions (Boesenberg 2006, 622). This is not the case in this sample, but can be explained by the rudimentary rolling process of the 18th century. The chemical composition of the slag inclusions shows that iron oxides dominate, beside phosphorus oxide, calcium oxide and silica (Table 2). The composition is typical for slag formed by hearth refining of pig iron (Dillmann and L'Héritier 2007). During this process, the pig iron is oxidised. The oxidising elements are Si, P, Mn, V and Cr. The analyzed slag inclusions contain more Fe than most published ones. The high P content is similar to published examples from the 18th century (Dillmann and L'Héritier 2007, 1820). The high calcium oxide content, which is often combined with high silica content, could originate from the addition of both materials while refining the pig iron to better eliminate the P. In one of our measurements, only the silica concentration is high (Table 2). This can be interpreted as resulting from the addition of sand during forging. Etching with Oberhoffer's reagent outlines the thick welding seam (M2, Fig. 5), the rolling direction and the P segregation. Etching with nital mainly shows a ferritic structure (Fig. 6). The grains vary in size (between ASTM grain sizes of 4 to 8) and are recrystallized. The ferrite shows local ghost structures, and includes Neumann bands and some needles (Figs. 7 and 8). These are typical structures of P-rich iron. The ghost structure is formed by a fast recrystallization of P-rich iron after heating above 1000°C. The Neumann bands indicate cold working. The hypoeutectoid steel consists of ferrite with lamellar pearlite (Fig. 9). The average hardness of the metal is HV1 185 (in the Empa test report a mean of HV10 175 was determined). The areas close to the welding seam are harder (ca. HV1 210). The calculated tensile strength based on HV1 175 is about 544N/mm^2.

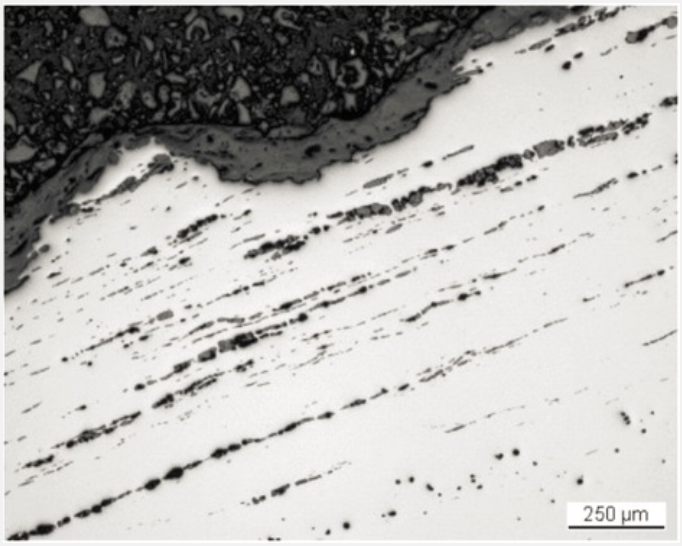
Fig. 4: Micrograph of the metal sample from Fig. 3 (reversed picture, detail), unetched, bright field. In white the metal, in grey the corrosion layer. There are numerous slag inclusions in the metal all orientated to form rows. Some inclusions are empty, probably due to sample preparation,

Fig. 5: Micrograph of the metal sample from Fig. 3 (reversed picture, detail), etched with Oberhoffer's reagent, bright field. The etching shows the P segregation near the welding line and outlines the irregular P distribution in the metal (white P-rich areas, dark P-poor areas),

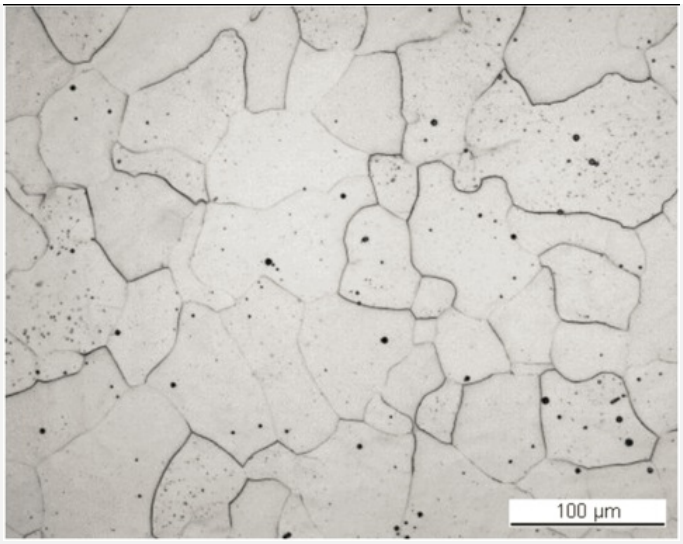
Fig. 6: Micrograph of the metal sample from Fig. 3 (detail), nital etched, bright field. The metal presents a ferritic structure,

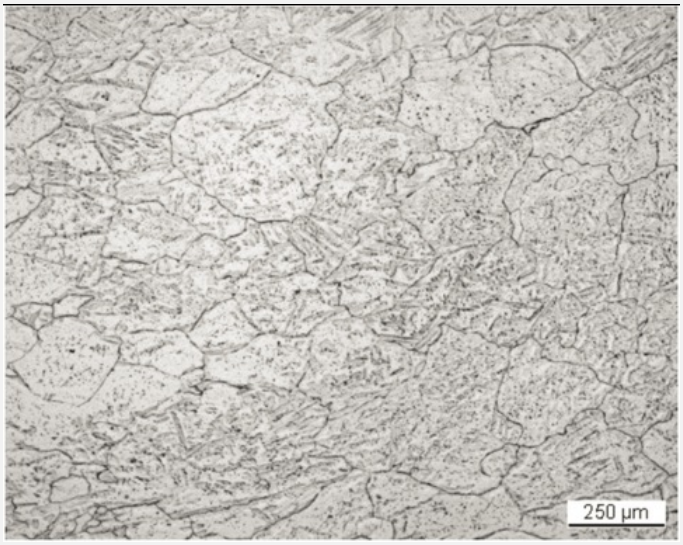
Fig. 7: Micrograph of the metal sample from Fig. 3 (detail), nital etched, bright field. The ferrite shows a ghost structure with needles,

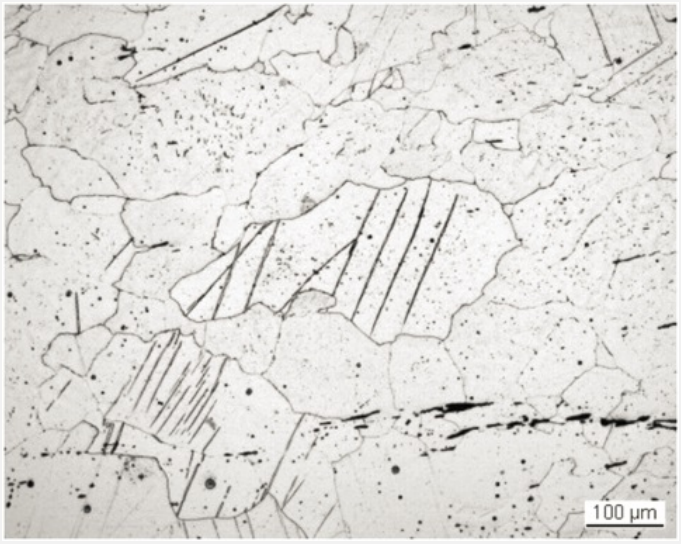
Fig. 8: Micrograph of the metal sample from Fig. 3 (detail), nital etched, bright field. The ferrite grains include Neumann bands,

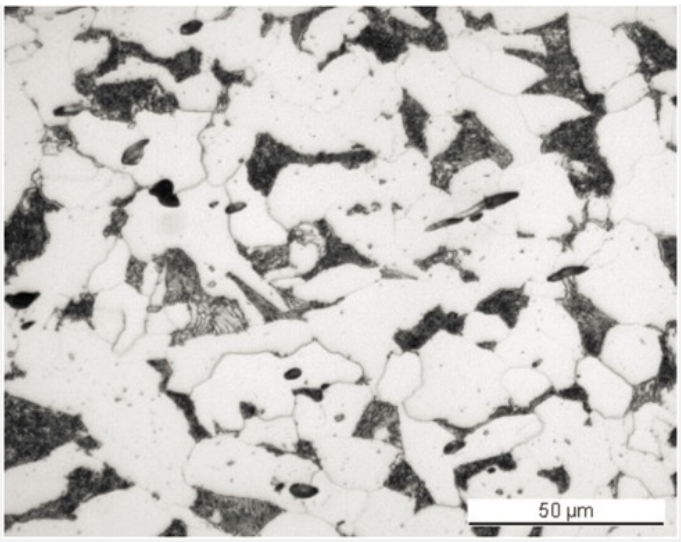
Fig. 9: Micrograph of the metal sample from Fig. 3 (detail), nital etched, bright field. The hypoeutectoid steel is constituted of ferrite in white and lamellar pearlite (in black),

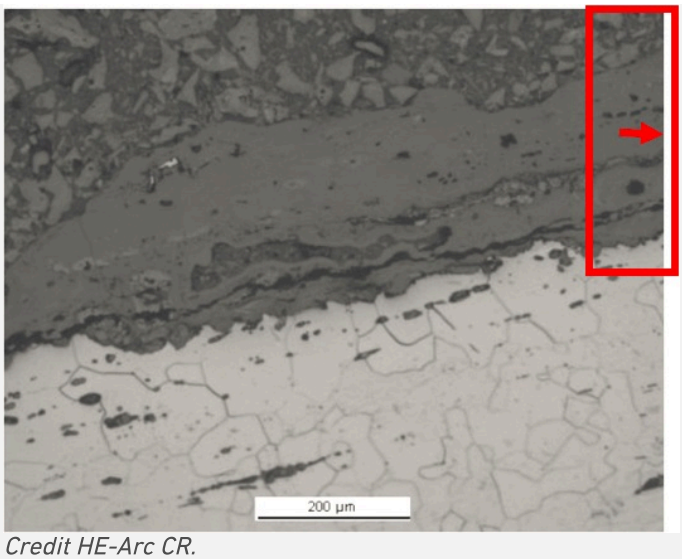
The corrosion crust is thin and irregular. It is restricted to one of the three surfaces. In bright field, the corrosion layer seems homogeneous and appears medium-grey with a fissure parallel to the metal surface (Fig. 10). Under polarised light the corrosion products near the metal surface are mostly red-orange (CP3), whereas in the outer layer they appear orange-brown (CP1) (Fig. 11). A dark-brown zone is visible between them (CP2) and contains bright inclusions with a chemical composition similar to wüstite (Table 3). This corresponds to corroded slag inclusions (internal markers). Chemical analysis (Table 3) and elemental mapping (Fig. 12) do not highlight a difference in composition of the corrosion layers, except for the corroded slag inclusions.

Fig. 10: Micrograph showing the metal - corrosion layer interface from Fig. 3 (reversed picture, detail), unetched, bright field. The grey corrosion layer contains bright inclusion rows. The area selected for elemental chemical distribution (Fig. 12) is marked by the red rectangle which expends beyond the micrograph,

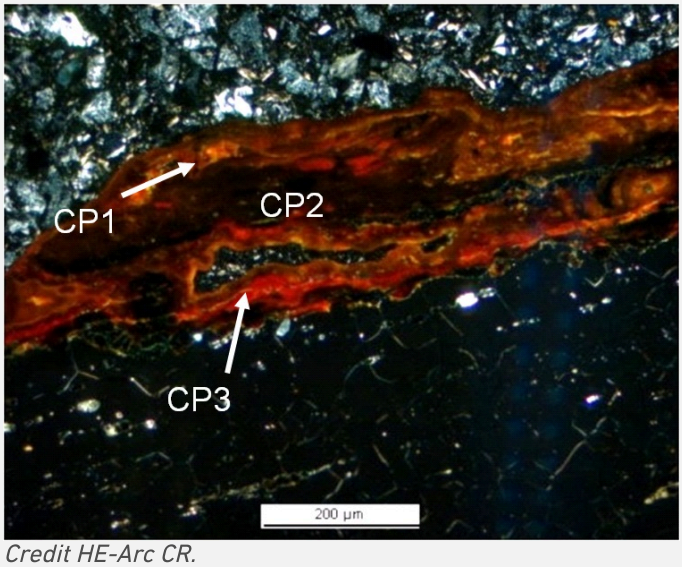
Fig. 11: Micrograph (same as Fig. 10) corresponding to the stratigraphy of Fig. 13, unetched, polarised light. We observe from bottom to top: a red-orange inner corrosion layer (CP3), followed by a dark-brown intermediate layer (CP2) and an orange-brown outer layer (CP1),

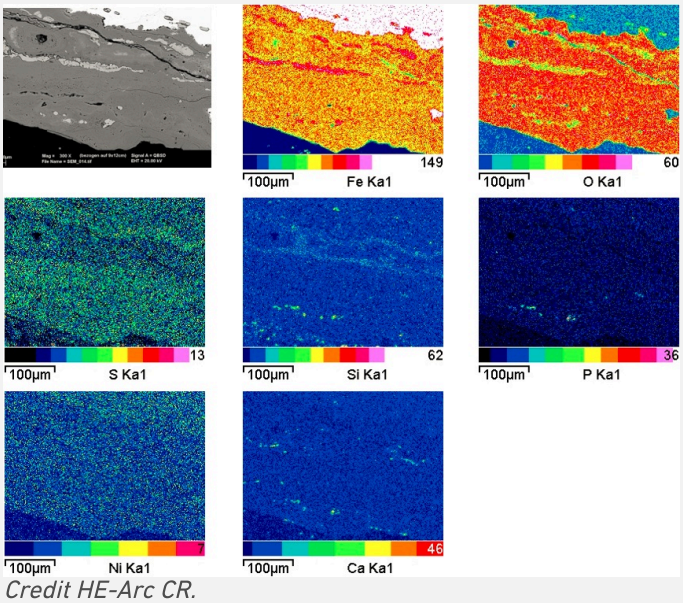
Table 3: Chemical composition (mass %) of the corrosion crust (from Fig. 12). Method of analysis: SEM/EDS, Laboratory of Analytical Chemistry, Empa.

Fig. 12: SEM image, BSE-mode, and elemental chemical distribution of the selected area from Fig. 10 (inversed, detail). Method of examination: SEM/EDS, Laboratory of Analytical Chemistry, Empa,

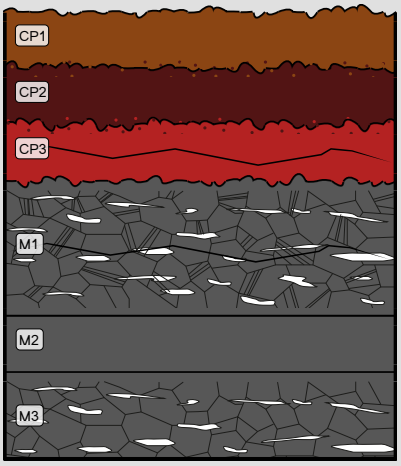
Fig. 13: Stratigraphic representation of the sample taken from the wedge part in cross-section (dark field) using the MiCorr application. The characteristics of the strata are only accessible by clicking on the drawing that redirects you to the search tool by stratigraphy representation. This representation can be compared to Fig. 11, Credit HE-Arc CR.
