FRAGMENT OF THE SUPPORT STRUCTURE OF AN ENGINE VHS-404 - GREY CAST IRON - MODERN TIMES

Artefact name	Fragment of the support structure of an engine VHS-404
Authors	Marianne. Senn (EMPA, Dübendorf, Zurich, Switzerland) & Christian. Degrigny (HE-Arc CR, Neuchâtel, Neuchâtel, Switzerland)
Url	/artefacts/897/

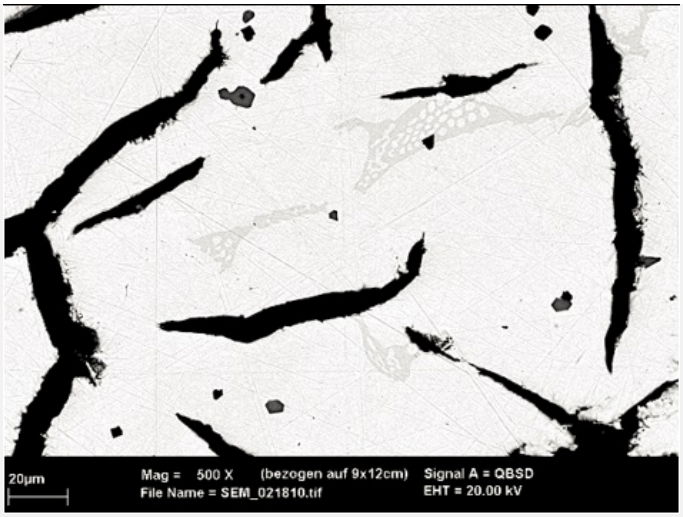
Fig. 5: SEM image from Fig. 3 (detail), BSE-mode, unetched. We observe the graphite flakes in black, the manganese sulphide inclusions in grey and the eutectic mixture in light-grey,

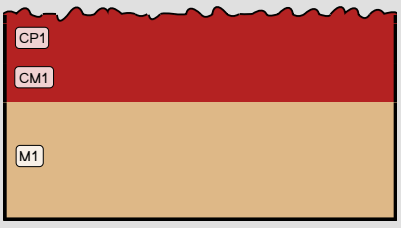
Fig. 12: Stratigraphic representation of an unpainted section of the fragment in cross-section (dark field) using the MiCorr application. The characteristics of the strata are only accessible by clicking on the drawing that redirects you to the search tool by stratigraphy representation. This representation can be compared to Fig. 10, Credit HE-Arc CR.
