FITTING ON BACK PANEL OF A MILITARY CARRIAGE – THOMAS STEEL – MODERN TIMES – SWITZERLAND

Artefact name	Fitting on back panel of a military carriage
Authors	Marianne. Senn (Empa, Dübendorf, Zurich, Switzerland) & Christian. Degrigny (HE-Arc CR, Neuchâtel, Neuchâtel, Switzerland)
Url	/artefacts/899/

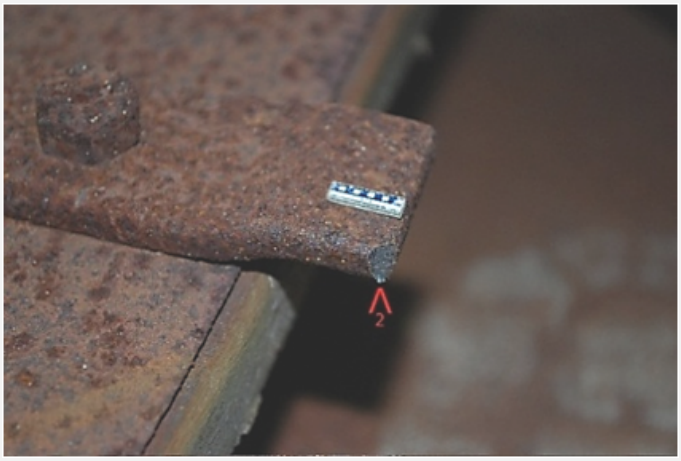
Fig. 1: Fitting on back panel of a military carriage,

Description of the artefact	Fitting on back panel, first exposed outdoors, later indoors (Fig. 1). Uniform corrosion and pitting corrosion are visible.
Type of artefact	Military carriage
Origin	Swiss Army, Thun, Bern, Switzerland
Recovering date	Built by Konstruktions-Werkstätte, 1918
Chronology category	Modern Times
chronology tpq	1918 A.D.
chronology taq	----
Chronology comment	
Burial conditions / environment	Outdoor to indoor atmosphere

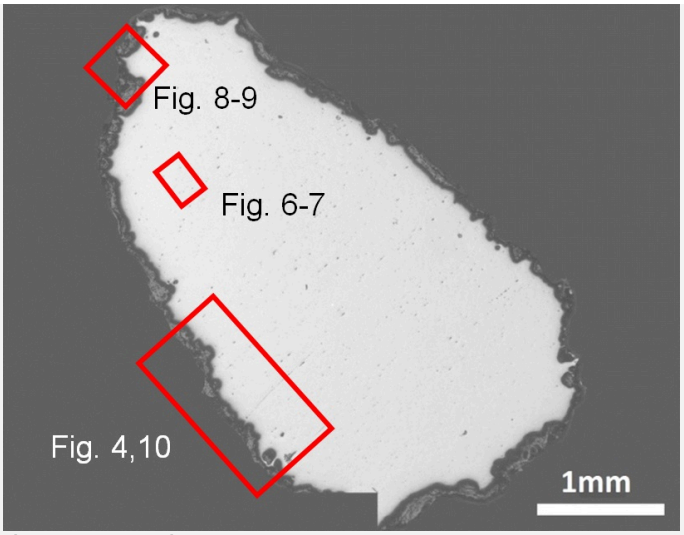
Fig. 3: Micrograph of the cross-section of the sample taken from the fitting showing the location of Figs. 4 and 6 to 10,

Description of sample	This sample is a cut from the corner of one of the two fittings on the back panel (Fig. 2). The metal is covered by a thin corrosion layer (Fig. 3).
Alloy	Thomas steel
Technology	Piled from several strips, hot rolled and annealed
Lab number of sample	POINT-Fe2
Sample location	HE-Arc CR, Neuchâtel, Neuchâtel
Responsible institution	Historical Swiss Army Material Foundation, Burgdorf, Bern
Date and aim of sampling	05/2009 metallography

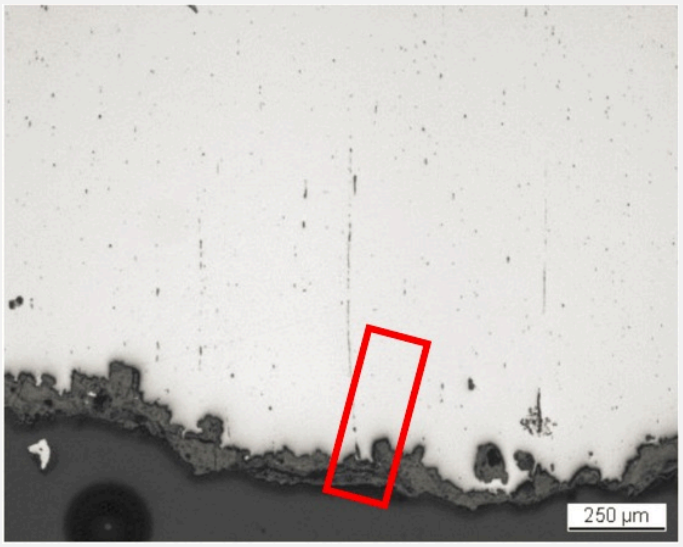
The remaining metal is a Mn-rich soft steel (C content around 0.1 mass%) containing manganese sulphide inclusions with a varying Fe content (Tables 1 and 2). The numerous inclusions form parallel rows (Fig. 4). This orientation is typical for hot rolled metal. After etching with Oberhoffer's reagent, three main welding seams (P-rich) become visible (Fig. 5). Near the surface they are also outlined by corrosion (Figs. 4 and 10). After nital etching, the metal shows a ferritic structure with tertiary cementite and lamellar pearlite at the grain boundaries (Figs. 6 and 7). The grains are small with an ASTM grain size of 10 and are recrystallized due to annealing after hot rolling. The average hardness of the metal is HV1 165. The hardness is slightly high for such a structure and this is due to the Mn content of the metal. The chemical composition, especially the Mn content and the presence of carbo-nitrides (not analysed here), is typical for Thomas steel.

Fig. 4: Micrograph of the metal sample from Fig. 3 (rotated by 270°, detail), unetched, bright field. We observe the metal including welding seams outlined by corrosion products and MnS inclusions. The area selected for elemental chemical distribution (Fig. 10) is marked by a red rectangle,

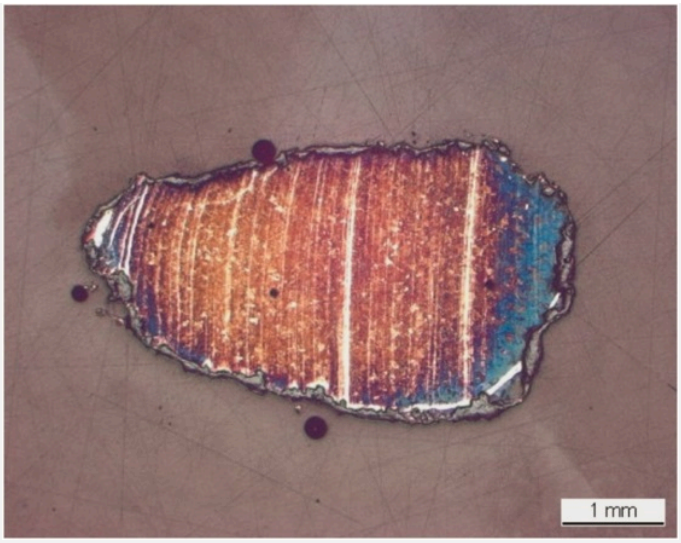
Fig. 5: Micrograph of the metal sample from Fig. 3, etched with Oberhoffer's reagent, bright field. We observe three P-rich welding seams in white,

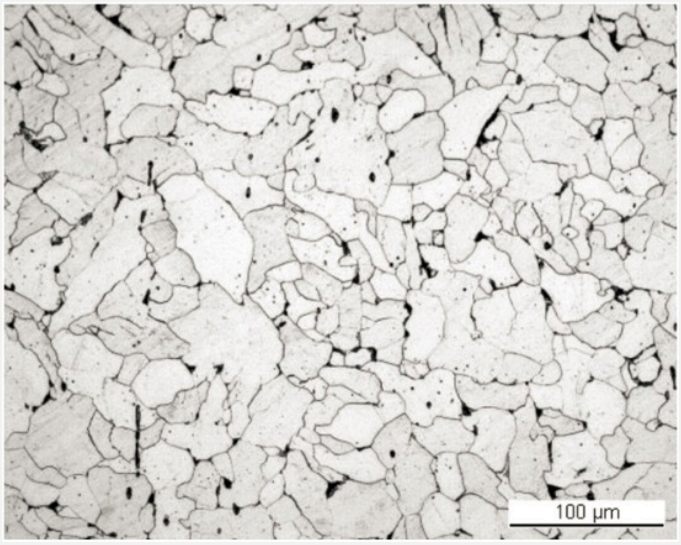
Fig. 6: Micrograph of the metal sample, nital etched, bright field. We observe tertiary cementite (black) on the grain boundaries,

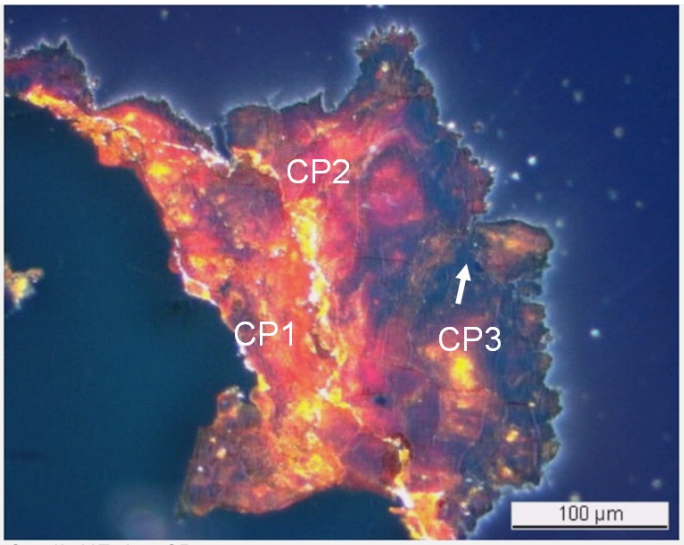
The average thickness of the corrosion products is about 80µm (Figs. 4 and 8). In bright field they appear grey, marbled and heavily cracked (Fig. 8). Under polarised light, the corrosion products appear orange to dark-brown (Fig. 9). At the metal - corrosion products interface they are dark-brown (CP3). The middle part (CP2) is dark-red and the outer part is bright orange (CP1). The elemental mapping of the corrosion layers shows no distinctive stratification, but areas near the metal - corrosion crust interface (CP3) as well as the top surface of the corrosion layer (CP1) seem to have a lower O content (Fig. 10). The O content indicates the presence of iron hydroxides (Table 3). Soil materials (such as rock fragments and dust) are found in the welding seams near the surface.

Fig. 8: Micrograph showing the metal - corrosion crust interface from Fig. 3 (rotated by 270°, detail), unetched, bright field. We observe in white the metal, in grey the corrosion products and in black the resin,

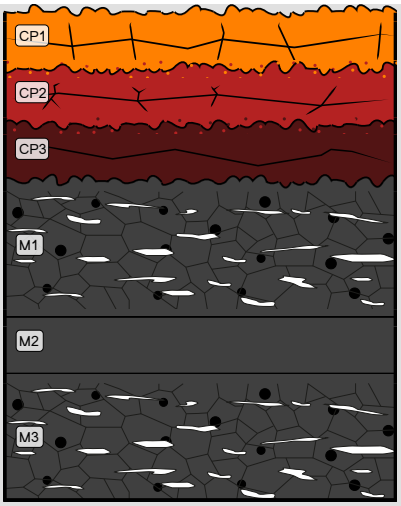
Fig. 11: Stratigraphic representation of the sample taken from the fitting in cross-section (dark field) using the MiCorr application. The characteristics of the strata are only accessible by clicking on the drawing that redirects you to the search tool by stratigraphy representation. This representation showing for the metal part a welding seam (M2) can be compared to Fig. 9, Credit HE-Arc CR.
