FITTING ON BACK PANEL OF A MILITARY CARRIAGE – THOMAS STEEL – MODERN TIMES – SWITZERLAND

Artefact name	Fitting on back panel of a military carriage
Authors	Marianne. Senn (Empa, Dübendorf, Zurich, Switzerland) & Christian. Degrigny (HE-Arc CR, Neuchâtel, Neuchâtel, Switzerland)
Url	/artefacts/899/

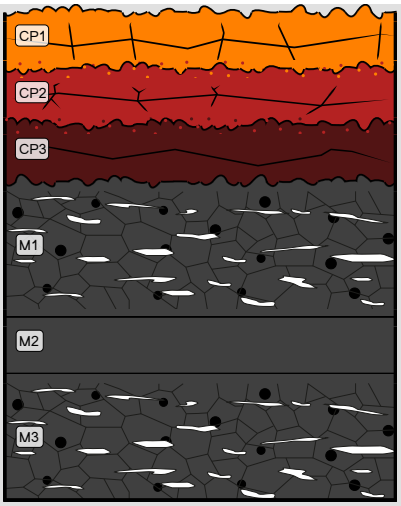
Fig. 11: Stratigraphic representation of the sample taken from the fitting in cross-section (dark field) using the MiCorr application. The characteristics of the strata are only accessible by clicking on the drawing that redirects you to the search tool by stratigraphy representation. This representation showing for the metal part a welding seam (M2) can be compared to Fig. 9, Credit HE-Arc CR.
