CHISEL POINT DEV 995 1069 PR – EUTECTOID TO HYPEREUTECTOID STEEL – EARLY MEDIEVAL TIMES – SWITZERLAND

Artefact name Chisel point DEV 995 1069 PR

Authors Marianne. Senn (Empa, Dübendorf, Zurich, Switzerland) & Christian. Degrigny (HE-Arc CR, Neuchâtel, Neuchâtel, Switzerland)

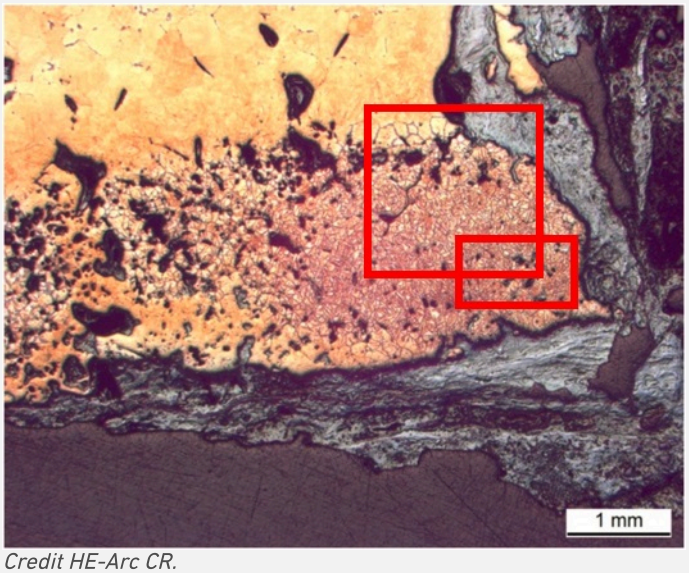
The remaining metal is a eutectoid to hypereutectoid steel (C 0.8-1 mass%) with cracks and porosity (Figs. 4 and 5). Its composition is given in Table 1 (except Fe). Of the trace elements, only Ni reaches a medium concentration (Ni 0.07 mass%). The composition and the high Ni/Co ratio are atypical for iron worked in smithies of the settlement at Develier-Courtételle JU, CH. The few slag inclusions and their chemical composition confirm this (Table 2). The slag is rich in CaO whereas the pisolithic or bean ore worked in the Central Jura smelting district is rich in Al_2O_3. The slag inclusions cannot be smithing slag because the artefact is formed from one piece of metal. The slag probably incorporated while refining the bloom or during the bloom smelting process. The ore from which this metal was smelted cannot yet be identified. Intergranular corrosion has developed, penetrating into the metal structure (Fig. 5). The etched metal shows a dominant martensitic structure, typical of quench hardened steel (Figs. 4, 6, 7 and 8). The characteristic forms of the martensite are non-organised needles (Fig. 7). In restricted areas bainite nodules occur (Figs. 6 and 7). In the centre of the point, hypereutectoid steel is composed of cementite in the grain boundaries and in needle like shapes within the grains (Fig. 9). Hypereutectoid regions also occur in the centre of the shaft and on its left surface (Fig. 4). Here the hypereutectoid steel is composed of martensite and cementite in the grain boundaries and in needle form within the grains (Figs. 5 and 8). Nevertheless, most of the chisel is dominated by eutectoid steel. The average hardness of the quench hardened eutectoid steel is about HV1 690. In the bainite nodules the average hardness drops to about HV1 350, the martensite has an average hardness of HV1 750.

Fig. 4: Micrograph of the metal sample from Fig. 3 (inverted picture, detail), etched, bright field. The metal contains porosity and cracks (in black). The micrographs of Figs. 5 and 8 are marked by the top and bottom rectangles respectively,

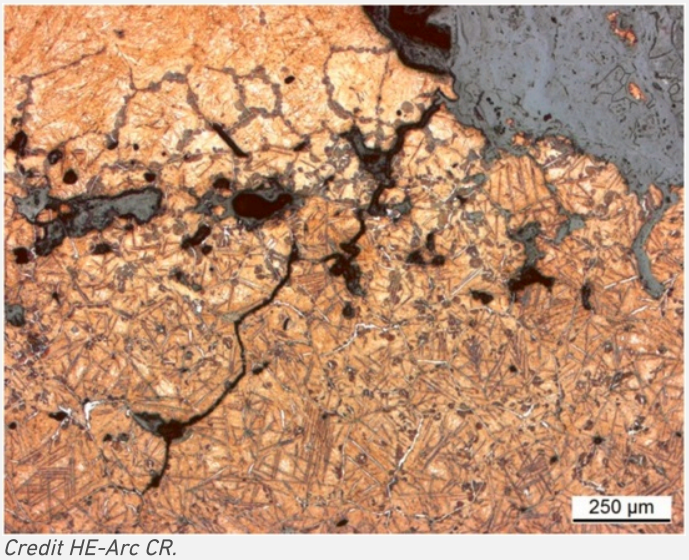
Fig. 5: Micrograph of the metal sample, detail from Fig. 4, etched, bright field. We observe martensite (in orange), cementite (in grey), porosity and intergranular cracks (in black) and corrosion,

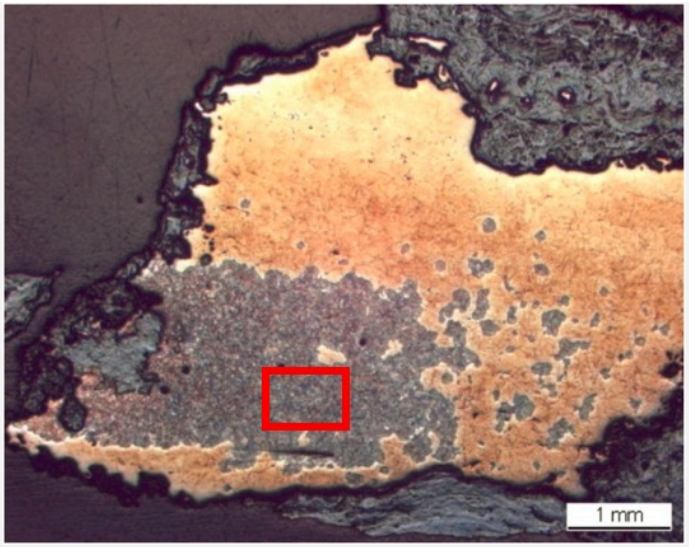
Fig. 6: Micrograph of the metal sample from Fig. 3 (inverted picture, detail), etched, bright field. We observe the metal with martensite (orange) and bainite nodules (blue). The micrograph of Fig. 9 is marked by a rectangle,

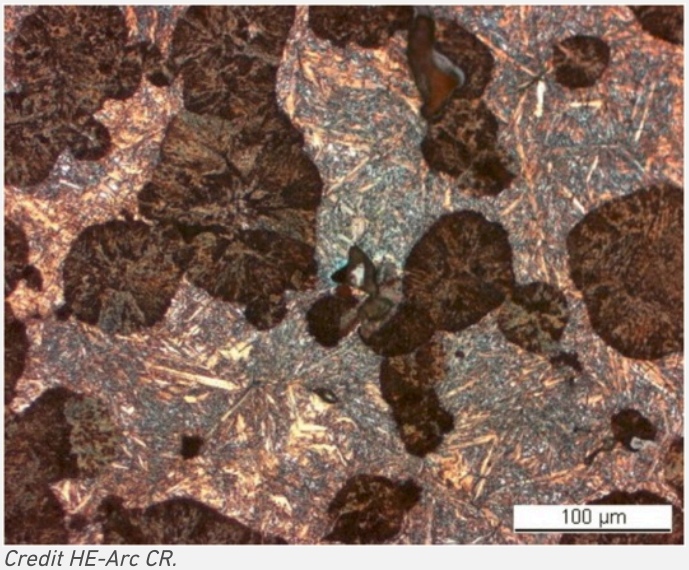
Fig. 7: Micrograph of the metal sample from Fig. 3 (detail), etched, bright field. We observe dark bainite nodules combined with martensite needles,

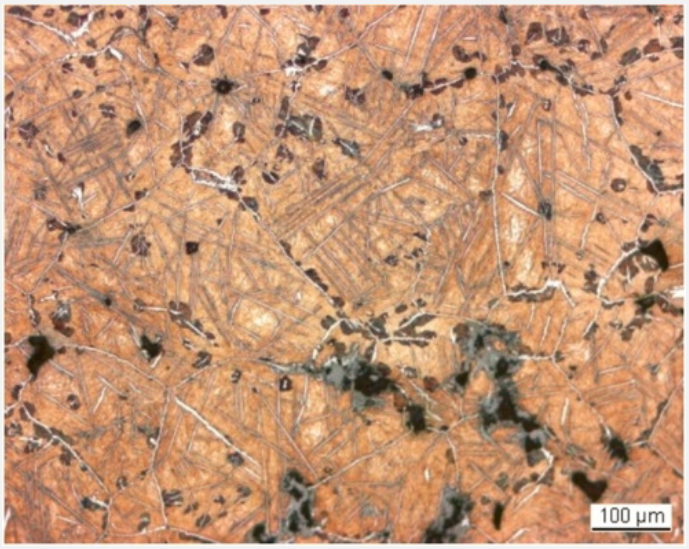
Fig. 8: Micrograph of the metal sample, detail from Fig. 4, etched, bright field. Hypereutectoid steel with a structure of cementite in white in the grain boundaries and in needle form combined with martensite (pink). Some bainite occurs around the grain boundaries,

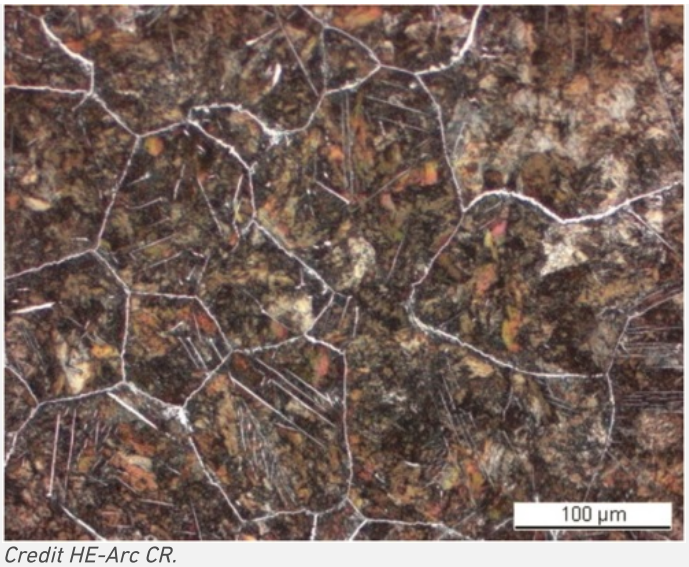
Fig. 9: Micrograph of the metal sample, detail from Fig. 6, etched, bright field. Hypereutectoid steel with a structure of cementite in white in the grain boundaries and in needle form combined with bainite (dark),

The tool is made of hard, eutectoid to hypereutectoid steel and was, as a last manufacturing step, entirely quenched. In this state it is too hard and brittle to be used. It is likely that the quenched hypereutectoid structure provoked the breakage of the tool when it was first used. The absence of a tempering process at the end is unclear. The chemical composition of the metal and the slag inclusions indicate that the artefact was imported to the hamlet of Develier-Courtételle JU. The corrosion has, in areas, replaced the metal structure retaining a ghost structure; the outer layer has been mostly removed during surface cleaning. Extensive pitting corrosion has occurred, typical for steel with an elevated C content. The presence of S in the inner layer can be explained by putrefaction processes in the soil. Chlorides are still present at the metal-corrosion interface as no desalination process was attempted. Iron carbonates are present in the centre of a corrosion pit. The corrosion is of terrestrial type.

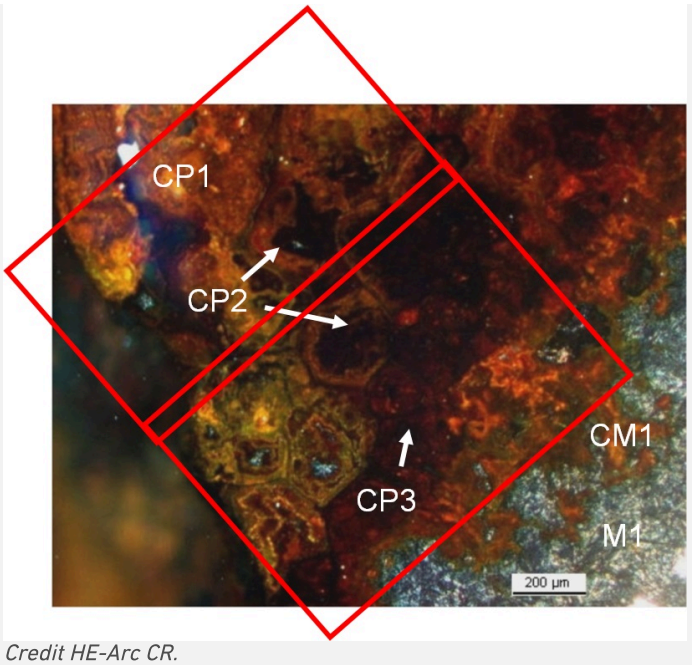
The metal is heavily corroded and the thickness of the corrosion crust is irregular, but averages about 0.5mm. The corrosion products enclose different ghost structures: the corrosion crust has preserved the shape of polygonal grains (Figs. 10 and 12) and cementite needles (Fig. 11). Under polarised light, the corrosion products at the metal - corrosion crust interface are dark-red and form an inner S-rich layer (CP3, Figs. 10 and 12). Cl occurs locally (CP3) and C is present in layers CP2 and CP3 (Fig. 12). The outer layer of the corrosion products (CP1) is orange and contains more O than the inner layer CP3 (Figs. 10 and 13).

Fig. 10: Micrograph showing the metal - corrosion crust interface from Fig. 3 (rotated by 270°, detail) and corresponding to the stratigraphy of Fig. 14, unetched, polarised light. Polygonal grains are visible as ghost structure in the corrosion crust. The selected areas for elemental chemical distribution (Figs. 12 and 13) are marked by two rectangles (bottom: Fig. 12 and top: Fig. 13),

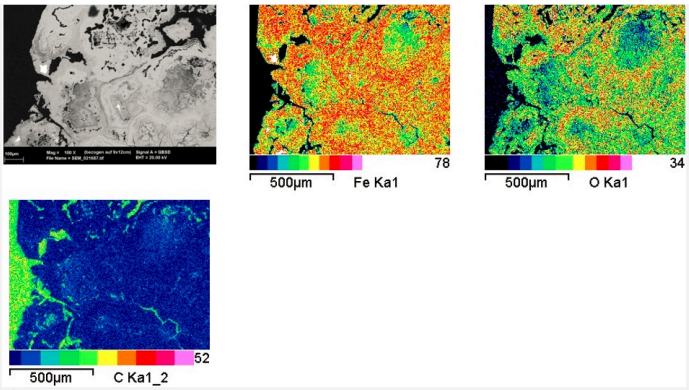
Elements	O	S	Cl	Fe	Total
Inner dark red layer (CP3)	27	1.2	1.3	72	103
Inner dark-brown layer (average of 2 similar analyses) (CP2)	31	0.9	<	66	99
Inner orange grain zone	36	<	<	63	101
Outer orange sub-layer (average of 2 similar analyses) (CP1)	35	<	<	63	98

Table 3: Chemical composition (mass %) of the corrosion crust (from Figs. 10-13). Method of analysis: SEM/EDS, Laboratory of Analytical Chemistry, Empa.

Fig. 13: SEM image, BSE-mode, and elemental chemical distribution of the selected area from Fig. 10 (rotated by 45°). Method of examination: SEM/EDS, Laboratory of Analytical Chemistry, Empa,

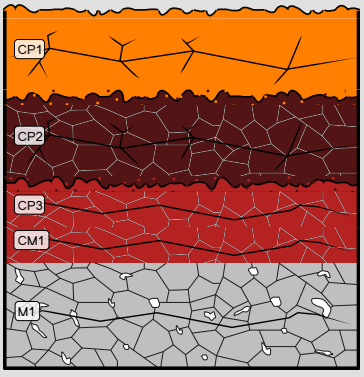
Fig. 14: Stratigraphic representation of the chisel point in cross-section (dark field) using the MiCorr application. The characteristics of the strata are only accessible by clicking on the drawing that redirects you to the search tool by stratigraphy representation. This representation can be compared to Fig. 10, Credit HE-Arc CR.
