SWORD M-SCH-B2735 - P-RICH IRON - IRON AGE - SWITZERLAND

Artefact name	Sword M-Sch-B2735
Authors	Marianne. Senn (Empa, Dübendorf, Zurich, Switzerland) & Christian. Degrigny (HE-Arc CR, Neuchâtel, Neuchâtel, Switzerland)
Url	/artefacts/901/

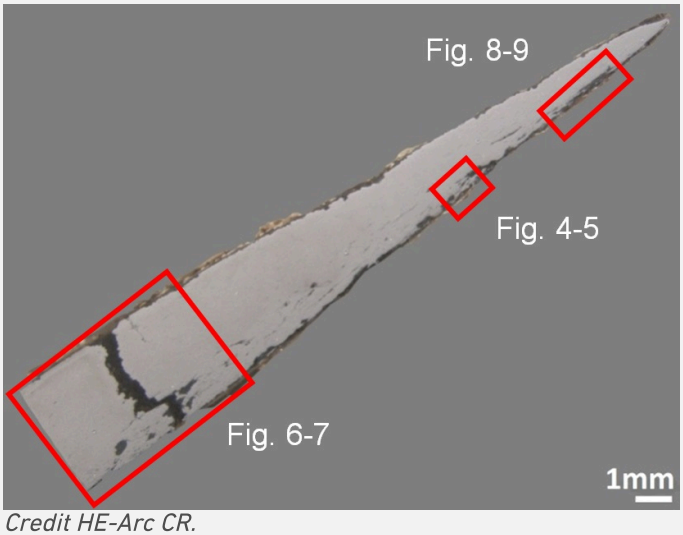
Fig. 3: Micrograph of the cross-section of the sample taken from the sword showing the location of Figs. 4 to 9,

Description of sample	The sample includes half of the sword blade (Figs. 2 and 3). The corrosion layer is thin (Fig. 3).
Alloy	P-rich iron
Technology	Forged, annealed and cold worked
Lab number of sample	M-SCH-B2735

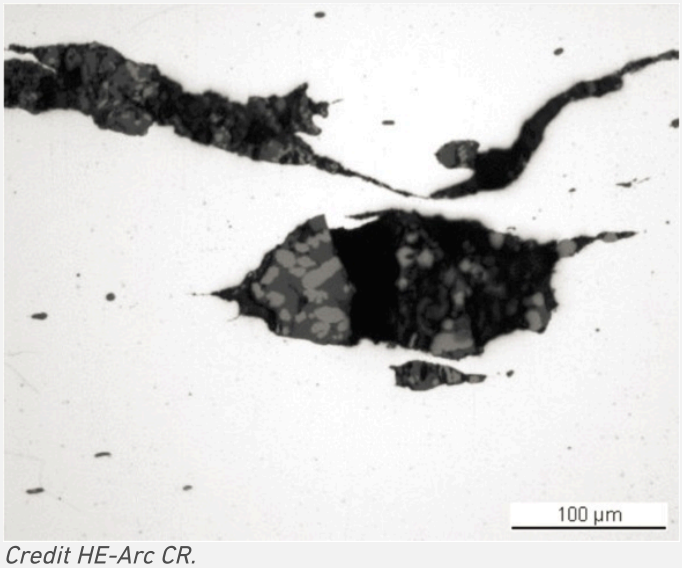
The remaining metal is a P-rich (0.2 mass%) iron (Table 1) with long parallel slag inclusions (Fig. 4) concentrated on one side of the blade. The slag inclusions are composed of wüstite/FeO dendrites and fayalite/Fe_2SiO_4 in a glassy matrix (Fig. 5 and Table 2). Their chemical composition is typical for iron produced by the bloomery process (dominated by iron oxides and silica). It is difficult to identify the ore type from the slag composition. Interestingly in one case the slag composition is very specific (alumina and P-rich material). After etching, the metal shows a ferritic structure (Fig. 6). The grain size is variable (between ASTM grain sizes of 4 to 7) and some grains include Neumann bands (Fig. 7). A large crack has developed through the metal section (Figs. 3 and 6). The average hardness of the metal (HV1 185) is quite high for a wrought iron. The level of hardness and Neumann bands are typical for a P-rich iron. Neumann bands are said to develop by cold working and shock deformation. According to Swiss and McDonnell 2003 they form when little cold work is carried out. Distortion (grain deformation) after cold working starts to be apparent in iron after a reduction in thickness of between 30-40%. Since no grain deformation is visible, the present reduction is probably a little less than this range.

Fig. 4: Micrograph of the metal sample from Fig. 3 (detail, rotated by 225°), unetched, bright field. In white the metal containing elongated slag inclusions (in grey); in black porosity,

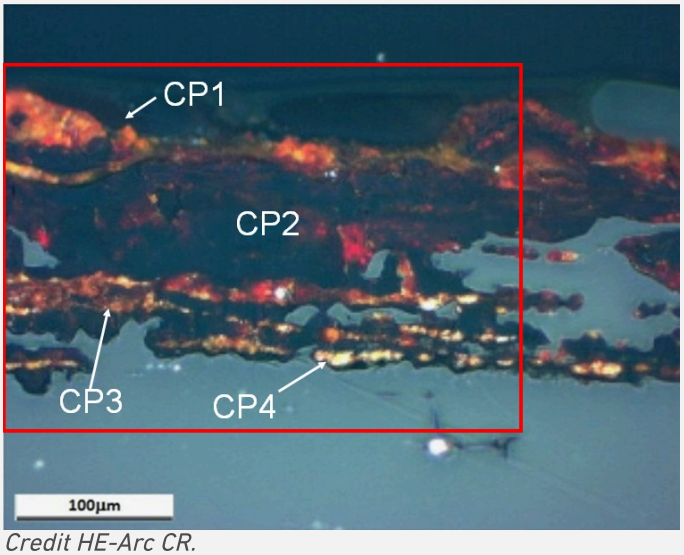
light, the richer the area is in Fe and the more depleted it is in O. Surprisingly the inner corrosion layers (CP3 and CP4) are contaminated with Si, Al and O.

Table 3: Chemical composition (mass %) of the corrosion layer (from Fig. 9). Method of analysis: SEM/EDS, Laboratory of Analytical Chemistry, Empa.

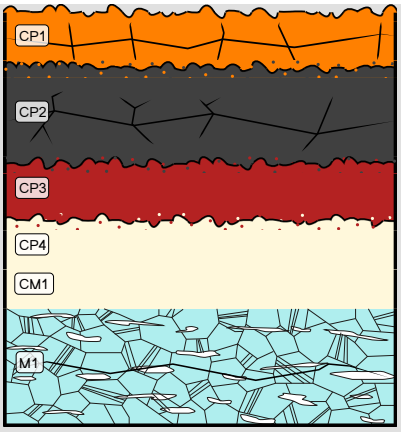
Fig. 10: Stratigraphic representation of the sample taken from the sword in cross-section (dark field) using the MiCorr application. The characteristics of the strata are only accessible by clicking on the drawing that redirects you to the search tool by stratigraphy representation. This representation can be compared to Fig. 8, Credit HE-Arc CR.
