SWORD M-SCH-B2735 - P-RICH IRON - IRON AGE - SWITZERLAND

Artefact name	Sword M-Sch-B2735
Authors	Marianne. Senn (Empa, Dübendorf, Zurich, Switzerland) & Christian. Degrigny (HE-Arc CR, Neuchâtel, Neuchâtel, Switzerland)
Url	/artefacts/901/

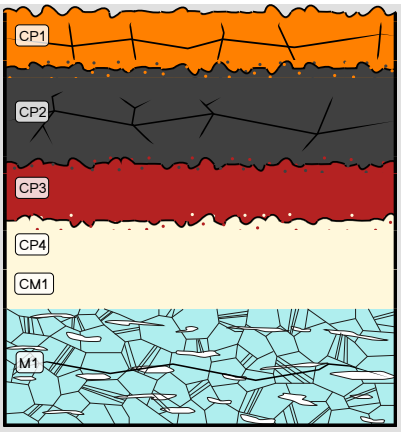
Fig. 10: Stratigraphic representation of the sample taken from the sword in cross-section (dark field) using the MiCorr application. The characteristics of the strata are only accessible by clicking on the drawing that redirects you to the search tool by stratigraphy representation. This representation can be compared to Fig. 8, Credit HE-Arc CR.
