SITULA EMT09-554.665 - TIN BRONZE - IRON AGE - SWITZERLAND

Artefact name Situla EMT09-554.665

Authors Christian. Degrigny (HE-Arc CR, Neuchâtel, Neuchâtel, Switzerland) & Marie-Jeanne. Scholl (HE-Arc CR, Neuchâtel, Neuchâtel, Switzerland) & Valentin. Boissonnas (HE-Arc CR, Neuchâtel, Neuchâtel, Switzerland)

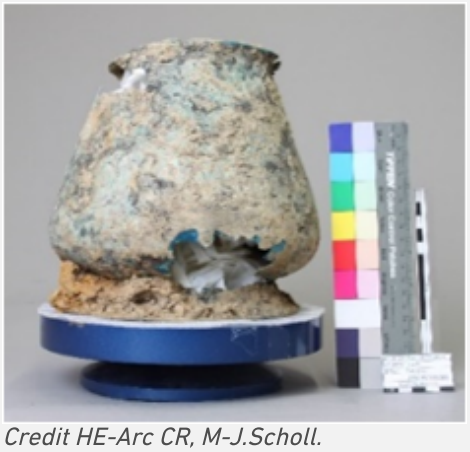
Fig. 1: Situla (Archeodunum (Gollion), 2009) inverted as found in situ,

Description of the artefact Situla (Fig. 1) covered with blue-green corrosion products and sediments. Attached to two riveted iron loops is an iron handle terminating in two swan heads (not shown here). Dimensions of the main body: Hmax = 340mm, Ømax = 220mm.

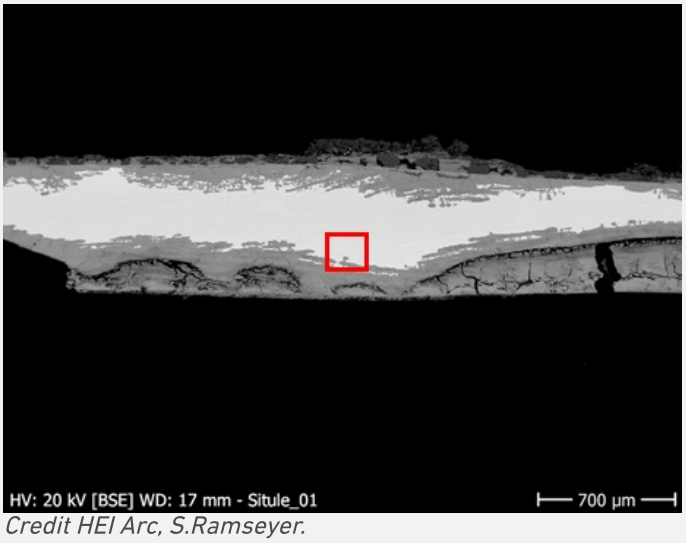
The remaining metal is a dense tin bronze (Fig. 5, Table 1), showing no inclusion. In bright field, the etched alloy shows a structure principally consisting of polygonal alpha phase grains (Fig. 6). Some of the grains include twin lines (Fig. 7). The presence of strain lines (slip lines) indicates a final cold work without annealing.

Fig. 5: SEM image, BSE-mode, of the metal sample from Fig. 4. Area of Fig. 6 is marked by a red square,

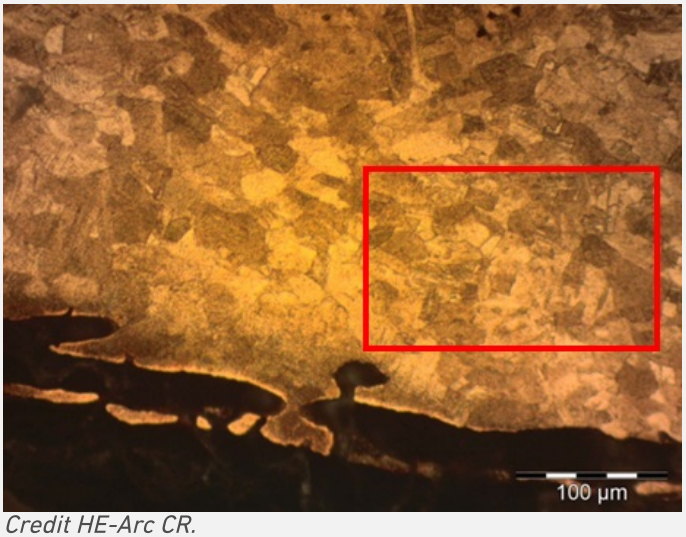
Fig. 6: Micrograph of the metal structure from Fig. 5 (detail), etched, bright field, 50x. The alpha phase of the alloy shows polygonal grains. Area of Fig. 7 is marked by a red rectangle,

Fig. 7: Micrograph of the selected area of Fig. 6, etched, bright field, 500x. The grains show both twin and strain lines,

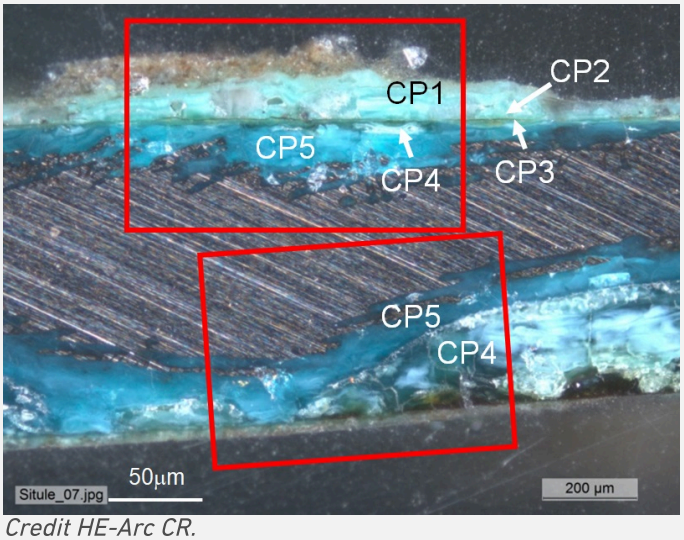
The corrosion crust is heterogeneous and has in places completely replaced the metal. The metal – corrosion products interface is irregular due to transgranular corrosion (Figs 5-6). In most cases, the corrosion crust can be divided in three main layers: first, an inner compact blue layer directly on the metal core (CP5, Figs. 8, 10 and 15 and CP3, Fig. 14). In areas of extensive corrosion this blue layer coexists with a friable light blue-green layer (CP4, Figs. 8, 10 and 15 and CP2, Fig. 14). Secondly, and depending on the area, either a very fine dark green (CP3, Figs. 8 and 15) or red corrosion layer (CP2, Figs. 10 and 15) marks the limit of the original surface. Finally, there is a fourth outer layer, consisting of friable and sometimes curly pale green corrosion products, interspersed with soil products (CP1, Figs. 8, 10 and 15). In heavily worked and fragile parts of the object a cleavage between the inner layers of blue and light blue-green corrosion is present, rendering the light blue-green corrosion vulnerable to loss (Fig. 9).

Fig. 8: Micrograph of the metal sample from Fig. 4, unetched, dark field, 50x. Areas of Fig. 9 (bottom, corresponding to the stratigraphy of Fig. 14) and Figs. 10 and 11 (top, corresponding to the stratigraphy of Fig. 15) are marked by a rectangle. Codes are those of Fig. 15,

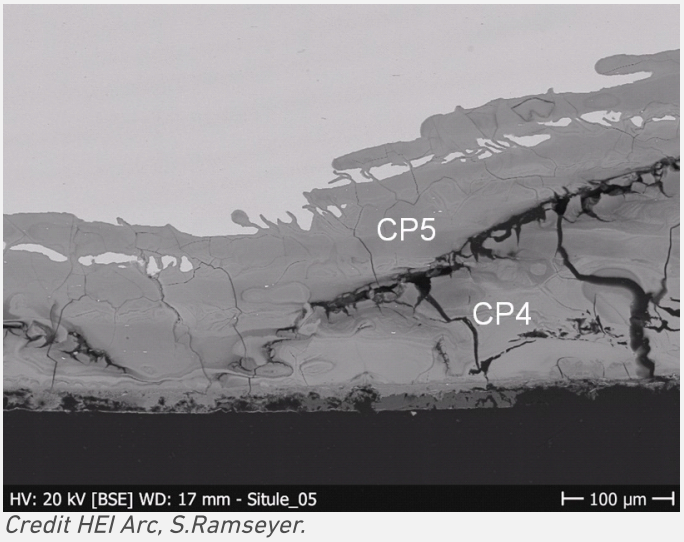
Fig. 9: SEM image, BSE-mode of the metal sample from Fig. 8 (detail) showing cleavage between the inner blue (CP5) and green (CP4) layers of Fig. 15,

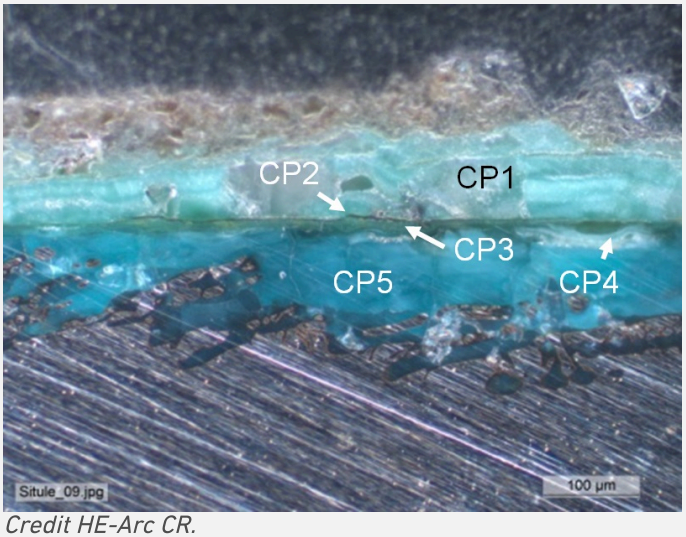
Fig. 10: Micrograph of the metal / corrosion interface (detail of Fig. 8) unetched, dark field, 100x. The outer layer (CP1 of Fig. 15) incorporates soil material and the thin dark layer (CP2 of Fig. 15) highlights the limit of the original surface,

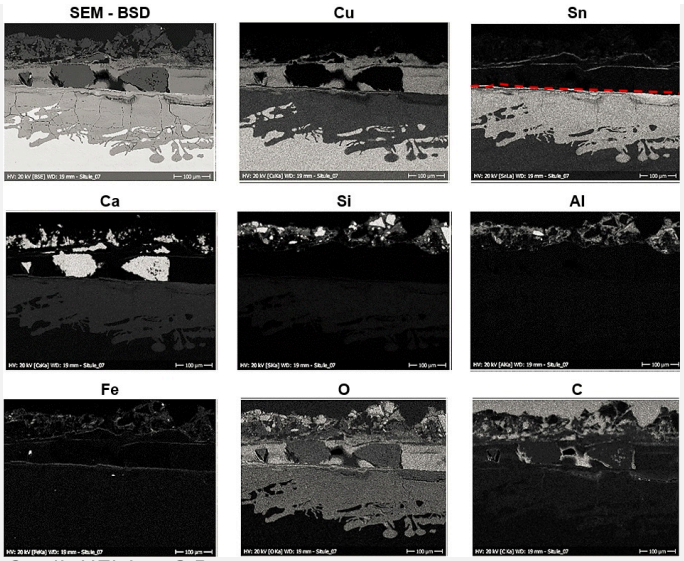
The inner layers (CP3-CP5) are Sn and O-rich and depleted in Cu (Table 2). The outer layers (CP1 and CP2) are Cu and O-rich, contain no Sn, and are contaminated with Ca, Si, Al and Fe coming from the soil (Fig. 11). The colour of the corrosion crust varies according to the content of Sn (the more Sn, the darker green or blue the corrosion). FTIR on the inner blue (CP5 and Fig. 12) and outer green (CP1 and Fig. 13) layers were difficult to interpret. Only malachite could be identified in both cases. XRD spectra could not be interpreted because of the deficiency of peaks.

Fig. 11: SEM image, SE-mode, and elemental chemical distribution of Fig. 10. In red: the limit of the original surface highlighted by the enriched tin layer. Method of examination: SEM-EDS, Lab of Electronic Microscopy and Microanalysis, IMA (Néode), HEI Arc,

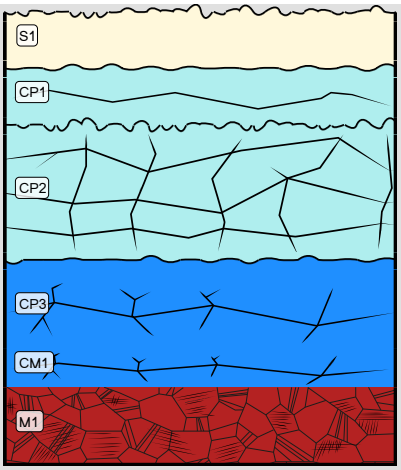
There are 2 stratigraphies (Fig. 14 corresponding to the interior face of the situla and Fig. 15 to its exterior face). The strata are similar in composition but their coding is different: CP1 to CP3 in Fig. 14 correspond to CP3 to CP5 in Fig. 15. Since the stratigraphy of Fig. 15 is more complete, the composition of each of its strata is given below.

Fig. 14: Stratigraphic representation of the sample taken from the detached fragment of the situla in cross-section (dark field) using the MiCorr application. The characteristics of the strata are only accessible by clicking on the drawing that redirects you to the search tool by stratigraphy representation. This representation shows the interior face and can be compared to Fig. 8 (bottom red rectangle), Credit HE-Arc CR, M-J.Scholl.

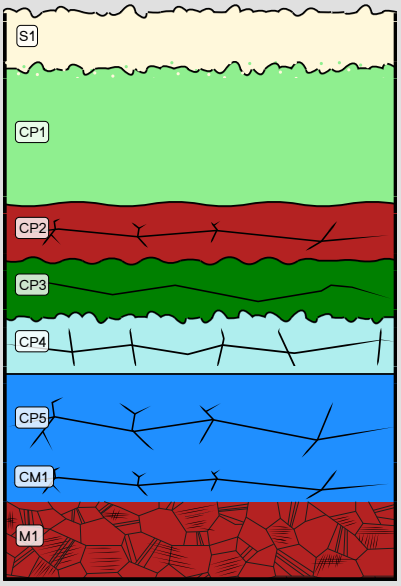
Fig. 15: Stratigraphic representation of the sample taken from the detached fragment of the situla in cross-section (dark field) using the MiCorr application. The characteristics of the strata are only accessible by clicking on the drawing that redirects you to the search tool by stratigraphy representation. This representation shows the exterior face and can be compared to Fig. 8 (top red rectangle), Credit HE-Arc CR, M-J.Scholl.
