SITULA EMT09-554.665 - TIN BRONZE - IRON AGE - SWITZERLAND

Artefact name Situla EMT09-554.665

Authors Christian. Degrigny (HE-Arc CR, Neuchâtel, Neuchâtel, Switzerland) & Marie-Jeanne. Scholl (HE-Arc CR, Neuchâtel, Neuchâtel, Switzerland) & Valentin. Boissonnas (HE-Arc CR, Neuchâtel, Neuchâtel, Switzerland)

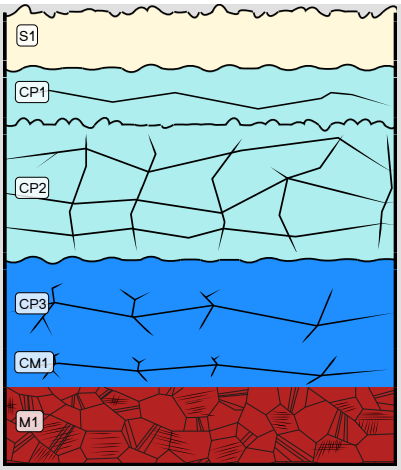
There are 2 stratigraphies (Fig. 14 corresponding to the interior face of the situla and Fig. 15 to its exterior face). The strata are similar in composition but their coding is different: CP1 to CP3 in Fig. 14 correspond to CP3 to CP5 in Fig. 15. Since the stratigraphy of Fig. 15 is more complete, the composition of each of its strata is given below.

Fig. 14: Stratigraphic representation of the sample taken from the detached fragment of the situla in cross-section (dark field) using the MiCorr application. The characteristics of the strata are only accessible by clicking on the drawing that redirects you to the search tool by stratigraphy representation. This representation shows the interior face and can be compared to Fig. 8 (bottom red rectangle), Credit HE-Arc CR, M-J.Scholl.

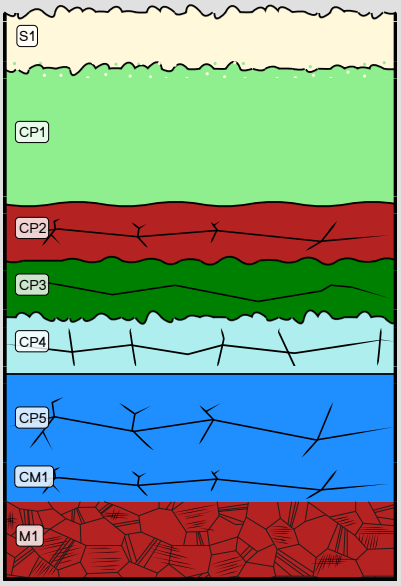
Fig. 15: Stratigraphic representation of the sample taken from the detached fragment of the situla in cross-section (dark field) using the MiCorr application. The characteristics of the strata are only accessible by clicking on the drawing that redirects you to the search tool by stratigraphy representation. This representation shows the exterior face and can be compared to Fig. 8 (top red rectangle), Credit HE-Arc CR, M-J.Scholl.
