SACRIFICIAL ANODE VHS-8339 - ZN ALLOY - MODERN TIMES

Artefact name	Sacrificial anode VHS-8339
Authors	Marianne. Senn (Empa, Dübendorf, Zurich, Switzerland) & Christian. Degrigny (HE-Arc CR, Neuchâtel, Neuchâtel, Switzerland)
Url	/artefacts/904/

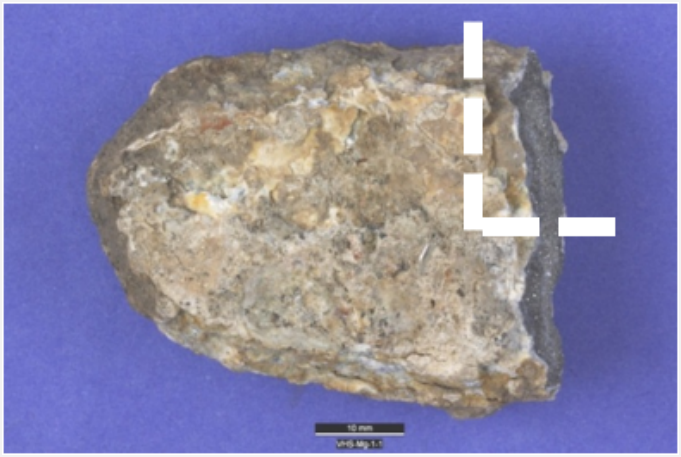
Fig. 1: Sacrificial anode (left) from submarine "Mesoscaph" (right) (www.verkehrshaus.ch),

Description of the artefact	The artefact could be a weight or sacrificial anode of a submarine (Fig. 1). It is surrounded by a whitish brown-grey corrosion crust. The broken metal has a greyish shiny colour. Dimensions: L = 4.9cm ; WT = 95g.
Type of artefact	Submarine part
Origin	Submarine “Mesoscaph” from Auguste Piccard
Recovering date	The sacrificial anodes (?) might have been added when the submarine was used in the sea.
Chronology category	Modern Times
chronology tpq	1970 A.D.
chronology taq	1974 A.D.
Chronology comment	
Burial conditions / environment	Outdoor atmosphere
Artefact location	Swiss Museum of Transport, Luzern, Lucerne
Owner	Swiss Museum of Transport, Luzern, Lucerne

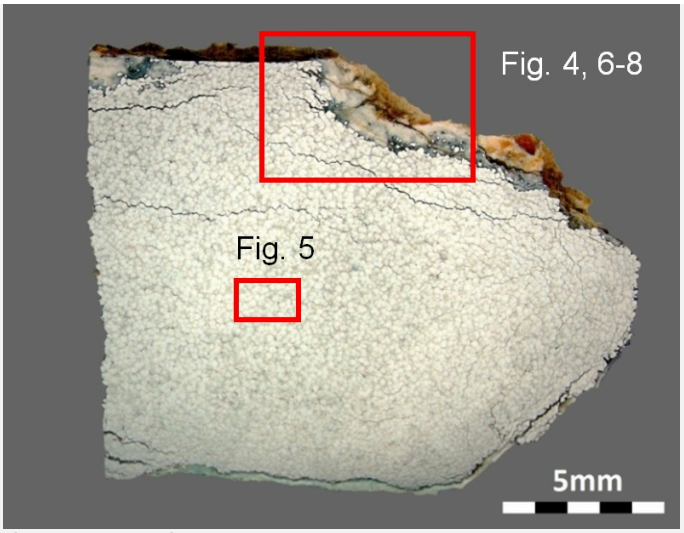
Fig. 3: Micrograph of the cross-section of the fragment sampled from the sacrificial anode showing the location of Figs. 4 to 8,

Description of sample	The sample (Fig. 3) shows a cross-section from the fragment of the sacrificial anode (Fig. 2). It has a silvery appearance. The thickness of the corrosion crust is variable. Dimensions: L = 17mm; W = 14mm.
Alloy	Zn Alloy
Technology	Cast and annealed
Lab number of sample	VHS-Mq-1
Sample location	HE-Arc CR, Neuchâtel, Neuchâtel
Responsible institution	Swiss Museum of Transport, Luzern, Lucerne
Date and aim of sampling	07/09/2009 metallography

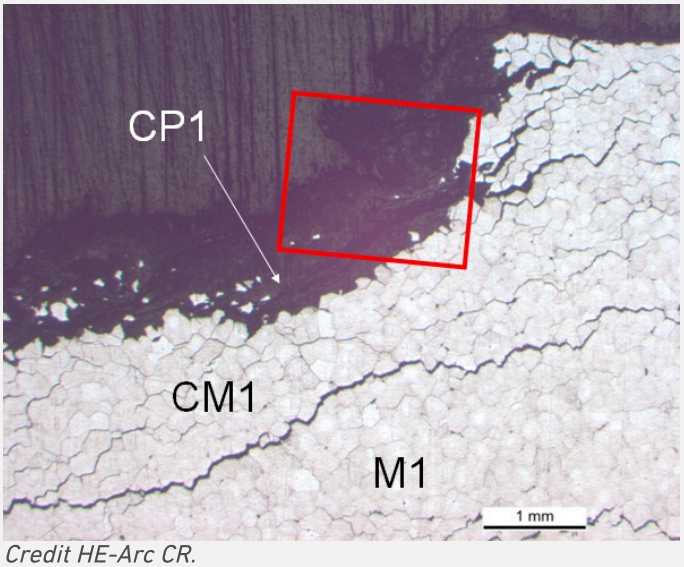
The remaining metal is an almost pure zinc alloy (Table 1). The oxygen content is not from the original alloy, but is due to secondary corrosion. The metal grains are visible without etching and present a polygonal structure (Figs. 4 and 5). The structure is recrystallised after annealing. The recrystallization of zinc alloys begins at room temperature.

Table 1: Chemical composition (mass %) of the metal. Method of analysis: SEM/EDS, Lab Analytical Chemistry, Empa.

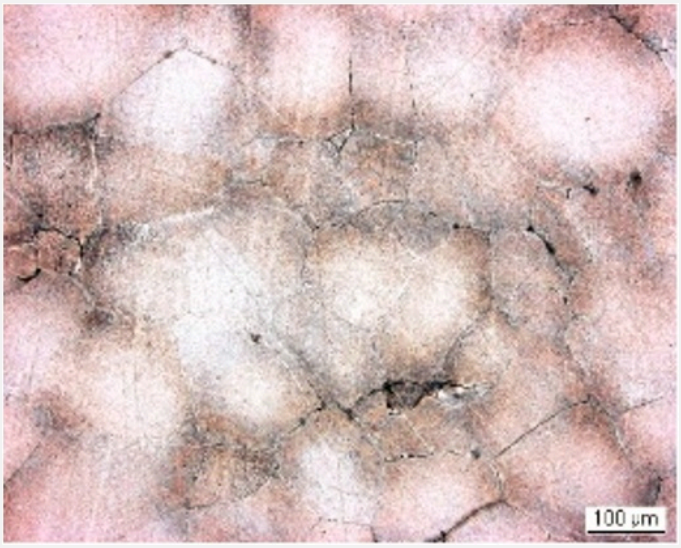
Fig. 4: Micrograph of the metal sample from Fig. 3 (reversed picture, detail), unetched, bright field. Extensive intergranular corrosion is visible.The rectangle marks Fig. 6,

Extensive intergranular corrosion / cracking has developed in the metal structure (Figs. 4, 5). The metal is covered by a corrosion crust that is hardly visible in bright field and which contains remnant metal (Fig. 4). On most of the sample the corrosion crust is uniform. In areas we see cracks (Fig. 6) appearing as brown lines separating the corrosion crust (Fig. 7). In bright field the corrosion crust appears grey containing dark-grey zones (Fig. 6). Under polarized light, the corrosion crust appears white with darker parts including remnant metal (Fig. 7). It contains Zn and O as well as S along some cracks (Table 2 and Fig. 8).

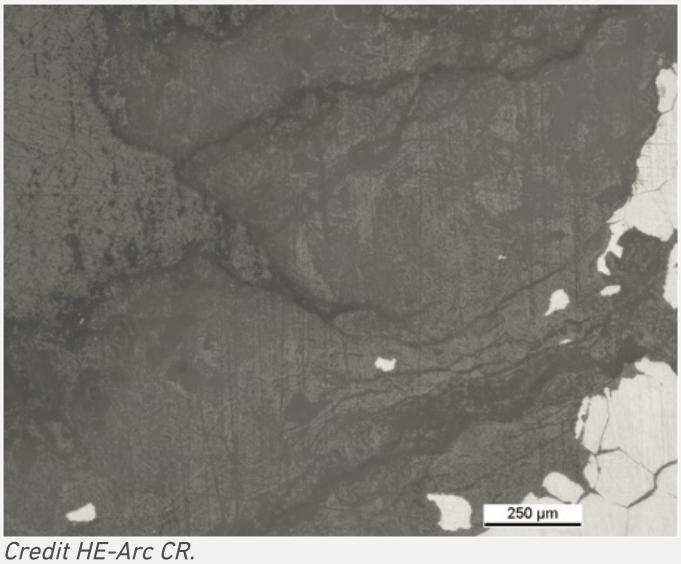
Fig. 6: Micrograph showing the metal - corrosion products interface from Fig. 5 (detail), unetched, bright field,

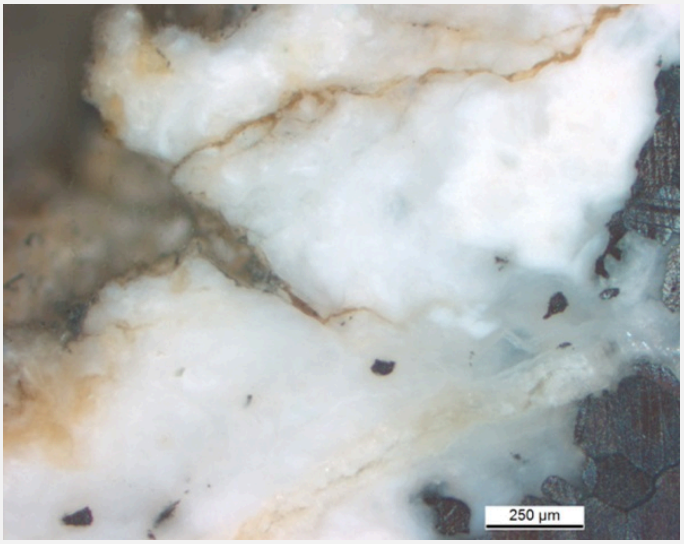
Fig. 7: Micrograph (same as Fig. 6) corresponding to the stratigraphy of Fig. 4, unetched, polarised light. We observe in dark-grey the metal, in white the corrosion crust separated by brown cracks including remnant metal,

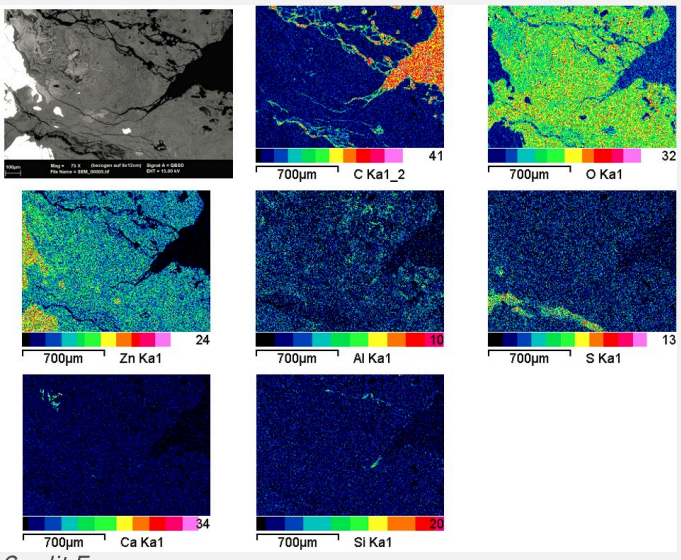
Fig. 8: SEM image, BSE-mode, and elemental chemical distribution of most of the area of Fig. 6 (reversed picture). Method of examination: SEM/EDS, Laboratory of Analytical Chemistry, Empa,

thick corrosion layer seems to consist of oxides or hydroxides. The origin of the sulphur along some of the cracks is unclear. Extensive intergranular corrosion/cracking has developed in the metal structure.

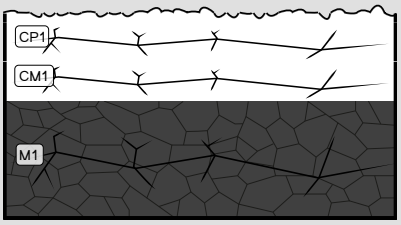
Fig. 9: Stratigraphic representation of the fragment sampled from the sacrificial anode in cross-section (dark field) using the MiCorr application. The characteristics of the strata are only accessible by clicking on the drawing that redirects you to the search tool by stratigraphy representation. This representation can be compared to Fig. 5, Credit HE-Arc CR.
