ROUND BRACELET WITH UNIFORM INCLINED INDENTATIONS B3482 - LEADED BRONZE - LATE BRONZE AGE - SWITZERLAND

Artefact name Round bracelet with uniform inclined indentations B3482

Authors Marianne. Senn (Empa, Dübendorf, Zurich, Switzerland) & Christian. Degrigny (HE-Arc CR, Neuchâtel, Neuchâtel, Switzerland)

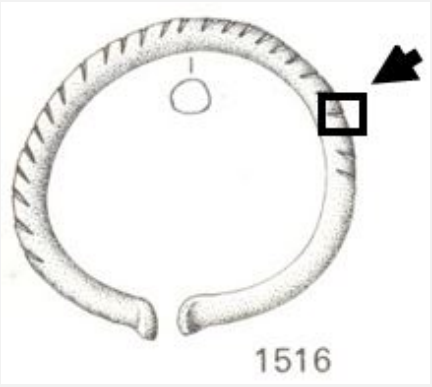
Fig. 2: Location of sampling area,

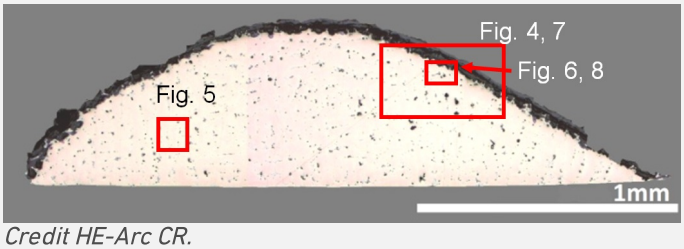
Fig. 3: Micrograph of the cross-section of the sample taken from the bracelet with uniform inclined rib showing the location of Figs. 4 to 8,

Description of sample	The sample is a section from the central part of the bracelet (Fig. 2). Its dimensions are: L = 2.5mm and W = 0.65mm. The corrosion layer is relatively thin (Fig. 3).
Alloy	Leaded Bronze
Technology	As-cast
Lab number of sample	MAH 77-110-5
Sample location	Musées d'art et d'histoire, Genève, Geneva
Responsible institution	Musées d'art et d'histoire, Genève, Geneva
Date and aim of sampling	1977 and 1991, study of the corrosion layer, metal composition

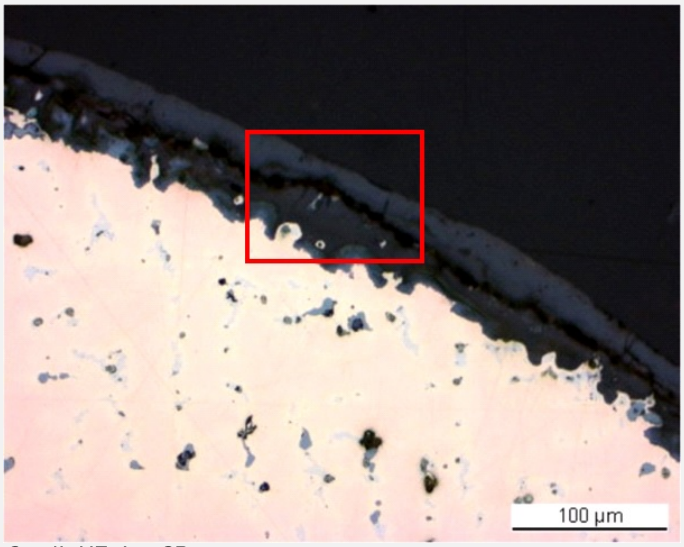
The remaining metal is a porous leaded bronze (Fig. 4 and Table 1). In bright field dark-blue copper sulphide (Fig. 4, Table 2) and tiny dark-grey Pb inclusions (Fig. 5) can be seen. The Sn-rich eutectoid alpha + delta phase appears in light-blue (Fig. 4) and incorporates Pb-rich inclusions. The etched leaded bronze has the dendritic structure of an as-cast metal (Fig. 5) with an average hardness HV1 90. After etching the inclusions have turned darker (Fig. 5) while the eutectoid phase appears whiter.

Fig. 4: Micrograph of the metal sample from Fig. 3 (detail), unetched, bright field. In pink the metal with porosity (black), light-blue the alpha-delta eutectoid, dark-grey lead inclusions and dark-blue copper sulphide inclusions. The rectangle marks the detail image of Fig. 5,

The interface between the metal and corrosion products is irregular (Fig. 4). The corrosion crust has an average thickness of 70µm and is composed of two layers separated by a large fissure (Figs. 4 and 6). In bright field, the inner layer includes remnant metal (Sn-rich eutectoid phase, Figs. 4 and 6) and is dark-grey (Fig. 4) while in polarised light it is orange-brownish (CP3, Fig. 7). This Cu depleted layer is rich in Sn, Fe, Si and O (Table 3 and Fig. 7). At the metal -

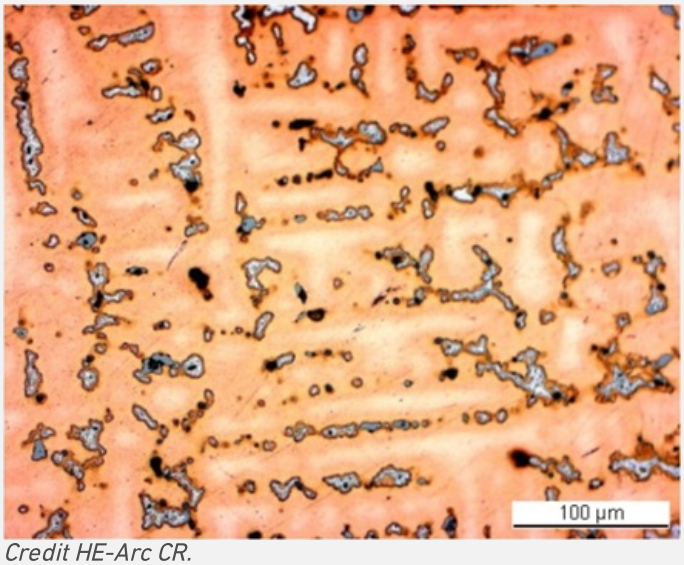
Fig. 5: Micrograph of the metal sample from Fig. 3 (detail), etched, bright field. The leaded bronze has the dendritic structure of an as-cast metal with the Sn-rich eutectoid alpha + delta phase appearing in white at the dendrites borders,

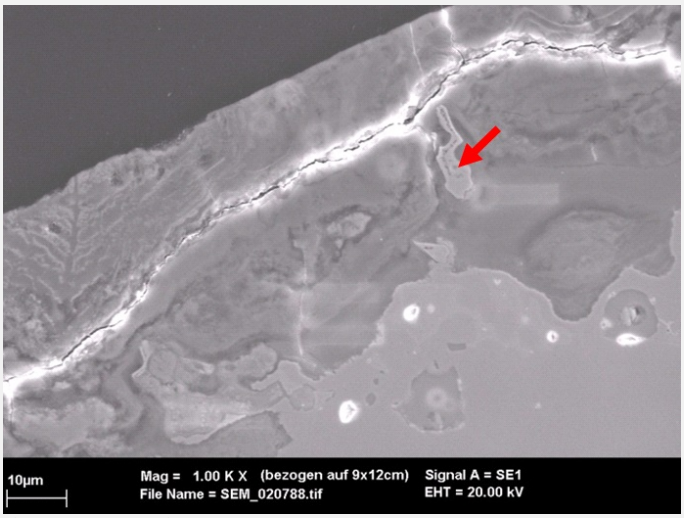
Fig. 6: SEM image of the metal sample (detail of Fig. 4, reversed picture), SE-mode. From bottom right to top left: the metal, the inner and outer corrosion layers separated by a large fissure. The red arrow indicates a remnant of the Sn-rich alpha-delta eutectoid,

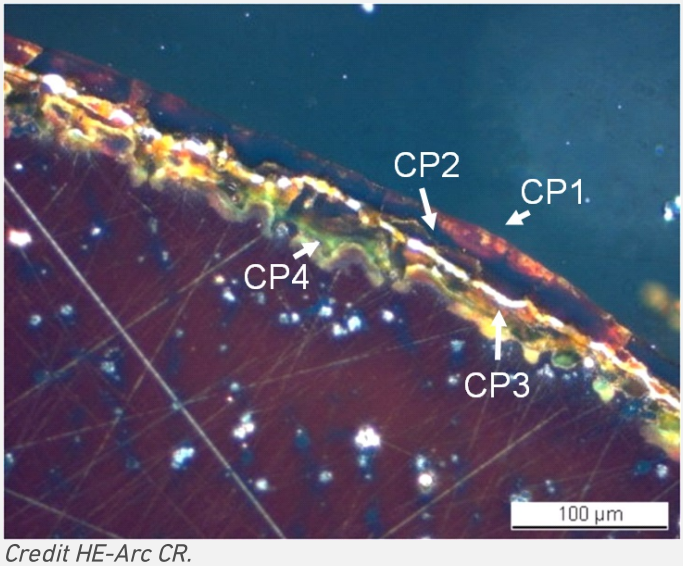
inner layer interface a corrosion product (CP4, light-grey in bright field, greenish in polarised light) shows a slight increase in Cu and Sn content but a decrease of the Fe content (Table 3). In bright field, the outer dense layer is light-grey (CP2, Fig. 5) while in polarised light it appears black with superimposed red to orange areas (CP1, Fig. 7). It is depleted of Cu and richer in Fe. The Sn content is variable but increases in the top brown areas (Table 3 and Fig. 8).

Fig. 7: Micrograph similar to Fig. 4 and corresponding to the stratigraphy of Fig. 9, polarised light. From bottom left to top right: the metal with blue inclusions and porosities in white, the inner corrosion layer in green, red and orange waves, the fissure in white and the outer corrosion layer in black and red (top zone),

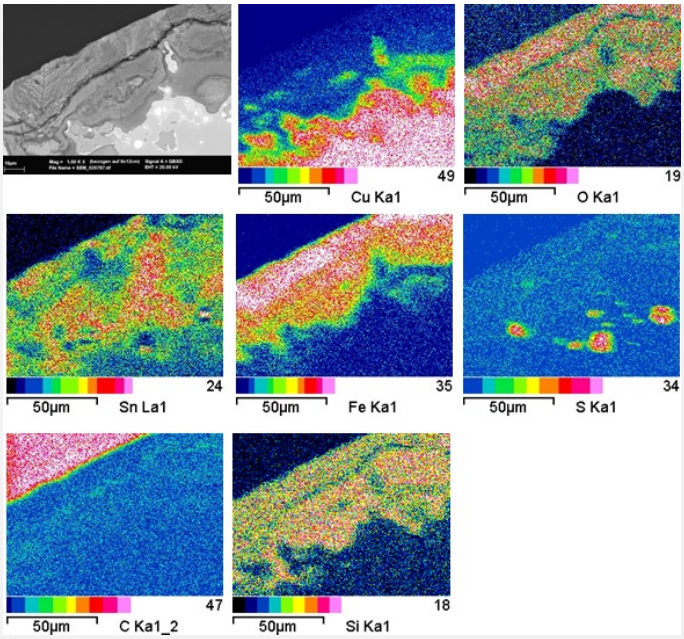
Table 3: Chemical composition (mass %) of corrosion layers from Fig. 8. Method of analysis: SEM/EDS, Laboratory of Analytical Chemistry, Empa.

Fig. 8: SEM image, BSE-mode, and elemental chemical distribution of the area of Fig. 6. The S mapping includes the copper sulphide and Pb inclusions, because of a peak interference. Method of examination: SEM/EDS, Laboratory of Analytical Chemistry, Empa,
