ROUND BRACELET WITH UNIFORM INCLINED INDENTATIONS B3482 - LEADED BRONZE - LATE BRONZE AGE - SWITZERLAND

Artefact name Round bracelet with uniform inclined indentations B3482

Authors Marianne. Senn (Empa, Dübendorf, Zurich, Switzerland) & Christian. Degrigny (HE-Arc CR, Neuchâtel, Neuchâtel, Switzerland)

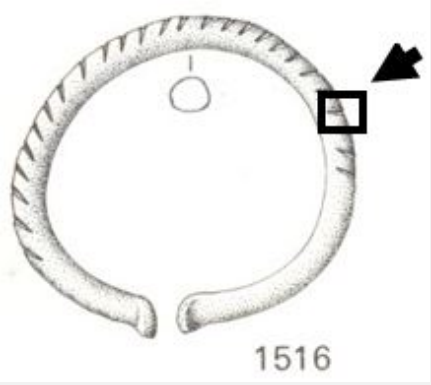
Fig. 1: Round bracelet with uniform inclined indentations (after Paszthory 1985, Tafel 137),

Description of the artefact Round bracelet with uniform inclined indentations after Paszthory (1985, 207). Dimensions: Ø = 4cm; WT = 18g (Fig. 1).

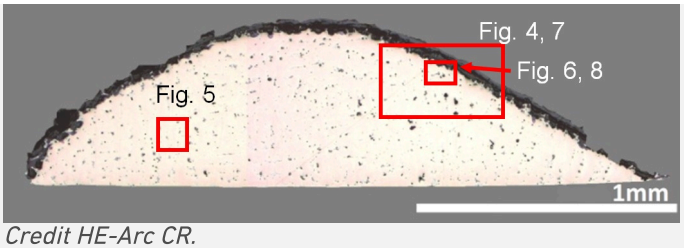
Fig. 3: Micrograph of the cross-section of the sample taken from the bracelet with uniform inclined rib showing the location of Figs. 4 to 8,

Description of sample	The sample is a section from the central part of the bracelet (Fig. 2). Its dimensions are: L = 2.5mm and W = 0.65mm. The corrosion layer is relatively thin (Fig. 3).
Alloy	Leaded Bronze
Technology	As-cast
Lab number of sample	MAH 77-110-5
Sample location	Musées d'art et d'histoire, Genève, Geneva
Responsible institution	Musées d'art et d'histoire, Genève, Geneva
Date and aim of sampling	1977 and 1991, study of the corrosion layer, metal composition

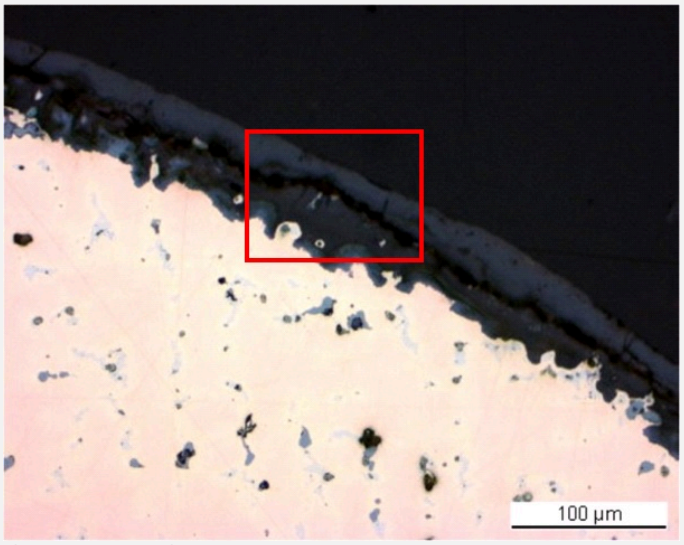
The remaining metal is a porous leaded bronze (Fig. 4 and Table 1). In bright field dark-blue copper sulphide (Fig. 4, Table 2) and tiny dark-grey Pb inclusions (Fig. 5) can be seen. The Sn-rich eutectoid alpha + delta phase appears in light-blue (Fig. 4) and incorporates Pb-rich inclusions. The etched leaded bronze has the dendritic structure of an as-cast metal (Fig. 5) with an average hardness HV1 90. After etching the inclusions have turned darker (Fig. 5) while the eutectoid phase appears whiter.

Fig. 4: Micrograph of the metal sample from Fig. 3 (detail), unetched, bright field. In pink the metal with porosity (black), light-blue the alpha-delta eutectoid, dark-grey lead inclusions and dark-blue copper sulphide inclusions. The rectangle marks the detail image of Fig. 5,

The interface between the metal and corrosion products is irregular (Fig. 4). The corrosion crust has an average thickness of 70µm and is composed of two layers separated by a large fissure (Figs. 4 and 6). In bright field, the inner layer includes remnant metal (Sn-rich eutectoid phase, Figs. 4 and 6) and is dark-grey (Fig. 4) while in polarised light it is orange-brownish (CP3, Fig. 7). This Cu depleted layer is rich in Sn, Fe, Si and O (Table 3 and Fig. 7). At the metal - inner layer interface a corrosion product (CP4, light-grey in bright field, greenish in polarised light) shows a slight increase in Cu and Sn content but a decrease of the Fe content (Table 3). In bright field, the outer dense layer is light-grey (CP2, Fig. 5) while in polarised light it appears black with superimposed red to orange areas (CP1, Fig. 7). It is depleted of Cu and richer in Fe. The Sn content is variable but increases in the top brown areas (Table 3 and Fig. 8).

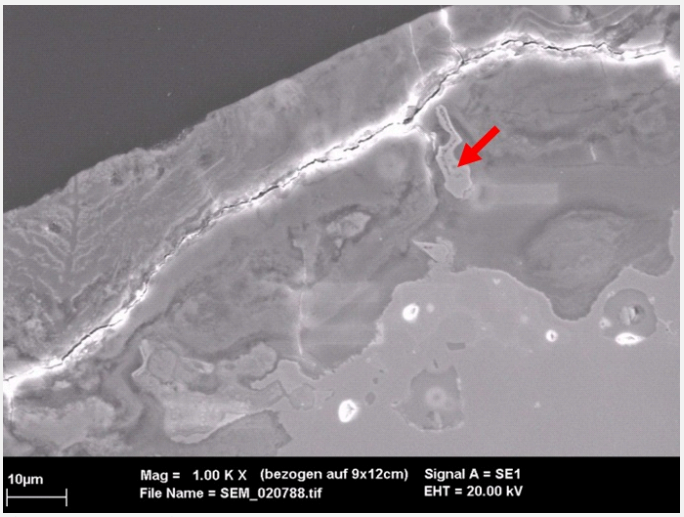
Fig. 6: SEM image of the metal sample (detail of Fig. 4, reversed picture), SE-mode. From bottom right to top left: the metal, the inner and outer corrosion layers separated by a large fissure. The red arrow indicates a remnant of the Sn-rich alpha-delta eutectoid,

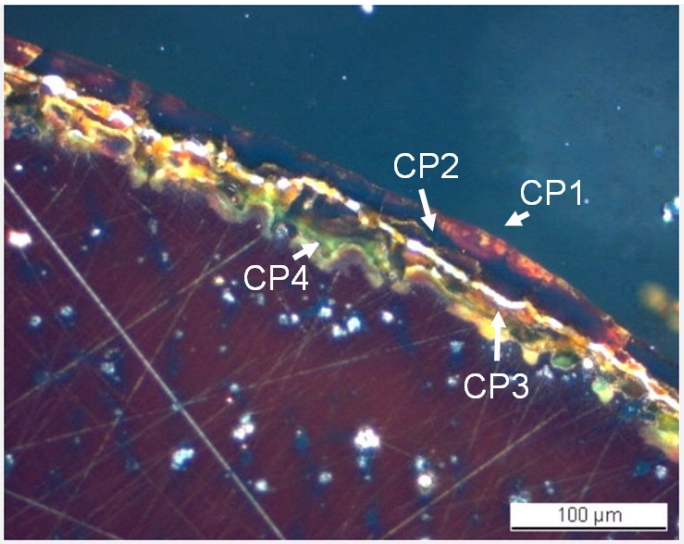
Fig. 7: Micrograph similar to Fig. 4 and corresponding to the stratigraphy of Fig. 9, polarised light. From bottom left to top right: the metal with blue inclusions and porosities in white, the inner corrosion layer in green, red and orange waves, the fissure in white and the outer corrosion layer in black and red (top zone),

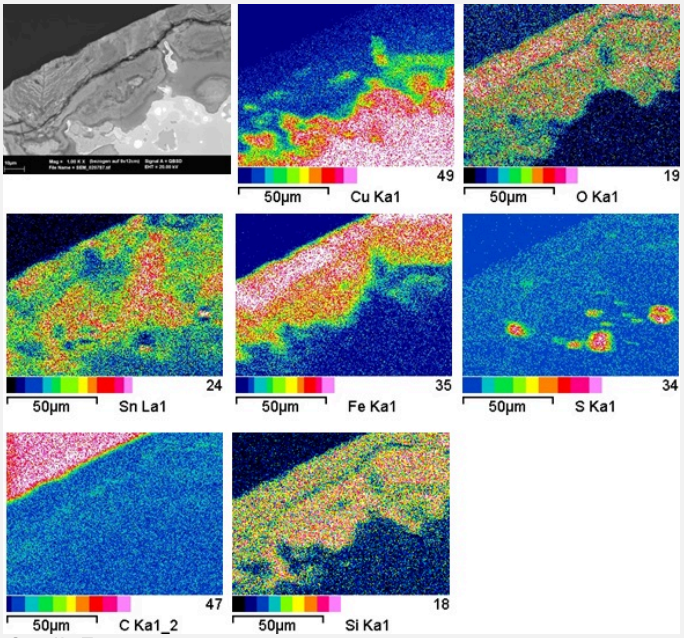
Table 3: Chemical composition (mass %) of corrosion layers from Fig. 8. Method of analysis: SEM/EDS, Laboratory of Analytical Chemistry, Empa.

Fig. 8: SEM image, BSE-mode, and elemental chemical distribution of the area of Fig. 6. The S mapping includes the copper sulphide and Pb inclusions, because of a peak interference. Method of examination: SEM/EDS, Laboratory of Analytical Chemistry, Empa,

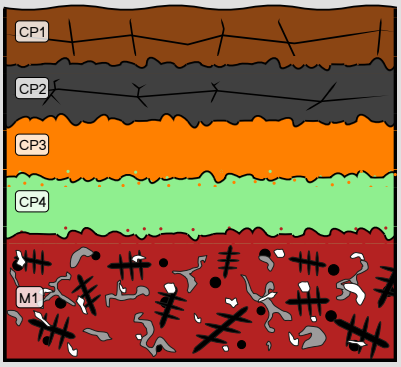
Fig. 9: Stratigraphic representation of the sample taken from the bracelet with uniform inclined rib in cross-section (dark field) using the MiCorr application. The characteristics of the strata are only accessible by clicking on the drawing that redirects you to the search tool by stratigraphy representation. This representation can be compared to Fig. 7, Credit HE-Arc CR.

The leaded bronze shows an as-cast structure. The metal surface is selectively corroded, showing a remnant Sn-rich phase in the inner corrosion layer. Because of this remnant metallic structure, the corrosion type is similar to a type 2 corrosion after Robbiola et al. 1998. In this case, two corrosion processes have occurred in parallel: a typical Cu depletion and Sn enrichment, but at the same time a surface enrichment with Fe and Si that could be explained by an Fe-rich lake environment.
